## RESPONSE OF A 25-STORY SRC RESIDENTIAL BUILDING DURING THE HYOGO-KEN NANBU EARTHQUAKE

NOBUYOSHI SAWAI, MIKIO TANAKA, RYUJI KOBORI

### ABSTRACT

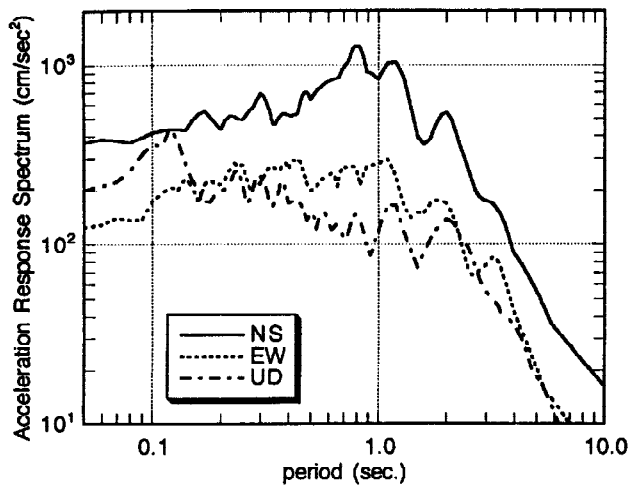
Fig.5 Acceleration response spectrum at the basement

***Frequency Component of the Recorded Motion*** Fig.5 shows the acceleration response spectra of the recorded motion at the basement for three observed components; NS, EW and UD. It was checked that the interpolation of the saturated data in NS direction did not affect much the response spectrum. From this figure, it can be seen that NS component has three dominant peaks at 0.8 second, 1.2 second and 2

second, while EW component does not have prominent peaks. The peak acceleration at 0.8 second in NS component exceeds  $1000 \text{ cm/sec}^2$ , which brings the validity to the interpolated acceleration record at the 24th floor;  $956 \text{ cm/sec}^2$ . The response in EW component holds lower than  $300 \text{ cm/sec}^2$  in the most of period range.

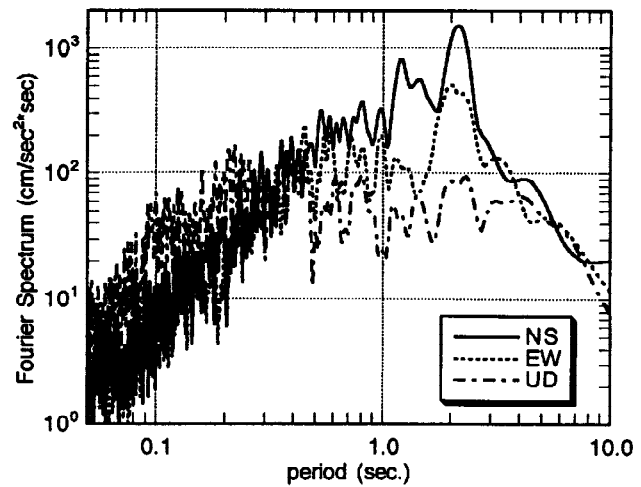
Fig.6 Fourier spectrum at the 24th floor

Fig.6 shows the Fourier spectra of the recorded motion at the 24th floor with Hanning window processing. It was checked that the effects of the interpolation of the saturated data were negligible in these frequency analyses. The prominent peak at around 2 second in both NS and EW component seems to be the principal period of the structure under the strong motion. Those natural periods are longer than the period of design model; which are described in the next section, as the design periods are for small amplitudes of motion.

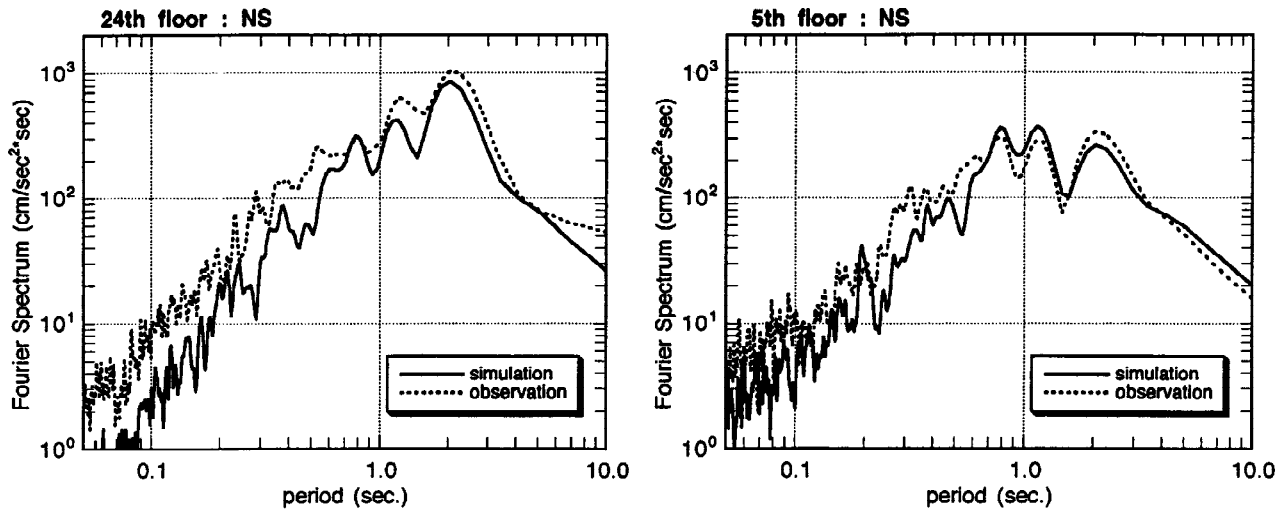
Fig.8 Fourier spectrum of simulated acceleration response in NS direction

Fig.8 shows the Fourier spectra of the simulated and the observed motions for NS direction. The left panel is for the 24th floor and the right panel is for the 5th floor. Comparing the simulation and the observation in the charts, notice that discord between them becomes larger in shorter period range; or higher frequency range. This can be attributed to the property of internal viscous damping that is applied to the design model, which becomes larger as frequency becomes higher. Regarding the dominant peaks

of the response between 0.8 second and 2 seconds, there are fairly well correspondence between the simulation and the observation.

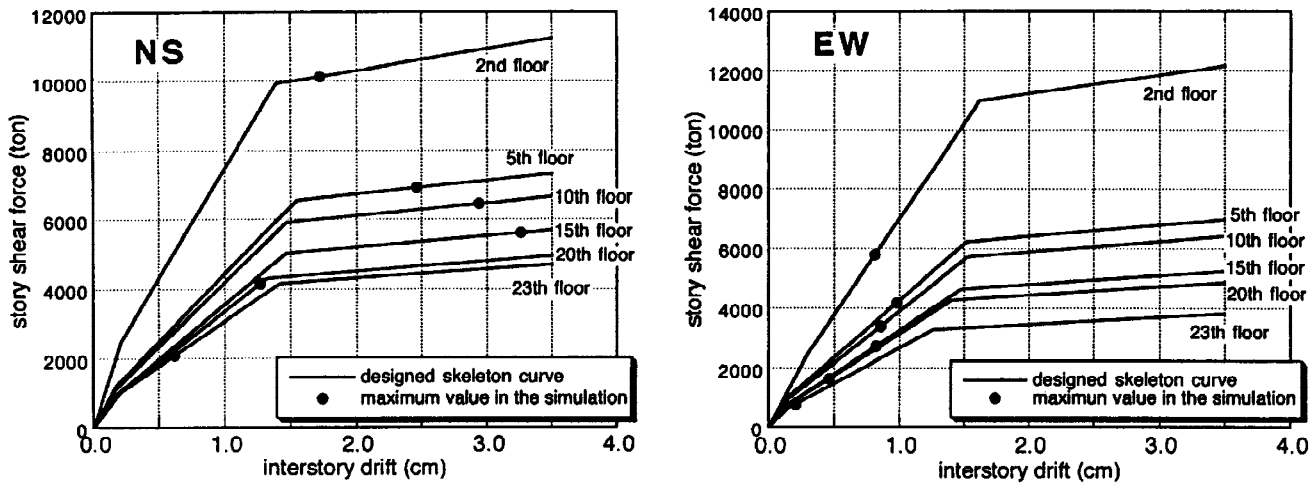
Fig.11 Maximum interstory drift and maximum story shear in the simulation

Fig.11 shows maximum interstory drift and maximum story shear force at several floors in the simulation.
