REPAIR OF DAMAGED STEEL MOMENT FRAME CONNECTIONS WITH BOLTED BRACKETS

ABSTRACT

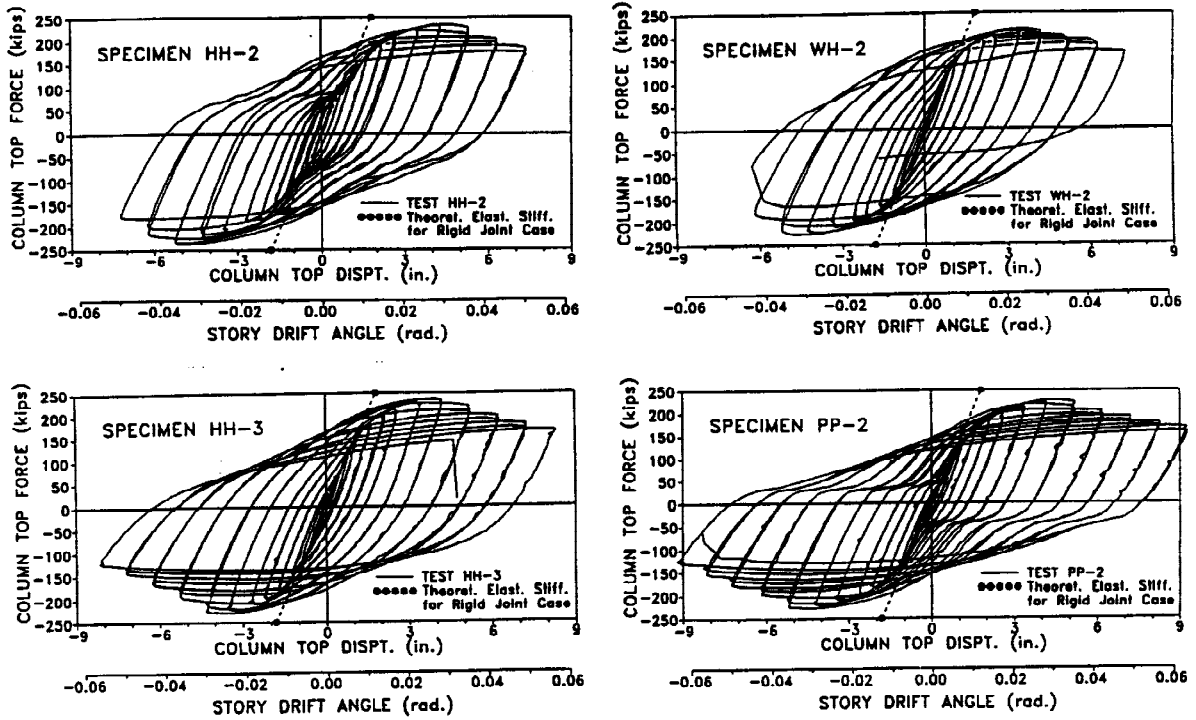
Fig.3(a) Column Top Deflection vs. Column Top Force Relationship for Phase 2 Tests.

The results of testing verified that the Kaiser/Lehigh Bolted Connections provide rigid moment frame connections with high ductility and without changing the elastic stiffness of the joint. Plastic rotational ductility, measured at the hinge, varied from 0.05 to 0.08 radians. The maximum story drifts were between 4% and 6% for the beam-column subassembly. In all cases plastic hinging through ductile yielding occurred in the beam while the connections remained largely elastic. In no cases did any bolts, plates, or welds fail in the bolted connections. The hysteretic curves for phases 1 and 2 are shown in figures 2 and 3.
