EARTHQUAKE SCENARIOS IN GUERRERO MEXICO, AN EARTHQUAKE HAZARD CHARACTERIZATION

Alonso GOMEZ-BERNAL¹, Hugon JUAREZ-GARCIA¹, Eduardo ARELLANO-MENDEZ¹, and
Emilio SORDO-ZABAY¹

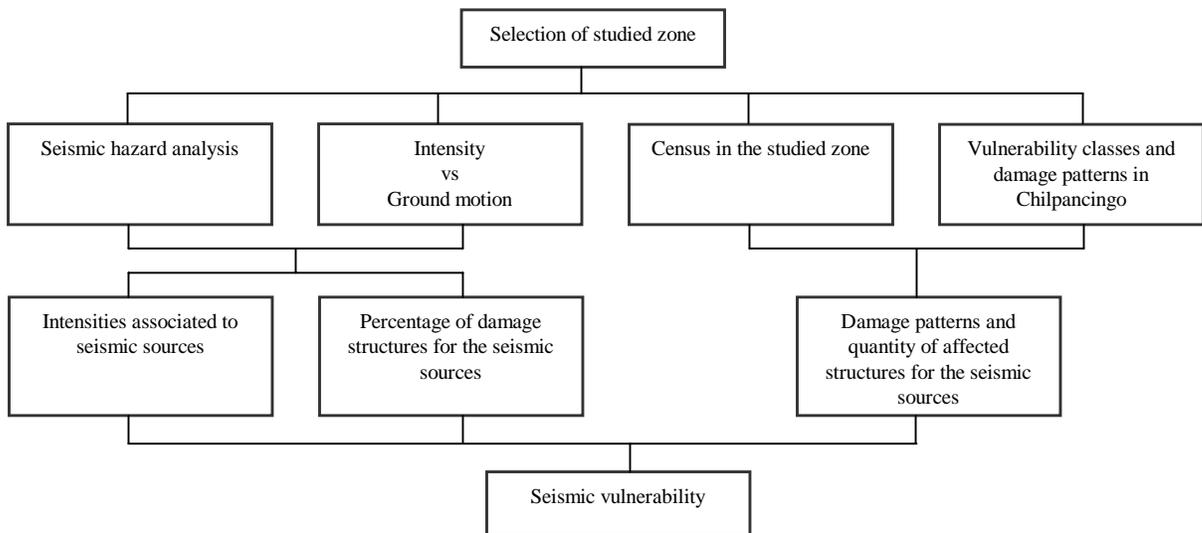
Figure 2: Methodology

It was necessary to determine a zone of study for Chilpancingo, the downtown area of Chilpancingo was selected, where past earthquakes inflicted severe damage, Figure 3; a description of structures was constructed by the structural census of more than 1300 structures and a data base was established. The seismic hazard analysis for Chilpancingo was started since 1999 [3]. The EMS (98) was selected because it considered different types of structures, such as adobe structures, masonry structures, and those with no technical advice; values for intensities and peak ground acceleration values were determined and used by Münchener [4]. The characterization of more than 1300 structures was carried out with a census, in order to identify those typical structures for the studied zone of Chilpancingo. It was necessary to slightly modify the EMS 98, so it can be possible to estimate the damage and vulnerability for those particular structures. The methodology proposed for this paper is illustrated in Figure 2.

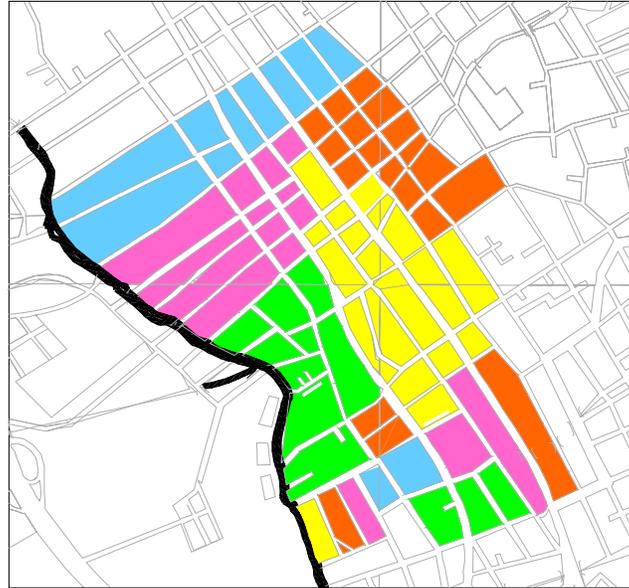
Figure 3: Studied zone for Chilpancingo, Guerrero.

According to the seismic history of Chilpancingo, it was observed that damages pattern occurred without systematic variation in the city. In Figure 3, Huacapa river is depicted in a black line, in colored squares are presented the blocks in the studied zone of Chilpancingo, the downtown area of the city, those blocks of the city include commercial, service and residential structures.

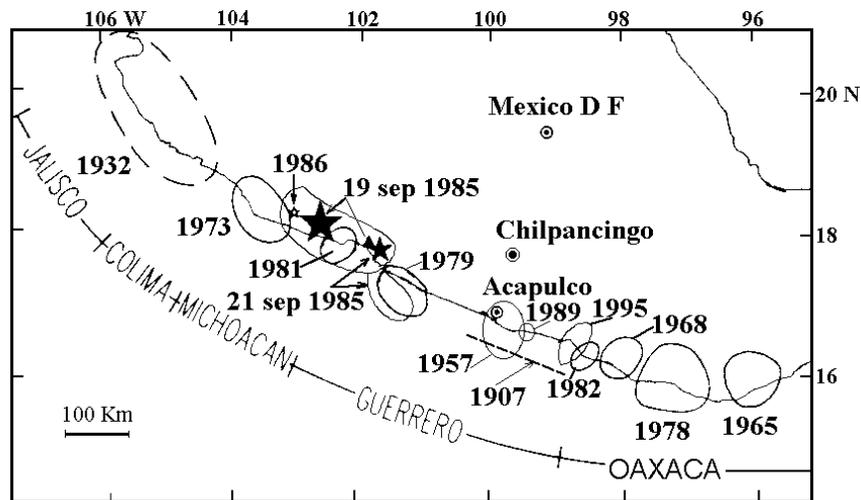
Figure 4. Rupture areas from earthquakes with magnitude $M > 7.0$, between 1932 and 1995.

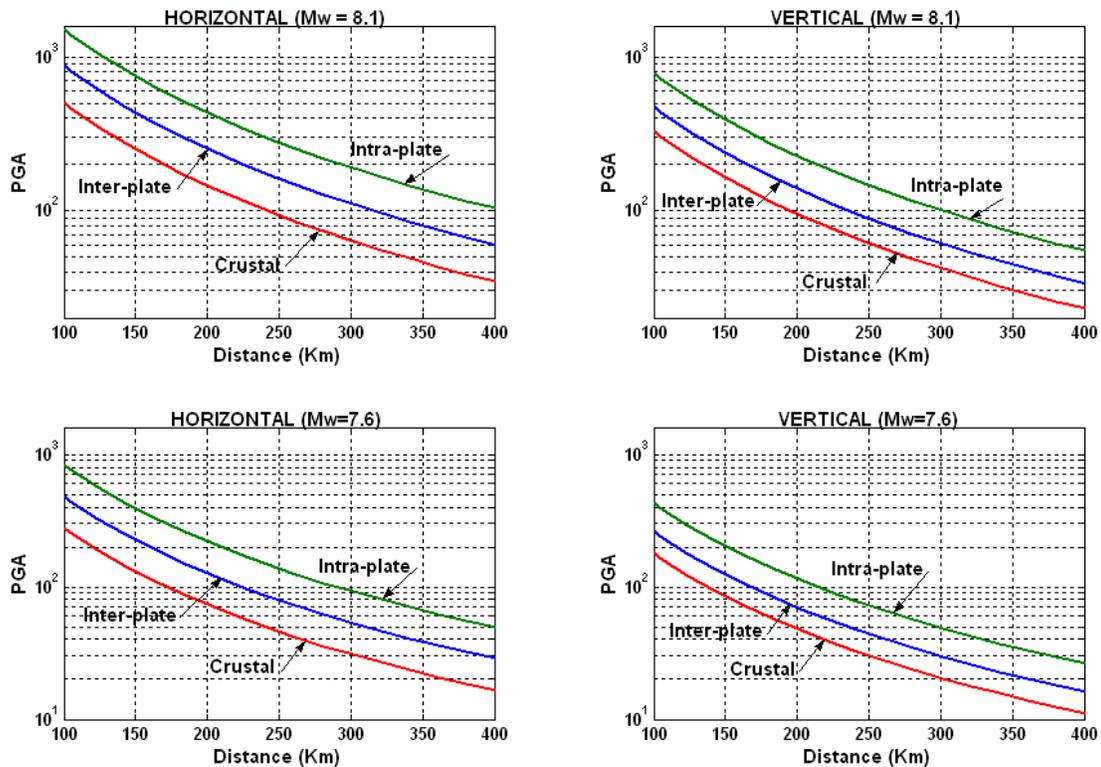
Figure 5 shows the PGA predictions from the attenuation models (2) and (3), for M_w 8.1 events (top) and for M_w 7.6 events (bottom). This figure compares the PGA curves among the three groups used in this work: intra-plate, inter-plate, and shallow crustal. The results of the regression analyses indicated that intra-plate earthquakes produce peak motions that are on average about 70 percent higher than those for inter-plate earthquakes for the same magnitude and distance. This difference in peak motion is the same when comparison is made between inter-plate and shallow crustal events.

Figure 5. Attenuation relationship fit to soft soil site of Chilpancingo city, using regression model (1), and the data from Table 2, for inter-plate, intra-plate and shallow crustal earthquakes. Accelerations are in cm/s^2 .

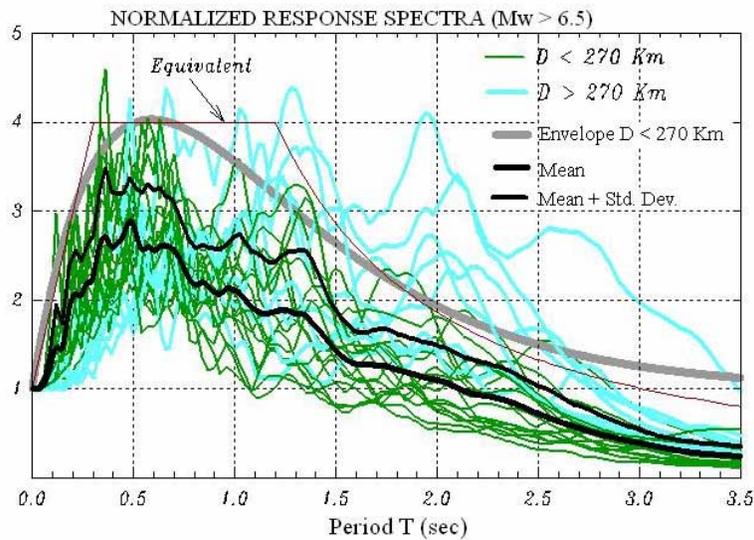
In order to estimate expected spectrum it is possible to calculate peak spectral ordinates. Nevertheless, in Chilpancingo there are no acceleration records from earthquakes with magnitude, M_w , higher than 7.5 and originated at less than 200 km. In the other hand, accelerograms recorded at distances less than 270 kilometers, indicate that spectral shapes are very similar. In order to estimate expected response spectra, in this work, average response spectra from earthquakes originated at 270 km were considered. Figure 6 contains all the normalized response spectra of earthquakes with magnitude greater to 6.5 registered in the stations CHI1 and RICC (Table 2). As it is to expect that very distant earthquakes do not produce important damage in this city, only the events originated to less than 270 kilometers were taken into account. The figure shows the spectra average of these earthquakes and the spectra average plus the standard deviation. The enveloped of the normalized spectra of earthquakes originated to less than 270 kilometers also appears in Figure 6, and it is possible to define this curve like:

$$A(T) = 1 + 14 \times T \times \exp(-1.7 \times T) \quad (4),$$

Figure 6. Acceleration response spectral shapes (SA/PGA, 5% damping) for the soil site of Chilpancingo computed using events with $M_w > 6.5$. Also shown are spectral shapes for the mean computed from events with $D < 270$ km, and the envelope spectra.

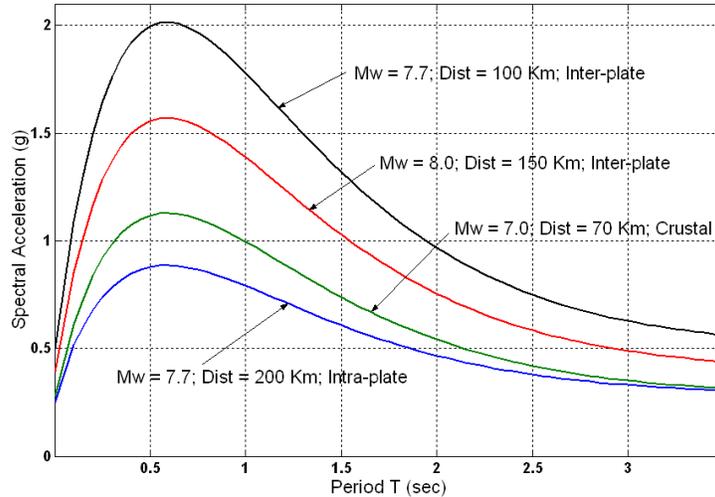
The predicted envelope-spectra was estimated in this work according equation (4), and with basis in the attenuation relationship. The four scenarios (A, B, C and D), were selected according to Gomez-Bernal *et al.* [3]. The corresponding curves are shown in Figure 7, and were calculated according with:

$$C \text{ (inter-plate, } M_w=7.7, D=100 \text{ km, PGA}=0.52 \text{ g): } SA(i) = 0.52 \cdot (1 + 14 \cdot T(i) \cdot \exp(-1.7 \cdot T(i))) \quad (7)$$

$$D \text{ (shallow-crustal, } M_w=7.0, D=70 \text{ km, PGA}=0.28 \text{ g): } SA(i) = 0.28 \cdot (1 + 14 \cdot T(i) \cdot \exp(-1.7 \cdot T(i))) \quad (8)$$

Figure 7. Maximum Spectral Ordinates (SA) computed for the most critical seismic scenarios in Chilpancingo.
