REHABILITATION OF EXISTING REINFORCED CONCRETE STRUCTURES USING CFRP FABRICS

Guney OZCEBE¹, Ugur ERSOY¹, Tugrul TANKUT¹, Ugurhan AKYUZ² and Emrah ERDURAN³,

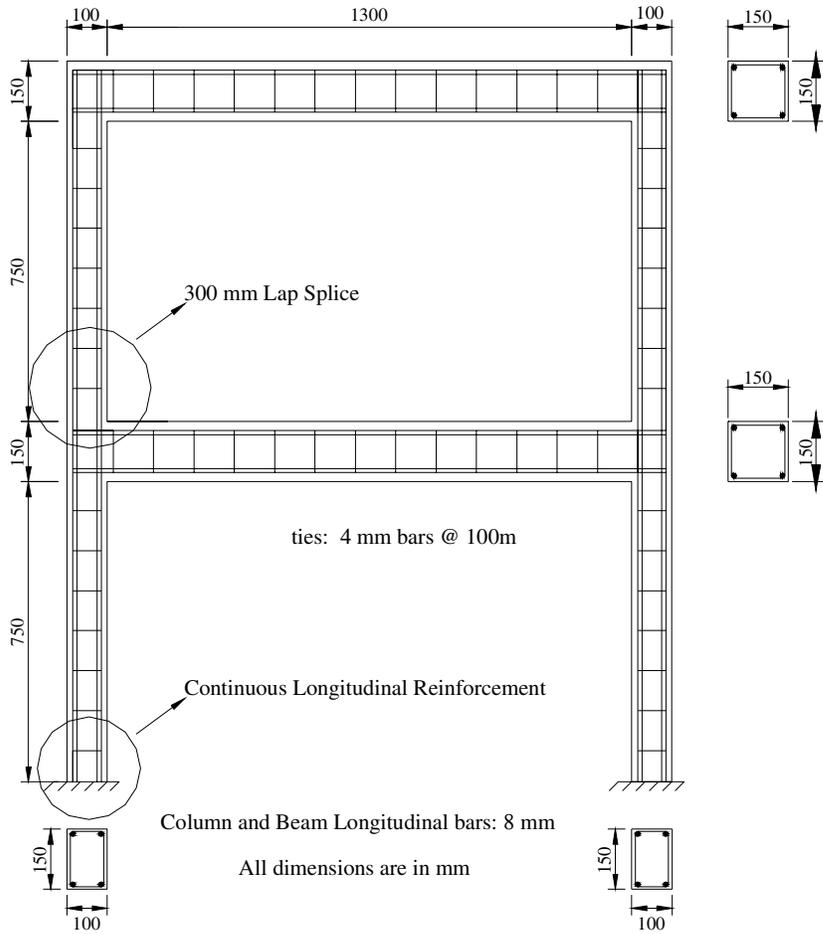
Figure 1 – Geometry and the Reinforcement Details of the Test Frames

Seven geometrically identical, one-bay, two-story RC frames with common structural deficiencies observed in the Turkish practice were constructed. The test specimen was a 1/3 scale model of a non-ductile frame having weak columns and strong beams. Insufficient confinement was provided at column and beam ends and no confinement was provided at beam-column joints. The ties used in beams and columns of the test specimens had 90 degree hooks at their free ends. Furthermore, the beam reinforcement was detailed considering gravity loads only. This led to inadequate anchorage of the beam bottom reinforcement. All frames had lapped splices in second story column longitudinal bars, made at the column base. Although the lap splice length was conforming to the Turkish Seismic Design Code [10] (forty times the diameter of the longitudinal bars), the transverse reinforcement provided in this region did not comply with the code requirements. Figure 1 presents the dimensions and the reinforcement details of the R/C frames. Upon the construction of the R/C frames, the hollow clay tile infills were constructed and plastered by a professional mason.

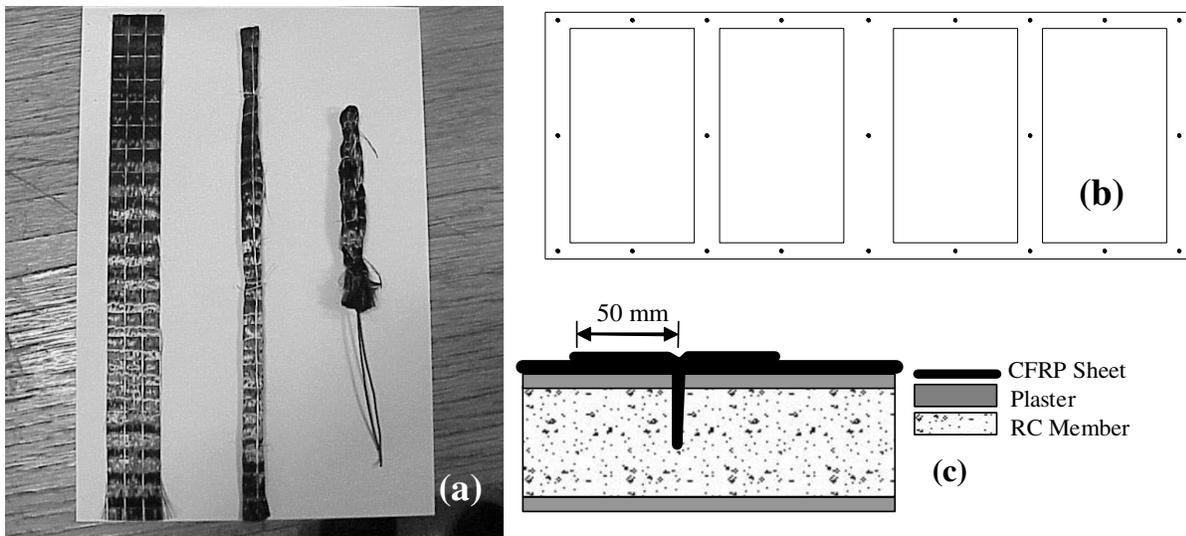
Figure 2 - (a) Anchors; (b) location and (c) configuration of anchors for Specimen SP-3

In Specimen SP-3 only the exterior face of the infill was fully covered by two orthogonal CFRP sheets (blanket type) which were also extended to the frame members. The CFRP sheets were bonded to the infill as in Specimen SP-2. The CFRP sheets were anchored to the frame members using special anchors developed. These anchors were made by rolling the CFRP sheets. The rolled CFRP anchors were folded and tied to a guide wire having a diameter of 1 mm, Figure 2a. Holes having a depth of 50 mm and a diameter of 10 mm were drilled into the frame members. After placing the CFRP sheets on the specimen, the drilled holes were filled with epoxy and the anchors were implanted in these holes by using the guide wires. The fibers of the anchors outside the holes were pierced using a knife and then these fibers were bonded to the CFRP sheets. Number, location and configuration of the anchors for specimen SP-3 are shown in Figures 2b and 2c.

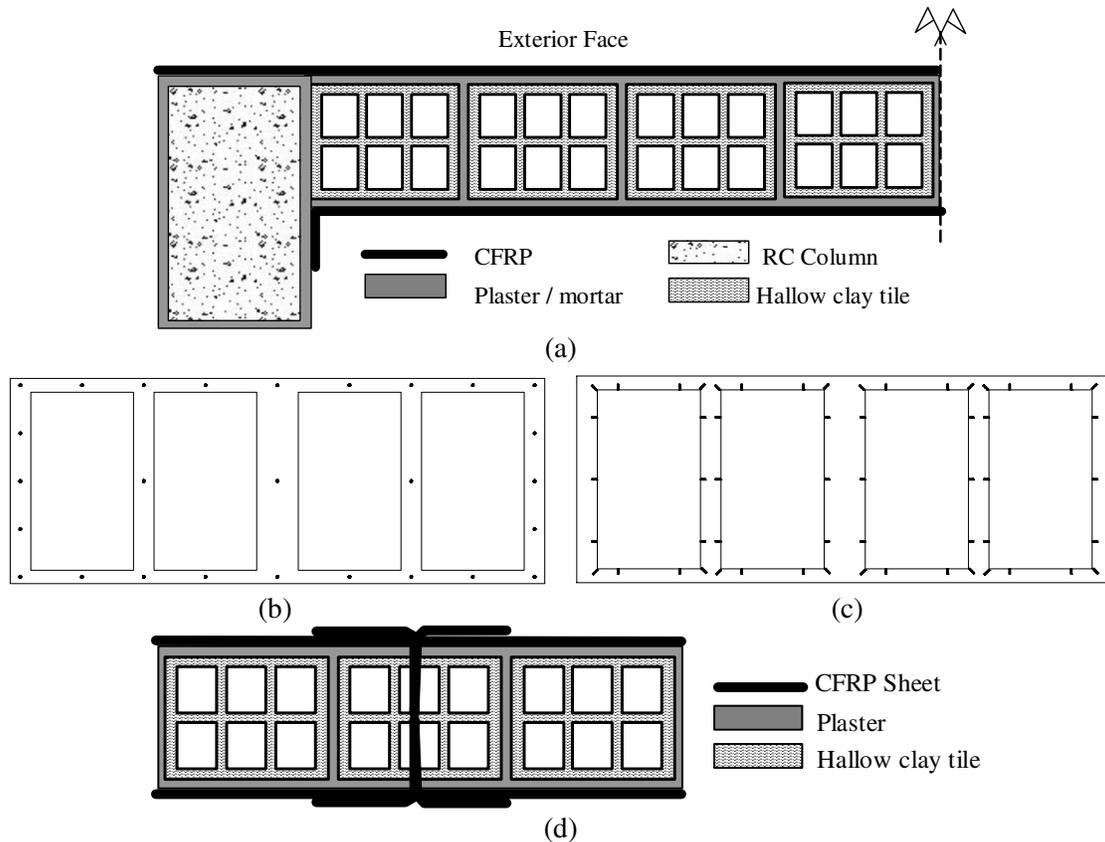
Figure 3 – Specimen SP-4: (a) CFRP pattern; anchors on the (b) exterior face; (c) interior face; (d) infill

In SP-4, both sides of the specimen were fully covered by two orthogonal layers of CFRP. The CFRP sheets on the exterior face were extended and anchored to the frame members. On the interior face, the CFRP sheets were bent and anchored to the beam and column face as shown in Figure 3a. The anchor dowels used in SP-3 contributed to the behavior of the specimen significantly. However, it was observed that, the number of the dowels used in SP-3 was insufficient. Thus, the number of dowels used was increased in SP-4, Figures 3b and 3c. In Specimen SP-4, CFRP sheets covering the two faces of the infill were connected to each other by using CFRP anchors. Holes were drilled through the infill to place these anchors as shown in Figure 3d.

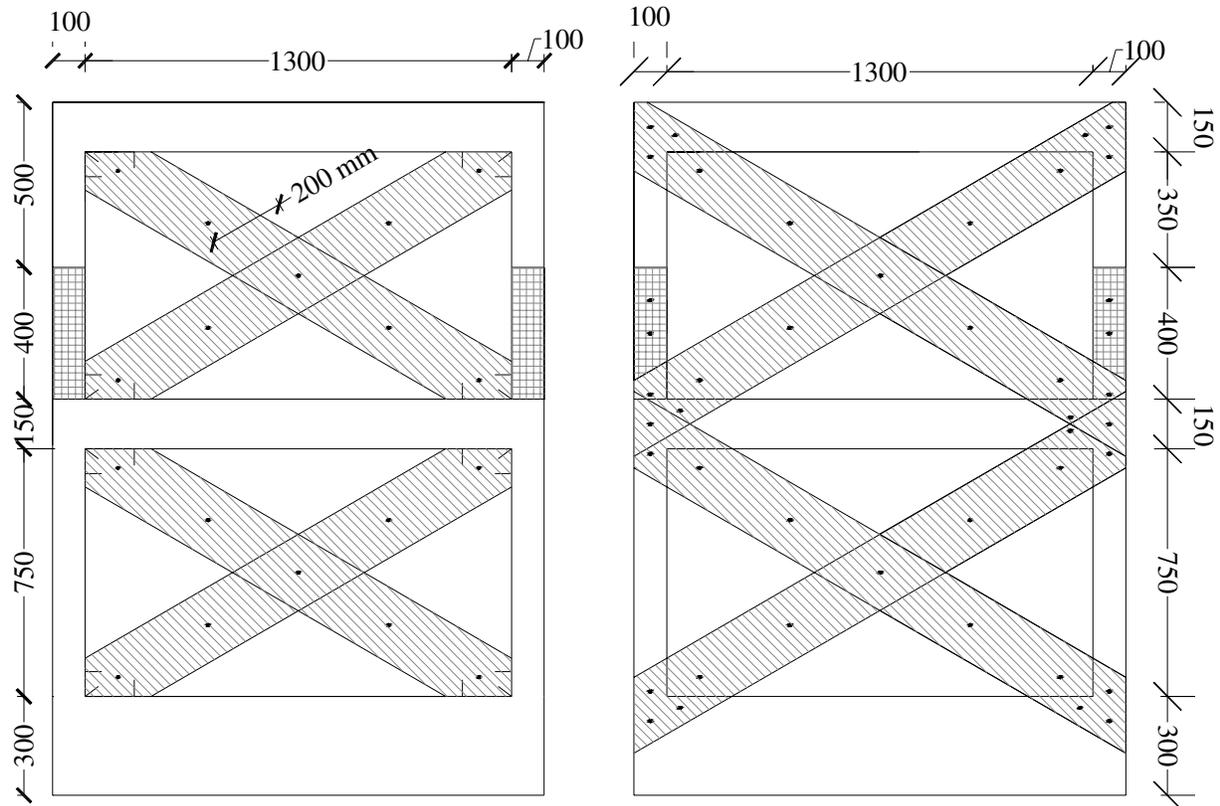
(a) Interior face

(a) Exterior face

Figure 4 – CFRP arrangement and location of the anchor dowels in Specimen SP-5 (dimensions are in mm)

The CFRP strengthening in Specimen SP-4 resulted in significant strength increase as compared to the reference specimen SP-1. However the amount of CFRP used in this specimen would make this type of strengthening uneconomical for practical use. Therefore in Specimen SP-5 it was decided to use CFRP strips placed in two diagonal directions instead of fully covering the infill. This type of strengthening was called, “Strut Type”. The width of the strips used as diagonals was 200 mm. The configuration of the CFRP strips and the anchor dowels used are shown in Figure 4. The lapped spliced region of this specimen was also confined with CFRP sheets similar to SP-4.

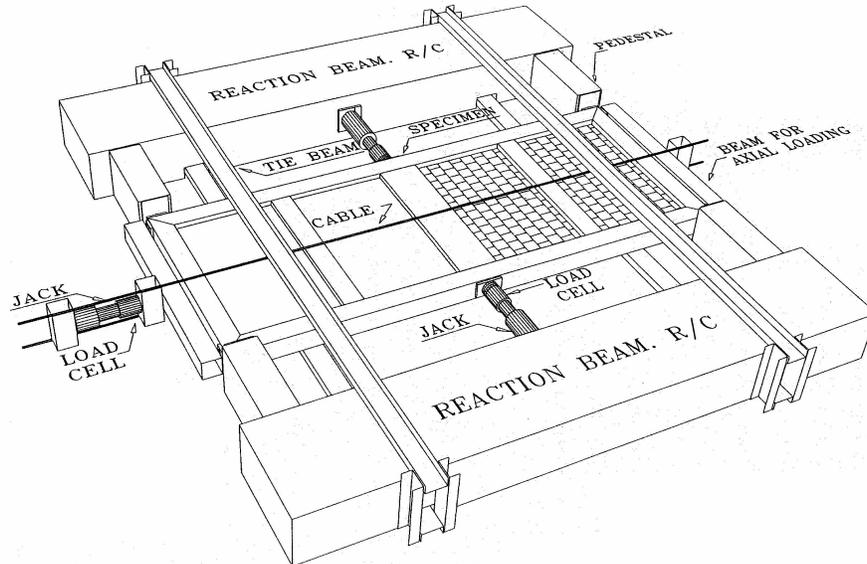
Figure 5 - Test Set-Up

The loading system and the test specimen are shown in Figure 5. The test set-up is similar to one which was developed by Smith [11]. Twin specimens with a common foundation beam were constructed and laid upon the steel plates resting on the ball bearings. The foundation beam was properly constructed and heavily reinforced to prevent the local failures.

The specimens were tested under reversed cyclic loading. The lateral load was applied through the foundation beam. Hence, the reaction forces at each end of the twin specimens become the lateral forces applied at the second story level. Axial load was applied to the columns by prestressing tendons as shown in Figure 5. The level of applied axial load on each column was about 25% of the nominal axial load capacity of the frame columns, $0.25N_o$.

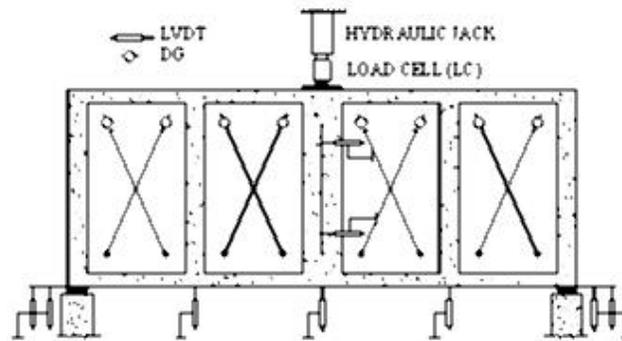
Figure 6 – Instrumentation

Test specimens were instrumented to measure the applied loads, lateral displacements, rotations of the foundation beam and diagonal strains on the infill. Figure 6 shows the instrumentation.

Lateral displacements and support settlements were measured by means of linear variable differential transducers (LVDT) which were mounted at each story and at the foundation beam levels. Two additional LVDTs were attached to the foundation beam to measure rotations. The infills were further instrumented with electrical dial gages (DG) placed diagonally to monitor the shear deformations. After each test, story displacements were calculated by making corrections considering both support settlements and rigid body rotations. Since each specimen consists of two parts, experimental results were presented only for the specimen where failure was observed.

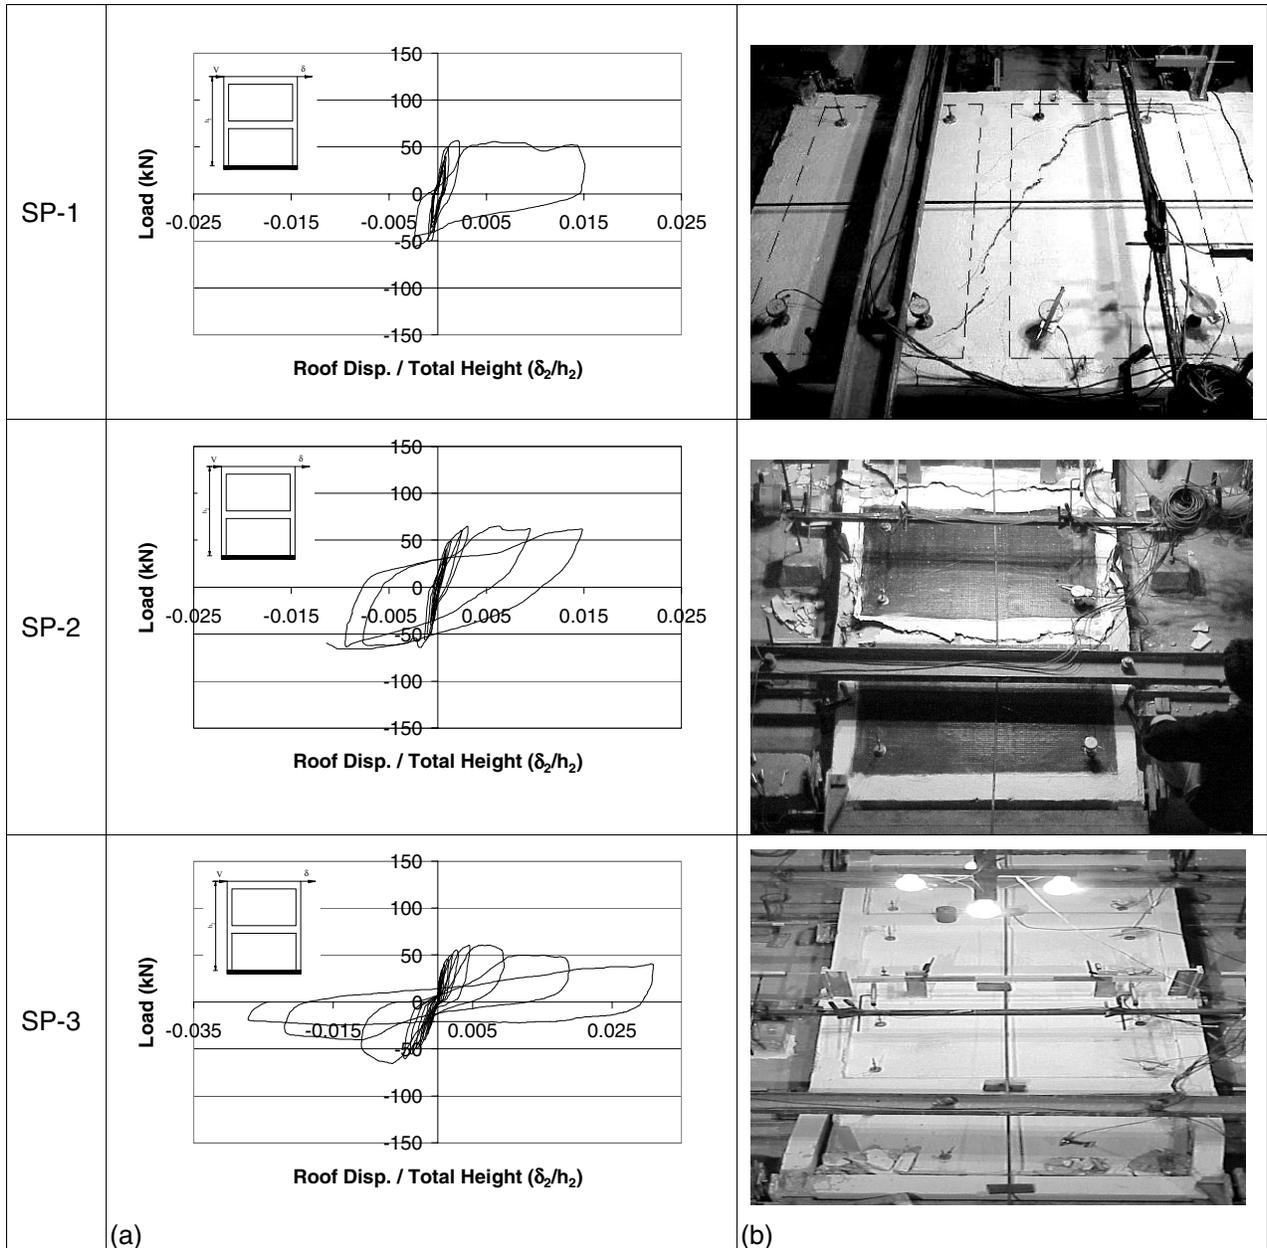
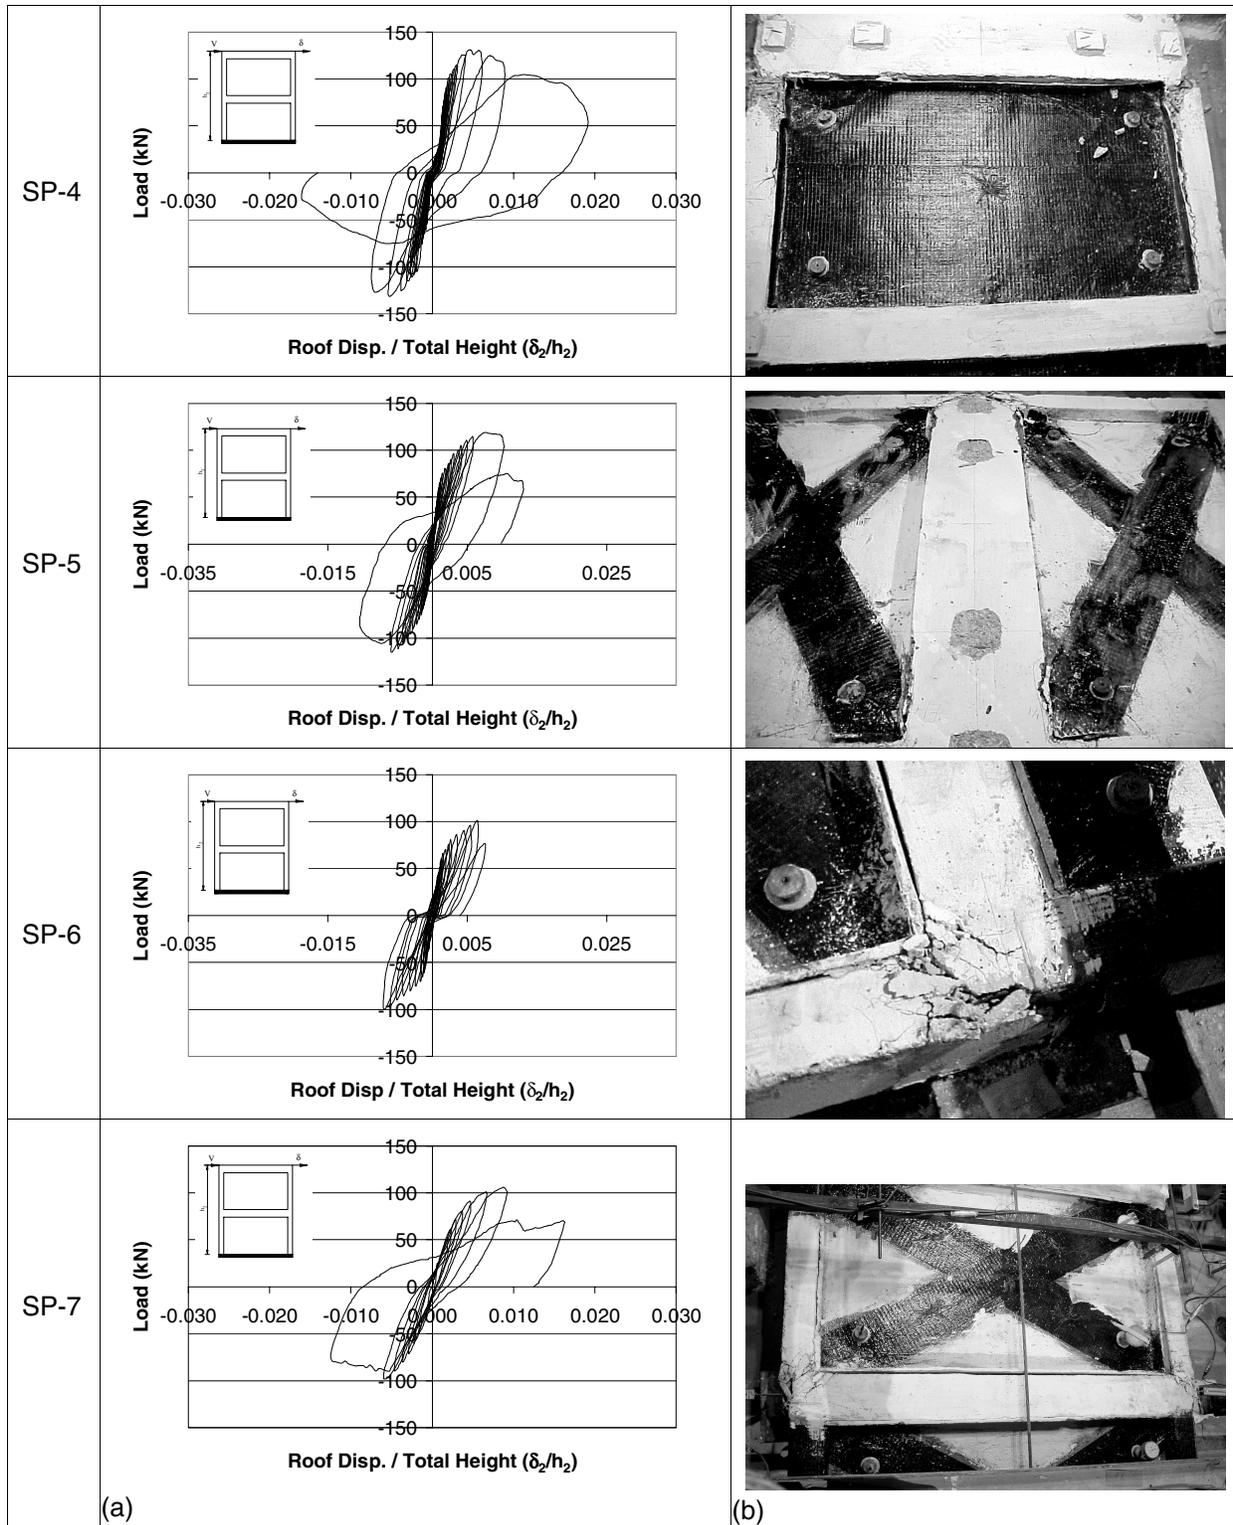
Figure 7 – (a) Load vs. roof drift ratio hysteretic relationships; (b) Specimens at the end of the test.

Figure 7 (cont'd) – (a) Load vs. roof drift ratio hysteretic relationships; (b) Specimens at the end of the test.

The experimental hysteretic load-deflection relationships of the test specimens and their views at the end of the tests are presented in Figure 7.

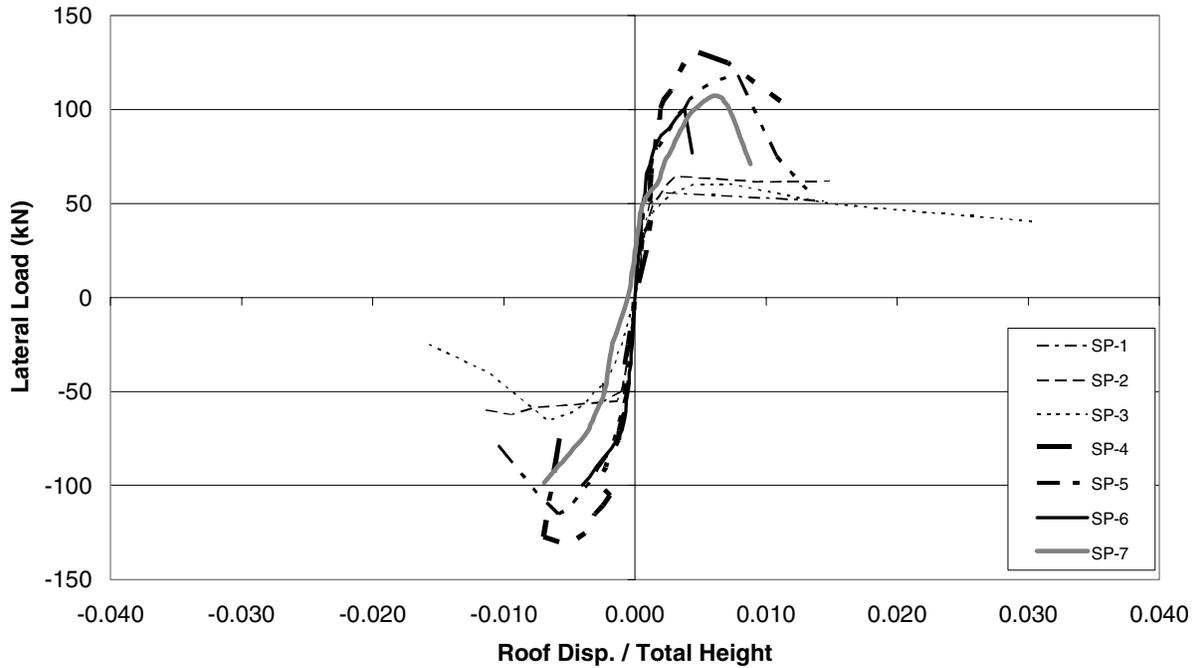
Figure 8 – Response Envelope Curves

The envelope curves for all the specimens tested are presented in Figure 8. The test results are also summarized in Table 2. As can be seen in Figure 8 and Table 2, specimens SP-4 and SP-5 displayed significantly superior behaviors as compared to the other specimens. Although, SP-4 behaved better than SP-5, the amount of CFRP used in that specimen was not economical at all. Thus, it can be stated that, the CFRP detailing used in SP-5 seems to be the most efficient strengthening scheme tested within the scope of this study as far as economy and the ease in application are concerned.
