**RAPID EVALUATION AND ASSESSMENT CHECKLIST (REACH)
PROGRAM –
A CASE STUDY AT NAVAL HOSPITAL BREMERTON**

SUMMARY

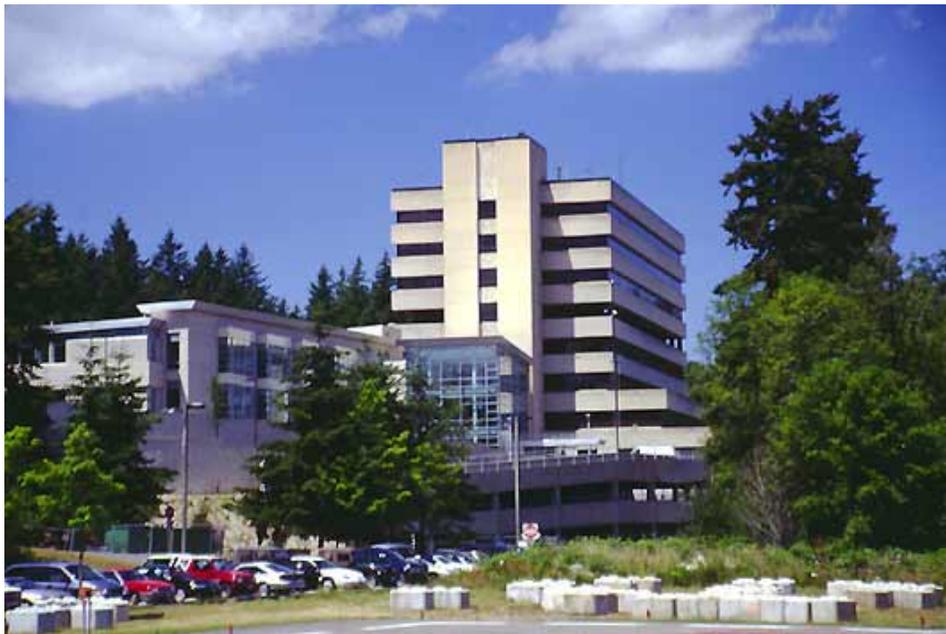
Figure 1 - Overall photo of the hospital from the southeast. A detached outpatient clinic and parking garage are visible to the left. The main hospital is beyond.

Naval Hospital Bremerton is a 249,000-square-foot, nine-story building constructed in 1976 (see Figure 1). On February 28, 2001, the Nisqually earthquake, with a magnitude 6.8, rocked the Puget Sound area of Washington State. The epicenter of the earthquake was approximately 30 miles away from the hospital, which experienced peak horizontal ground acceleration of approximately 11% g and a peak acceleration at the roof of approximately 47% g.

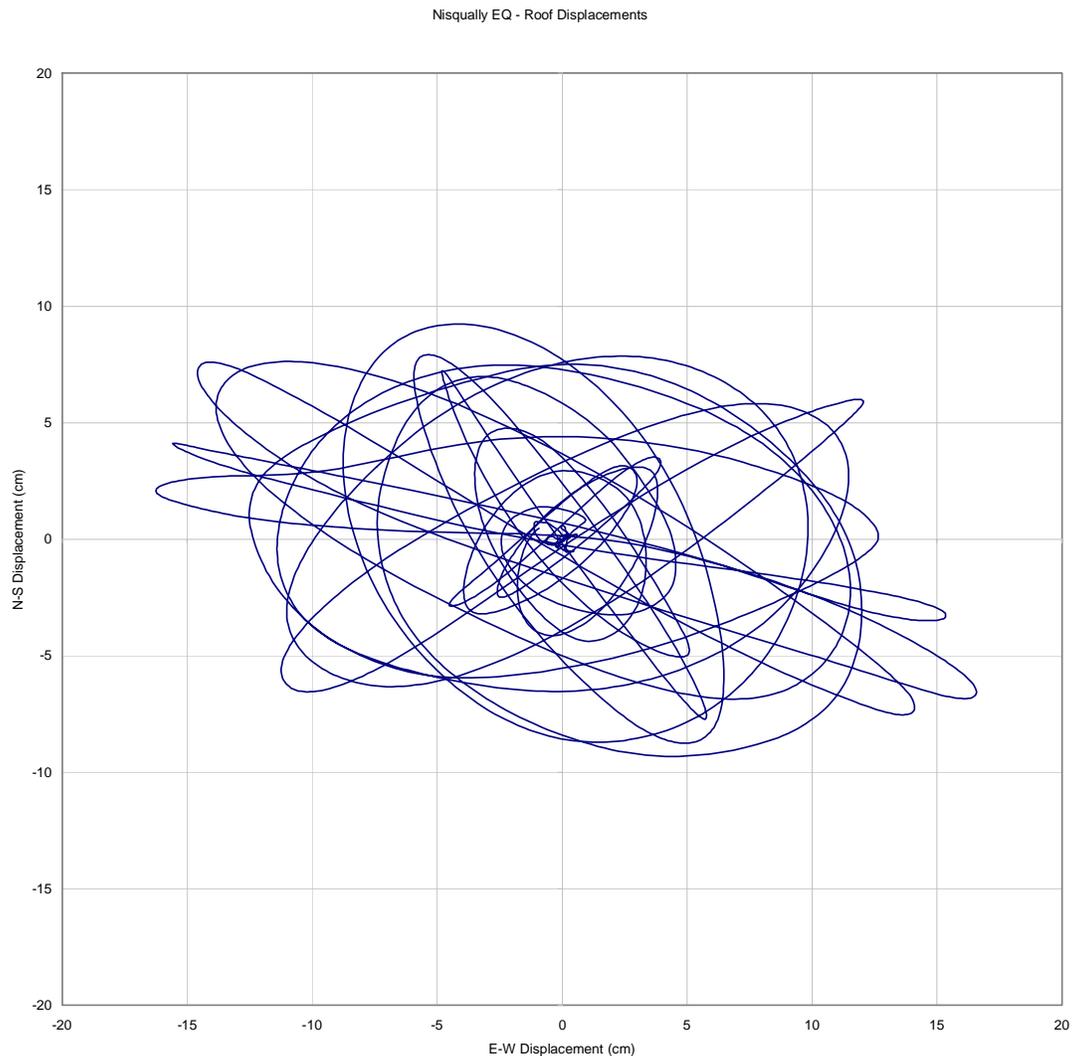
Figure 2 – Roof displacements recorded during the Nisqually earthquake.

The hospital structure experienced significant drifts during the earthquake– particularly on the upper floors. Figure 2 depicts recorded roof displacements during the Nisqually earthquake.

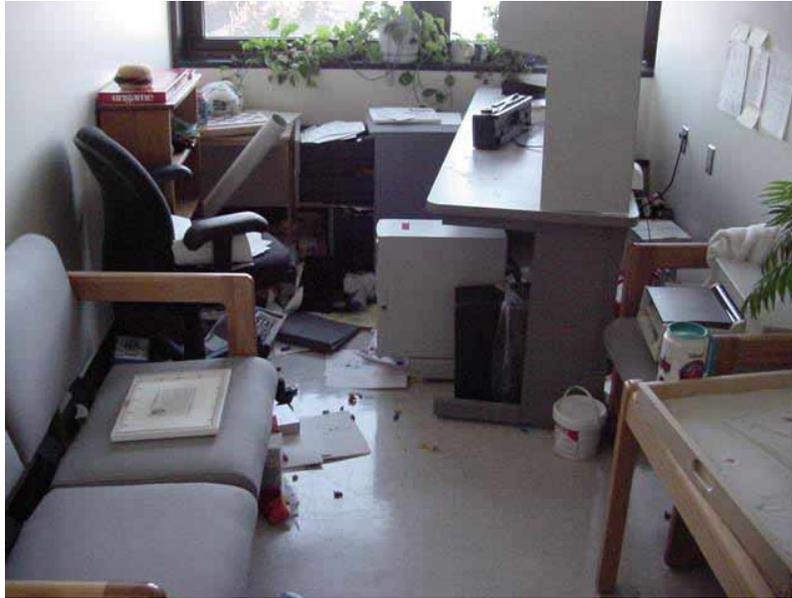
Figure 3 - Typical effect on the contents of office space from the Nisqually Earthquake

This displacement caused extensive non-structural damage to the facility, including gypsum wall board damage, displacement of light fixtures in suspended ceiling, overturning of bookshelves, cabinets, and computer workstations, and the rupture of a fire sprinkler pipe in an elevator roof penthouse (the sprinkler leak was not located for over 30 minutes, which caused water intrusion from the elevator shaft on all levels of the hospital). The displacement also caused personnel to be thrown about. This, combined with the non-structural damage, caused widespread confusion and chaos, even bordering on panic in some cases (refer to Figure 3).

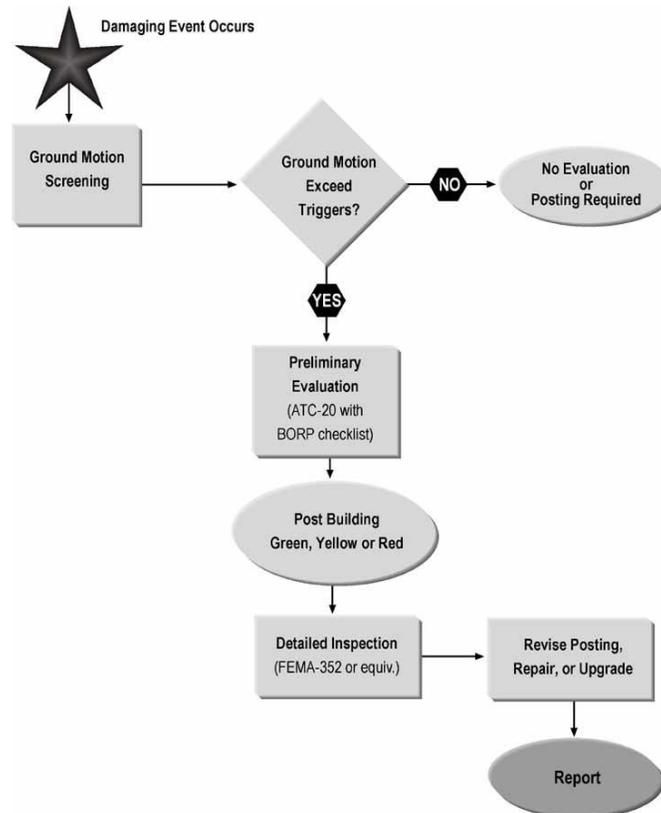
Figure 4 - REACH Process Flow Chart

The REACH process is shown graphically in Figure 4. The process begins when a potentially damaging event occurs. Since it is difficult to accurately perceive the severity of an earthquake, any event that is felt should be considered a potentially damaging event. Provided that there are not obvious signs that the building is unsafe for occupancy (such as partial collapse), the next step is to review the recorded seismograph data. Through engineering analysis, trigger values were developed, which are compared with the recorded ground and building accelerations and displacements. If the triggers are not exceeded then no evaluation is required. If the trigger values have been exceeded then a preliminary evaluation using the REACH checklist is warranted. Based on this evaluation, a determination of the acceptability of continued occupancy can be made and the hospital can be posted appropriately.
