## VULNERABLE DWELLING TYPOLOGIES IN EUROPEAN COUNTRIES AFFECTED BY RECENT EARTHQUAKES

### SUMMARY

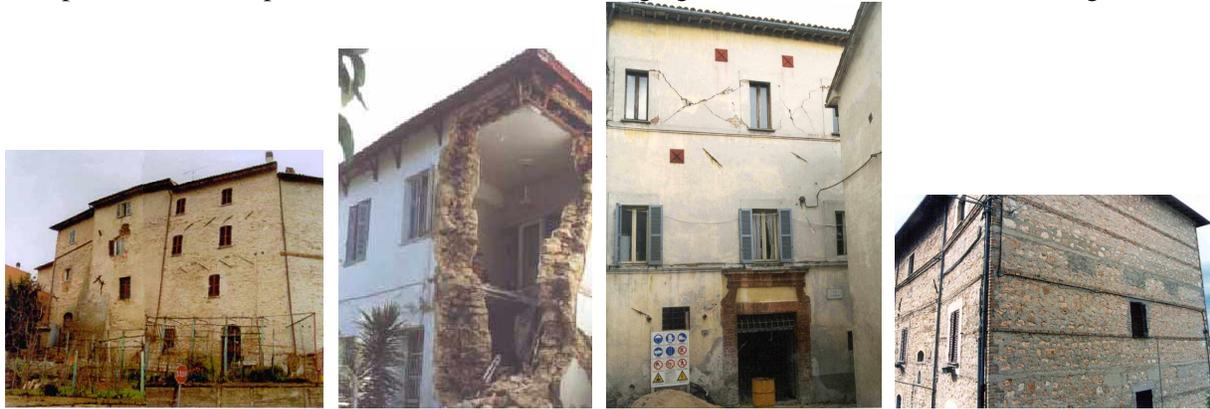
**Figure 1: a) Typical array of Buildings in Nocera Umbra; b) corner failure in a building with stiff roof diaphragm (Greece) ; c) shear cracks on a wall with ties and stiffened vaulted floors (Nocera Umbra); d) introduction of concrete ring beam at each storey level (Nocera Umbra).**

The Italian example shows an array of buildings from an historic hilltop town centre (WHE Report 28). They have common party walls and variable number of stories on the hillside (up to 2 or 3) and valley side (usually 4 or 5, with a maximum of 6). The typical house is usually formed by one or two masonry cells, depending on the depth of the block, with a staircase running, usually but not necessarily, along the party walls. The masonry is made of roughly squared stone blocks set in lime mortar, and the walls are made of two leaves with a rubble core at the base, tapering at the upper floors. Limestone is used for the blocks, while a particular type of tuffa stone is used for the lintels above openings. At ground level there are sometimes vaulted structures, while the upper stories were originally spanned by timber beams, with joist and timber boards covered by tiles. The roof structure is usually original and made of timber trusses. In recent past, many of the original floors have been replaced either with iron "I" beams and jack arches (refurbishments occurred before the World War II) or more recently with weakly reinforced concrete slabs (last fifty years). Other alterations include vertical extensions, closing and opening of windows, introduction of hygienic services. A high proportion of these houses show traditional iron ties introduced in the 18th Century to tie together orthogonal walls and floors, to ensure better seismic performance. After the introduction of modern seismic codes in 1980s many buildings have undergone further strengthening, represented by RC ring beams and concrete jacketing of walls. The example chosen, in Nocera Umbra, was hit by an earthquake in 1997 of magnitude 5.6. Typical damage ranged from out of plane failure and corner damage for buildings with no strengthening to shear cracks and in plane failure in buildings with ties and stiff diaphragm.

Similar damage patterns were reported also for buildings hit by the 1999 Athens earthquake (WHE Report 16). This earthquake came as a surprise, since no seismic activity was recorded in this region for the last 200 years. According to strong-motion recordings, the range of significant frequencies is approximately 1.5-10 Hz, while the range of the horizontal peak ground acceleration were between 0.04 to 0.36g. The most heavily damaged areas lie within a 15 km radius from the epicenter. The consequences of the earthquake were significant: 143 people died and more than 700 were injured. The structural damage was also significant, since 2,700 buildings were destroyed or were damaged beyond the repair and another 35,000 buildings experienced repairable damage. According to the EERI Reconnaissance report (EERI 1999), in the meizoseismal area, most stone masonry structures with undressed stones, constructed in the first half of the century, suffered significant damage. This included partial collapse of external walls, collapse of corners, separation of the two walls converging at a corner, and extensive cracking.

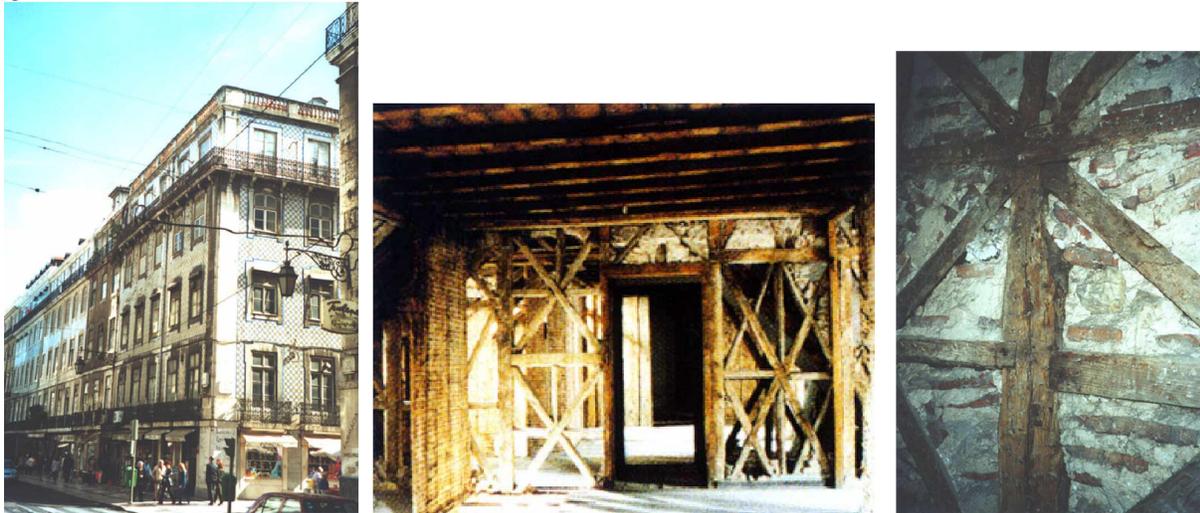
**Figure 2: a) typical building block in the Baixa pombalina, Lisbon, Portugal; b) the cajola; c) cajola with infilled masonry**

Historically, perhaps the most exemplar case of systematic strengthening of stone masonry buildings was carried out in Portugal, after the 1755 destructive earthquake of Lisbon. As the fire that ensued destroyed almost entirely the medieval downtown, this was rebuilt following new urban planning criteria including a number of mandatory seismic resilient features (WHE Report 92). The buildings, called 'Pombalino' from 'Marquês de Pombal', the king's minister responsible for the reconstruction, can be identified by the existence of a three-dimensional timber structure named 'gaiola pombalina' enclosed in internal masonry walls above the first floor. This timber structure is like a cage made of vertical and horizontal elements braced with diagonals and clad in brickwork. Exterior walls like facades and party walls between buildings are single leaf masonry. Roofs are built with timber trusses and ceramic tiles and floors have timber joists structures covered with timber boards. Ground floor walls are roughly dressed stone masonry supporting a system of vaults made of clay tiles, with stone arches. Foundations are made of short and small diameter timber piles connected by a timber grid. Indeed, the inclusion of the timber braced structure would allow for possible partial collapse of the external masonry walls, with no frame, while at the same time preventing the collapse of the internal structure and hence reducing the number of deaths in case of a future earthquake. The buildings original use was commercial at the ground floor and residential at the upper floors, with a housing unit or two per storey. For the buildings that maintain their original conception, the main problems result from poor maintenance like loss of waterproofing for roofs, leading to water ingress in the walls, particularly critical for timber structural elements. Most buildings were adapted to new functions in the past century, leading to the opening of larger shop windows at ground floor, sometimes accompanied by complete demolition of the exterior masonry walls at this level. Other important changes are interior walls demolition at any floor, introduction of stairs and elevators and the addition of more storeys. The expected collapse mechanisms due to earthquake actions are overturning of

facades (out-of-plane) or shear failure at the plane of the walls at ground floor level (global shear mechanism), leading to a global collapse mechanism. The introduction of a concrete/steel beam around the entire perimeter of the building, at roof eaves level, is a typical reinforcement solution to connect roof to walls, avoiding out-of-plane mechanism of facades. The introduction of steel elements/pre-stressed cables or anchors connecting parallel masonry walls increases strength connection of masonry walls, especially at corners. Steel elements are also used to connect detached timber elements from floors and 'gaiola' to masonry. New techniques applying new materials like fibre Reinforced Polymers (FRP), for example, are also used to increase the capacity of connections of timber elements that compose the 'gaiola'.

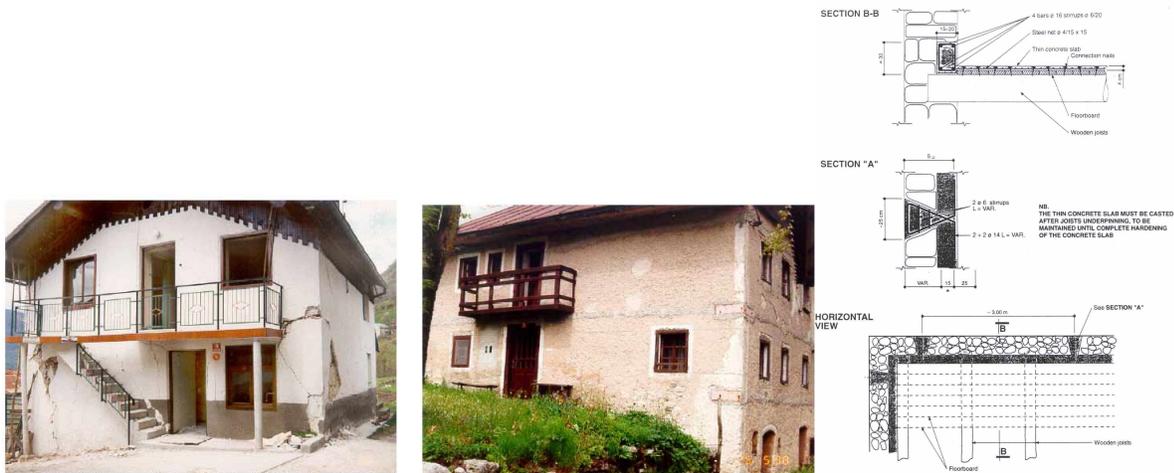
**Figure 3: a) typical damage to a rubble masonry building in Slovenia; b) implementation of retrofitting measures; c) detail of strengthening of existing timber floor with thin r.c. slab, r.c. ring beam and r.c. dove tail anchorages.**

A more modern example of extensive retrofit of stone masonry residential houses is represented by the Slovenian experience (WHE Report 58). Rubble stone masonry detached houses were the common residential housing type throughout northwestern Slovenia. After their destruction during World War I, these houses were rebuilt, mostly with the recycled stone material (from the buildings that were demolished). Many houses of this type were subsequently damaged during the last two earthquakes in Slovenia (1976 Friuli and 1998 Bovec). In order to preserve the country's architectural heritage, about 66% of these houses were strengthened after the earthquakes. The epicenters of the main shock on May 6, 1976 ( $M=6.5$ , focal depth 20-30 km) and the strongest aftershock on September 15, 1976 ( $M=5.9$ ) were in Friuli, Italy, 20.5 km from the border between Italy and Slovenia. In Italy 965 people died and enormous damage was caused. In Slovenia, the maximum intensity was VIII EMS. Out of 6,175 damaged buildings, 1,709 had to be demolished and 4,467 were retrofitted (Ladava 1982). The strongest earthquake with the epicenter in Slovenia in the 20th century occurred on April 12, 1998. The epicenter was approx. 6.3 km South-East from the town of Bovec, and the focal depth was between 15 and 18 km. No building collapses were reported, however out of 952 inspected buildings, 337 were found to be unsafe, out of which 123 beyond repair. The effectiveness of strengthening methods applied in 1976 was analyzed. A seismic deficiency common to this house type is the lack of connecting stones between the two exterior and interior wythes of which the wall are made and the large number of voids in the rubble infill. This is usually remedied by systematic filling of the voids with injected cementitious grout. The grout is injected into the wall through injection tubes and nozzles, which are built into the joints between the stones uniformly over the entire surface of the wall. Low pressure is used to inject the grout. The injected grout has the purpose to bond the loose parts of the wall together into a solid structure. When orthogonal walls are not tied together, then steel ties are placed symmetrically at each floor level on both sides of all

bearing walls, just below the floor structures, in horizontal notches, which have been cut in the plaster up to the wall surface. Ties are threaded at the ends and bolted on steel anchor plates. Ties are usually of diameter 16 - 20 mm. Another common seismic flow is the fact that the floor structures are supported only by the interior wall wythe and are not attached to the external wythe. In this case steel elements are used to anchor the timber joist or in some case replacement concrete floor slab to exterior wall surface.

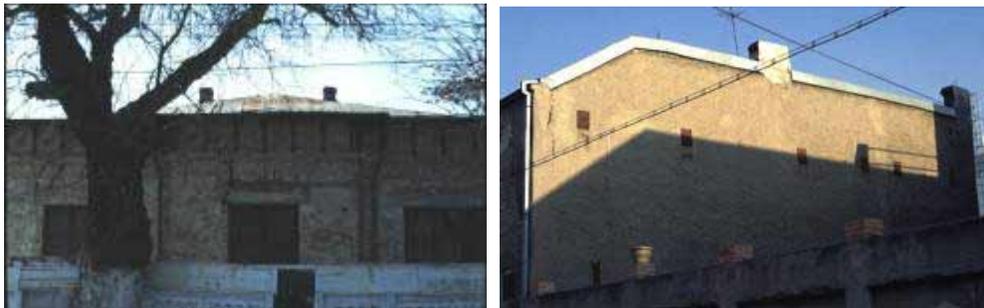
Figure 5: Wagon house; a) Typical damage; b) Retrofit with “ties” for “wagon” type house

several transversal confined brick walls, separating the rooms which form a wagon like array, hence the name of this building type: “wagon-house”. The horizontal structural system is made of wood boards and joists. They performed well except of occurrence of rifts and cracks (Figure 5). Anchoring the walls or floors of adjacent units by means of metal ties is a typical strengthening method (figure 5). Sometimes the original floors, either of timber or jack arches on iron beams were replaced with reinforced concrete slabs, while the provision of vertical concrete posts or r.c. frames around doorways are also common.

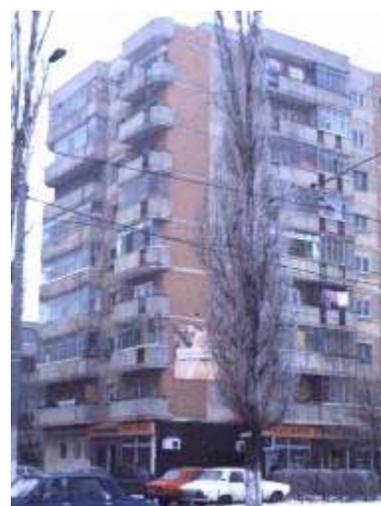
**Figure 13: Typical photo**

This multi-family urban housing construction appeared in Bucarest in the late 1960s and became fairly common between 1997 and the early 1990s. The load bearing system is a precast reinforced concrete large panel construction. Such buildings are typically high-rises (10 to 11 storeys), although there are also low to medium rise buildings (4 to 8 storeys) of this construction type, with different structural details. They consist of a rectangular plan, housing four apartments per floor. The panels are mechanically coupled at the base with continuous vertical reinforcement bars. The lateral stability is provided by columns tied to the wall panels. The special feature of the building described in this report is not having prefabricated façade elements, but lightweight block masonry. Boundary elements are used instead of the columns as stiffening elements at the exterior. There was no significant damage reported to the buildings of this construction type in the 1977 earthquake. Consequently, this construction technique continued to be practiced afterwards. The building described in this report was built after 1977 and so far has not been exposed to damaging earthquakes.
