## **EARTHQUAKE RESISTANT STRUCTURES OF PORTUGUESE OLD 'POMBALINO' BUILDINGS**

### **SUMMARY**

Portuguese 'Pombalino' masonry buildings were built mainly in Lisbon Downtown after the 1755's Lisbon Earthquake. The conception of these buildings included anti-seismic provisions, which are described in this paper. One of the most relevant provisions is the inclusion of an interior three-dimensional braced timber structure named 'gaiola' enclosed in masonry walls above the first floor aiming at providing resistance to horizontal forces. Seismic assessment of one representative 'Pombalino' Building is discussed, where the influence of 'gaiola' walls in its seismic behavior is referred. The expected collapse mechanism of 'Pombalino' buildings is discussed, as well as usual strengthening solutions. Seismic assessment of these buildings is discussed based on their actual conservation state and on structural changes on the original structure.

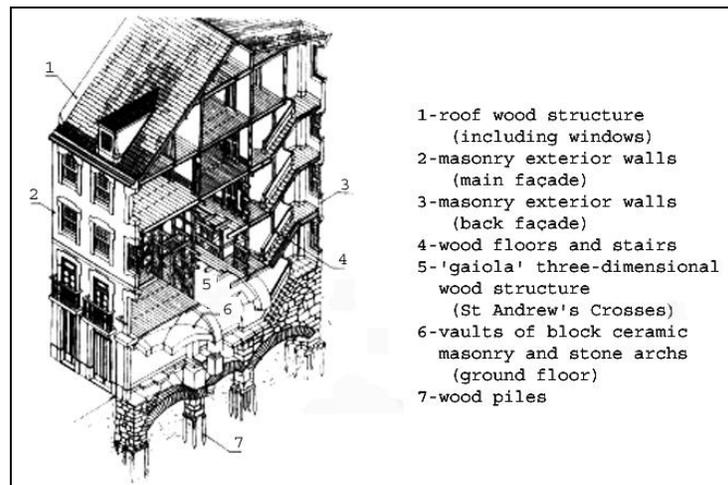
Figure 2 – Structural details of a 'Pombalino' Building (*adapted from* Mascarenhas [2])

Figure 2 presents structural details of 'Pombalino' Buildings, where the presence of the 'gaiola' enclosed in masonry interior walls is identified. The other interior walls (partition walls) are wooden panels that should not be considered having structural functions. Roofs are made with timber truss and ceramic tiles and may include window openings. Floors are timber slabs and can be considered as a flexible diaphragm. Ground floor walls are masonry walls supporting a system of vaults made of blocks of ceramic masonry and stone arches. Foundations include short and small diameter woodpiles connected by a timber grid. The masonry of the exterior walls (thickness 0.80m) is made of irregular blocks of calcareous stone and lime mortar with very poor strength capacity. Masonry infill of the 'gaiola' can be stone rubble, some of it from the earthquake-collapsed buildings, or clay bricks, similar to the bricks used at ground floor vaults. It is usual to find both type of masonry at the interior walls.

As previously mentioned, ‘Pombalino’ Buildings (Figure 2) are old masonry buildings that can be identified by the presence of a three-dimensional timber structure named ‘gaiola pombalina’ enclosed in masonry interior walls above the first floor (Figure 6). The other interior walls (partition walls) are timber panels and can be distinguished from ‘gaiola’ walls because ‘gaiola’ walls are thicker (18 to 25 cm) than partition walls (10 to 15cm).

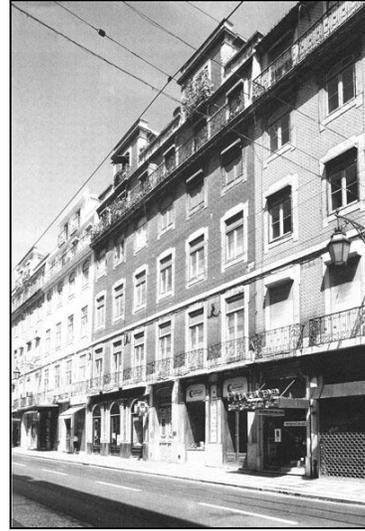
Figure 4 – ‘Pombalino’ Building from Lisbon Downtown (Prata Street, 210 to 220) (Santos [3])

The façades architecture (Figures 4 and 5) allows distinguishing 'Pombalino' Buildings from other masonry buildings due to the geometry regularity and symmetry. According to the original conception, dimensions and horizontal spacing of openings are the same for all 'Pombalino' Buildings. Front façades present vertical alignment of the openings, identifying individual vertical and horizontal masonry alignments.

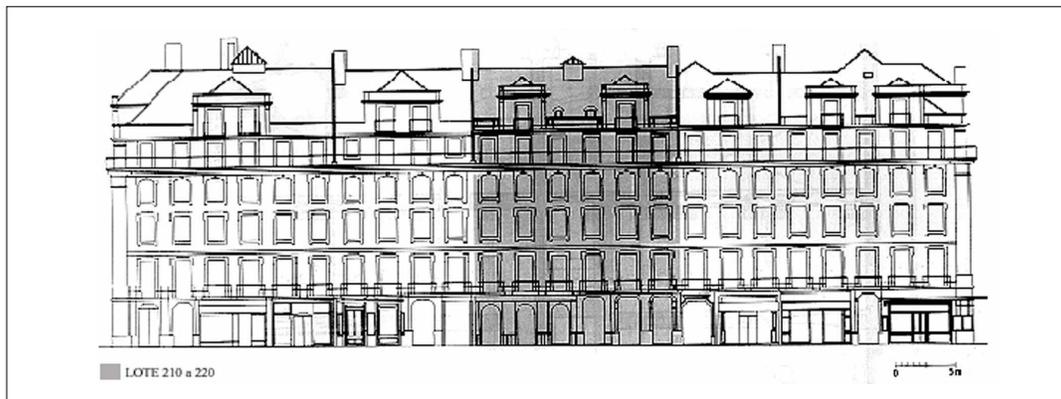
Figure 5 – Façades architecture of a Downtown typical block (Santos [3])

For a typical 'Pombalino' Building, ground floor openings are doors. First floor openings are all of the same type (only doors with balconies or only windows), depending on the importance of the street in front. The other floor openings are windows. At the top floor, openings are included in the roof structure and

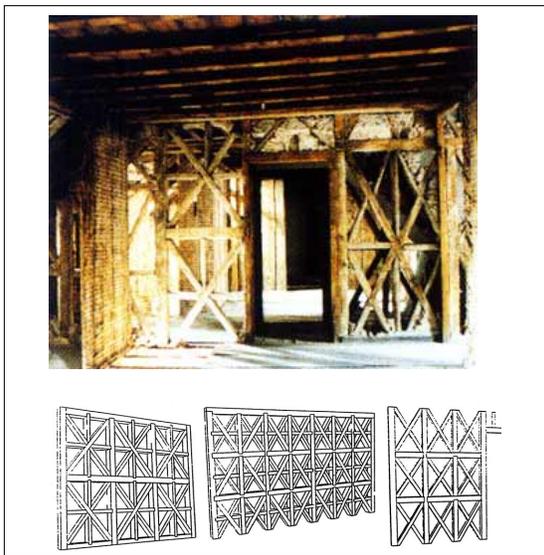
Figure 6 – Timber elements of ‘gaiola’ enclosed in masonry interior walls (Cardoso [4])

The timber structure of ‘gaiola’ is like a birdcage made of vertical and horizontal elements braced with diagonals named St Andrew’s Crosses (Figure 6). The connections between the timber elements of ‘gaiola’ and the exterior masonry walls are performed by iron elements but experience shows that sometimes these elements do not exist. Most of the times, timber elements of ‘gaiola’ are notched together (Figure 7) or connected by nails or iron ties according to historical information regarding construction techniques. The timber frame conception of ‘gaiola’ and connections between timber elements were inspired in ship construction, which was an excellent Portuguese expertise.

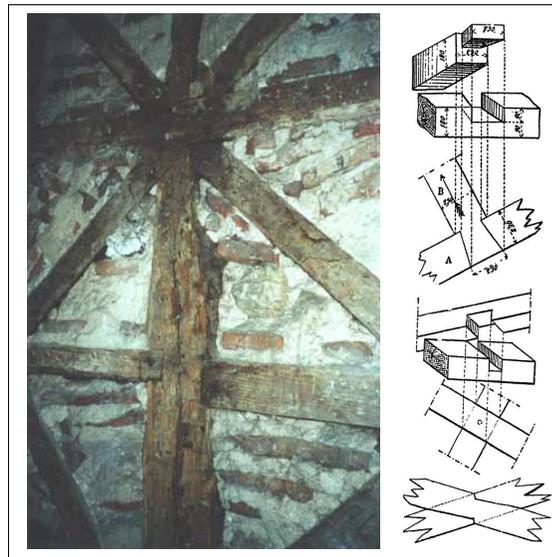
Figure 7 – Connections between timber elements of ‘gaiola’ (Cardoso [4])

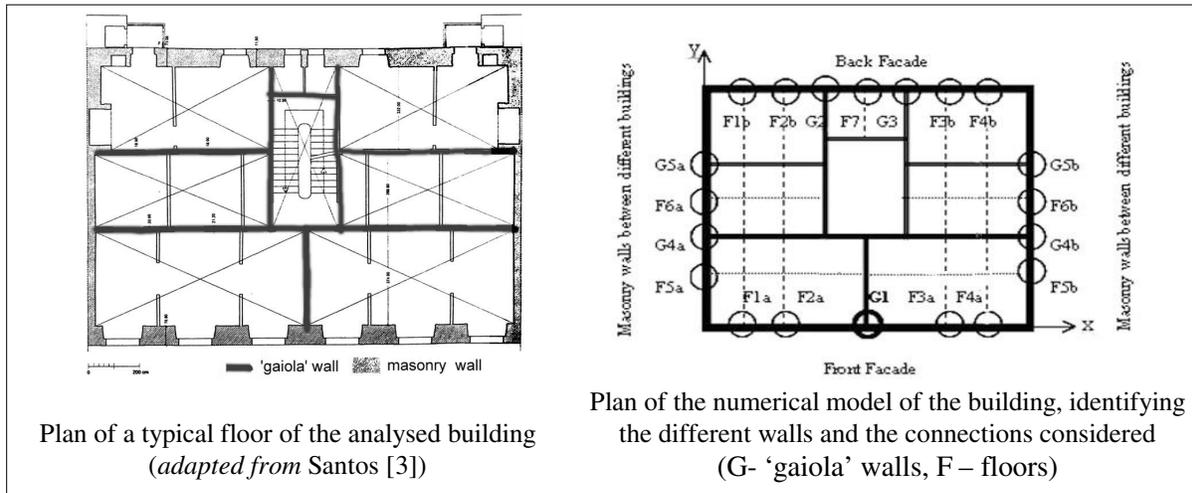
Figure 8 – Plan of the analysed building

A previous study (Cardoso [4]) was performed to understand the influence of the three-dimensional timber structure in the dynamic global behavior of a ‘Pombalino’ Building. In this study, a numerical model of a building from Lisbon Downtown (Prata Street, 210) was developed. The plan of an intermediate floor of the building is presented in Figure 8, where the ‘gaiola’ walls and their connections to masonry walls are identified.

Figure 9 presents the out-of-plane displacements of the front façade of the building with and without the ‘gaiola’, obtained in the connection G1 (Figure 8) for the seismic action defined in Portuguese Code of Actions (RSA [5]). The seismic action adopted was defined intending to simulate an earthquake similar to the 1755 Lisbon Earthquake and considering soft soil, according to the soil found in Lisbon Downtown. The maximum displacements were obtained in the top of the building. The local displacements presented in Figure 9 are the displacement corresponding to the real out-of-plane deformed configuration of the front façade, defined by the difference between the displacements obtained in the connection G1 and the one obtained in the corner of the building.

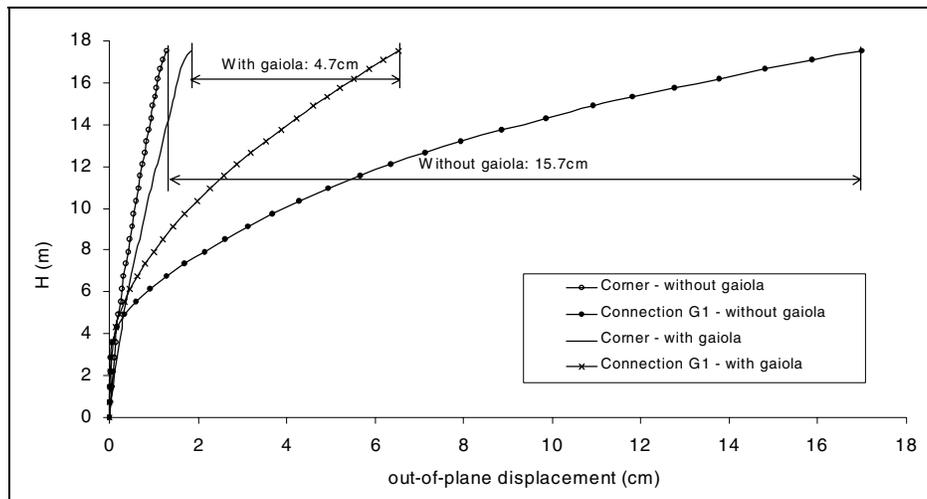
Figure 9 - Out-of-plane displacements of the front façade obtained in the connection G1 for the seismic action defined in Portuguese Rules (RSA [5]).

According to the obtained results, the local displacement due to the presence of the ‘gaiola’ is reduced about 70% (from 15.7cm, in the building without ‘gaiola’, to 4.7cm in the building with this timber

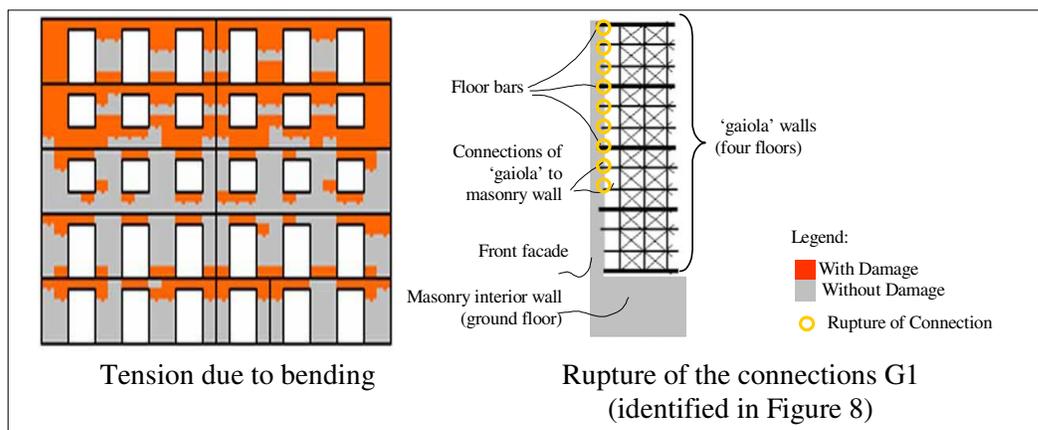
Figure 10 - Masonry damages and the rupture of connections that allowed identifying the bending of the front façade collapse mechanism (Cardoso *et al.* [1])

The collapse mechanism obtained for the analyzed building was out-of-plane bending of the front façade. Figure 10 presents the damages that allowed identifying this mechanism. The rupture of the connections G1 between the front façade and the perpendicular ‘gaiola’ wall and damages in the masonry wall simultaneously allowed identifying this collapse mechanism. The masonry damages considered were due to tension and compression due to bending and shear in and out of plane of the wall.

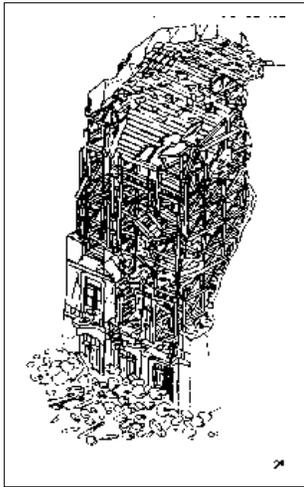
Figure 11 - Collapse mechanism according to original conception

The collapse mechanism obtained corresponds to the expected one for these buildings according to what may have been their original conception. In fact, this structure would allow the overturning of the façades without the collapse of the building, as presented in Figure 11. This conception may be efficient for one or two floor buildings as it shown in Figure 12 that represents a building whose exterior walls have fallen out-of-plane in the 1998 Azores earthquake. However, there are some uncertainties regarding its efficiency in buildings with more than two floors because the out-of-plane fall of the façades may bring down other parts of the building.

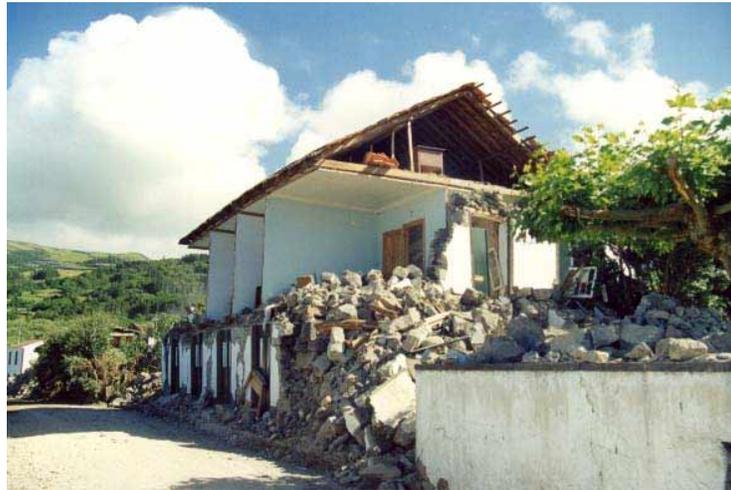
Figure 12 - Fall out the plane of exterior walls without complete collapse (1998 Azores earthquake)

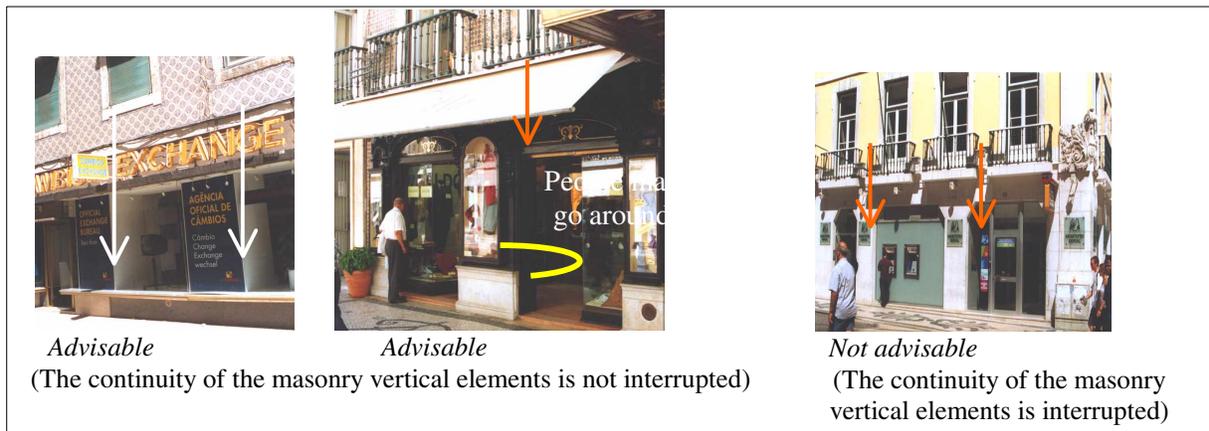
Figure 13 – Usual interventions performed to open larger shop windows

The most relevant changes in these buildings are the inclusion of bathrooms and running water and the opening of larger shop windows at ground floor, sometimes with partial or complete demolition of exterior masonry walls at this level. The building vulnerability to shear base collapse mechanism is increased after the demolition of ground floor masonry vertical elements. Figure 13 presents ground floor interventions performed to open larger shop windows.

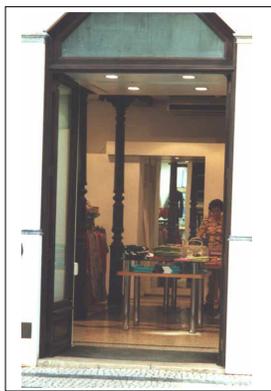
Figure 14 – Metallic element replacing demolished wall

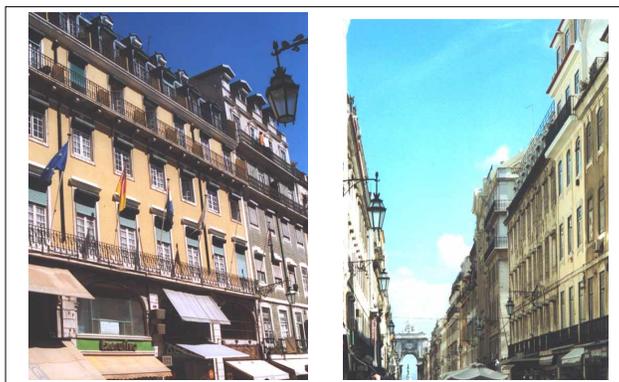
Figure 15 - Introduction of more stories in the top of the buildings (each building has different number of stories)

Another important structural change is the demolition of interior walls, the introduction of stairs and elevators and the construction of more stories at the top of the original building. These changes are critical especially when they introduce structural elements that have different properties than the original ones. For example, it is very common to find metallic elements (Figure 14) replacing the demolished masonry walls. The introduction of more stories at the top of the building (Figure 15) is also critical because the mass increases at the top, increasing the effects of the seismic action in the building and the out-of-plane displacements at the top of the façade, which may lead to the collapse of the façades.

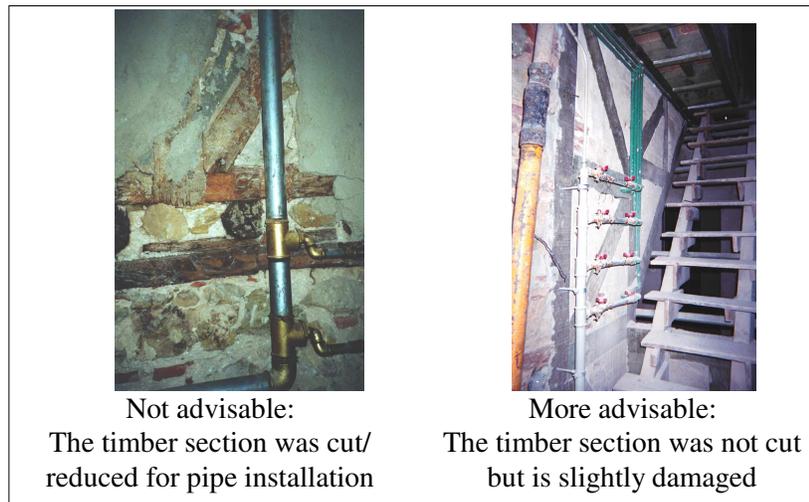
Figure 16 – Hidden damages in ‘gaiola’ walls

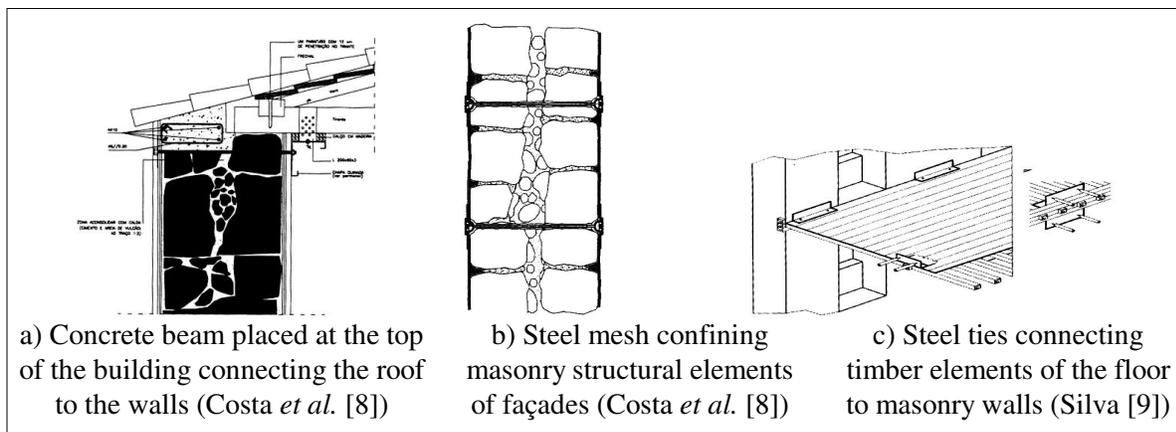
Figure 17 – Most usual strengthening techniques

| <i>Structural Deficiency</i> | <i>Strengthening provision used</i> |
|---|---|
| Masonry low shear strength may be critical to shear failure of the building due to the formation of a global shear collapse mechanism. | Introduction of a steel mesh confining masonry structural elements of façades (Figure 17 b)). |
| Low strength connection between timber elements and masonry walls | Introduction of steel elements, like ties, that connect timber elements to masonry (Figure 17 c)). |

The introduction of a concrete/steel beam executed at the entire perimeter of the building at top is an efficient strengthening solution because it prevents the out-of-plane mechanism of façades that was the mechanism observed in the study performed. This is a usual strengthening solution due to its relative low cost and medium level of complexity.
