PRE-1970 RC CORNER BEAM-COLUMN-SLAB JOINTS: SEISMIC ADEQUACY AND UPGRADABILITY WITH CFRP COMPOSITES

Murat Engindeniz¹, Lawrence F. Kahn², and Abdul-Hamid Zureick²

School of Civil and Environmental Engineering, Georgia Institute of Technology, Atlanta, GA, USA

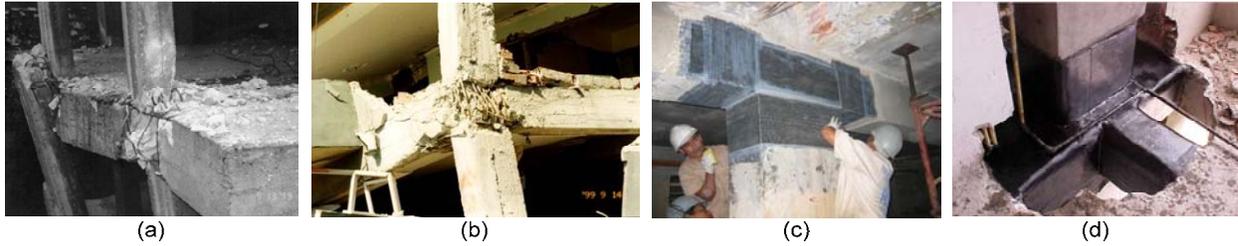
Figure 1 – (a, b) Beam-column joint damages in 1999 İzmit, Turkey earthquake (Said and Nehdi 2004; Güney Özcebe 1999), and (c, d) implementation of FRP joint retrofit schemes in construction (Jorge Rendón 2007).

1. Establish seismic adequacy of pre-1970 corner joints under bidirectional loading,
2. Investigate the efficacy of CFRP composites for: (a) post-earthquake retrofit such joints in cases of severe, moderate, or no existing damage, and (b) pre-earthquake retrofit in cases of moderate- or low-strength concrete, and
3. Ensure the applicability of the retrofit schemes to actual structures by accounting for the presence of floor members, and ensure the ease of retrofit construction by avoiding massive interventions to building appearance and occupancy such as those shown in Fig. 1d.

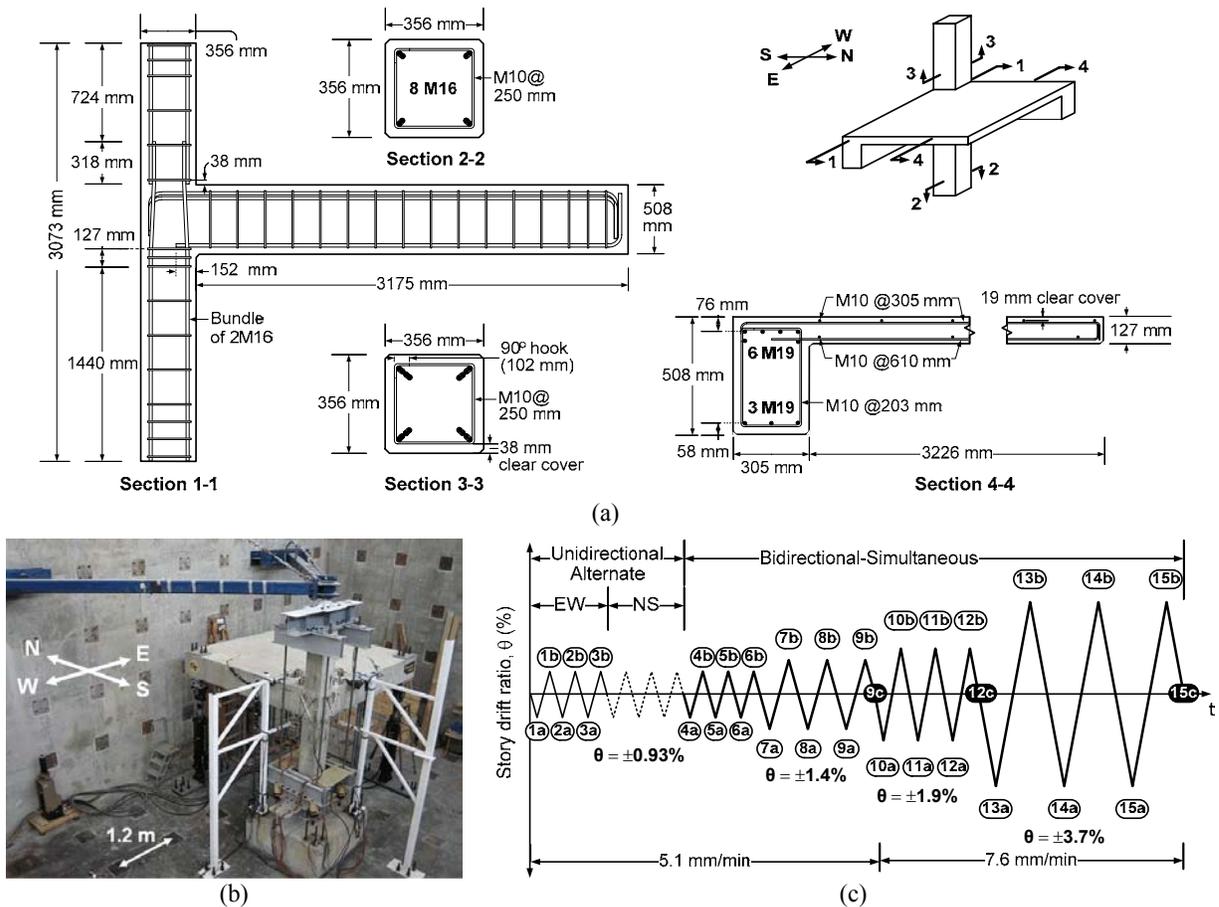
Figure 2 – (a) Reinforcement details, (b) test set-up, and (c) applied displacement history.

Tests were conducted in a setup shown in Fig. 2b, where the base of the column had a fixed support, and the top of the column had a pin support with free vertical translation. Cyclic lateral loads were simulated by quasistatic cyclic loading of the beams in the vertical direction with the actuator-to-beam connections allowing free rotation around all three major axes (i.e., including torsion). Prior to cyclic loading, gravity load effects were accounted for by applying a column axial load of 10% of the column's compressive capacity, and then displacing both beams downwards until the strong-axis bending moments at the column faces were similar to those estimated for an actual building under service loads. The applied reverse-cycle displacement history consisted of alternate unidirectional loading up to $\pm 0.93\%$ interstory drift (θ) in each primary frame direction followed by simultaneous loading in both directions up to $\theta_{EW}=\theta_{NS}=\pm 3.7\%$ drift (i.e., bidirectional drift

$\theta_b = \pm 5.2\%$) as shown in Fig. 2c. The applied displacement levels correspond to 1.0, 1.5, 2.0, and 4.0 times the displacement at first yield observed in Specimen 1 before retrofit. An extensive instrumentation layout consisting of 160 data acquisition channels was used. All details of the experimental program can be found elsewhere (Engindeniz 2008).

The adequacy of the as-built joints was evaluated by testing Specimen 1 and Specimen 2 up to point 12c and point 9c in the loading history (Fig. 2c), respectively. During downward loading of the beams, damage modes included extensive yielding in the column bars especially at the inside (NE) corner with limited or no yielding in beam top bars, joint shear cracking and large joint shear rotations, and bulging of the joint panels. When the beams were loaded upwards, the loss of anchorage of beam bottom bars was solely responsible for the poor behavior. Such bond failure was why the cracking in the joint panels was along one diagonal only, and not in the often observed “X” pattern. These unfavorable damage modes were so dominant that, at the $\pm 1.9\%$ drift level ($\theta_b = \pm 2.7\%$) applied to Specimen 1, up to 70% of the beam end displacement during downward was caused by joint shear rotations, and 100% of that during upward loading was caused by the loss of anchorage of beam bottom bars as quantified by Engindeniz (2008). Much of the damage progression in Specimen 1 took place during the $\pm 1.9\%$ drift cycles ($\theta_b = \pm 2.7\%$) where the diagonal joint shear cracks tripled in width and extended vertically into the upper column causing the loss of anchorage of lap-spliced column bars (Fig. 3a). Even at a lower drift level of $\pm 1.4\%$ ($\theta_b = \pm 2.0\%$), however, joint shear cracking and the anchorage loss of beam bottom bars were significant as seen from the state of damage in Specimen 2 at the end of its testing (Fig. 3b).

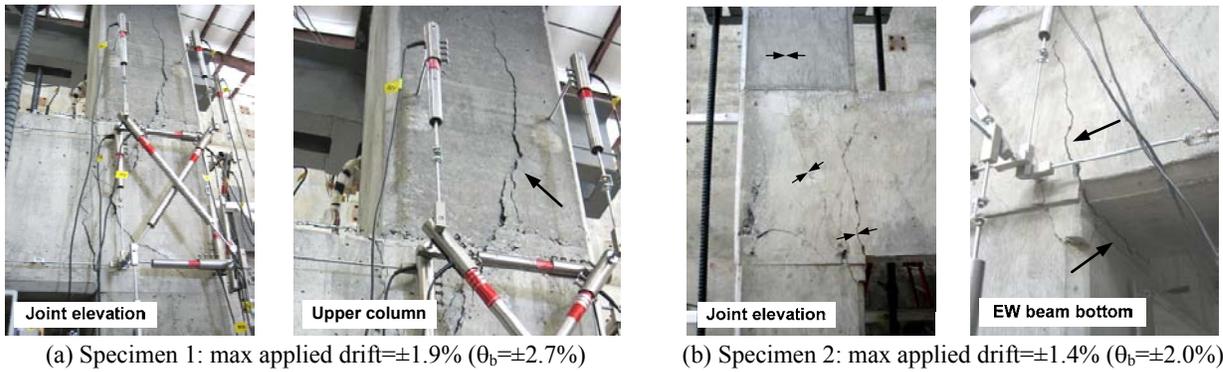
Figure 3 – Damage modes before retrofit.

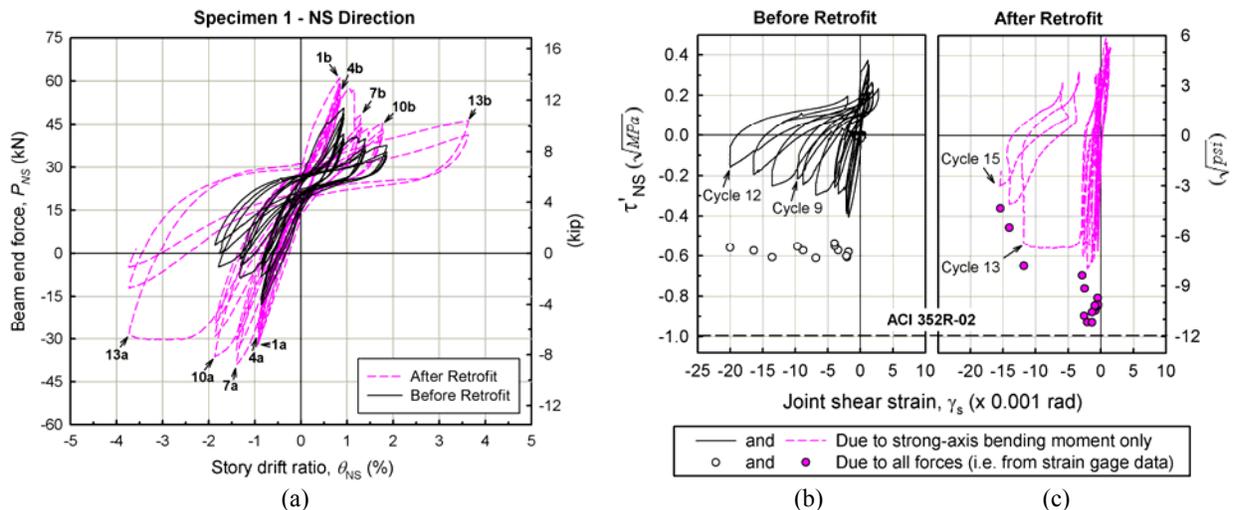
Figure 4 – Hysteretic behavior of Specimen 1, NS direction: (a) force-drift, and (b, c) joint shear stress-strain.

The aforementioned damage mechanisms resulted in force-drift hysteretic curves characterized by lack of ductility due to severe degradation in stiffness, pinching, and loss of strength especially after the beginning of the bidirectional cycles. The curves obtained for the NS beam in Specimen 1, for example, are shown with solid lines in Fig. 4a. The curves are shifted from the horizontal line representing zero load due to the initial compressive (positive) loads on the actuators at the simulated service load level.

While the method of considering the strong-axis bending moments only does not accurately estimate the joint shear strength, it provides an effective means to plot the hysteretic variation of normalized joint shear stress τ' versus joint shear strain γ_s as shown with solid black curves in Fig. 4b for Specimen 1 NS direction. From these curves, it was clear that the joint was far from being “rigid” during downward loading as evidenced by joint shear strains up to -0.02 rad, and unable to mobilize any resistance during upward loading due to pull-out of beam bottom bars. These findings, coupled by the aforementioned damage modes and the resulting deficiencies in stiffness and energy dissipation indicated the need for significant shear strengthening of the joint to achieve an ideal “rigid” joint behavior.

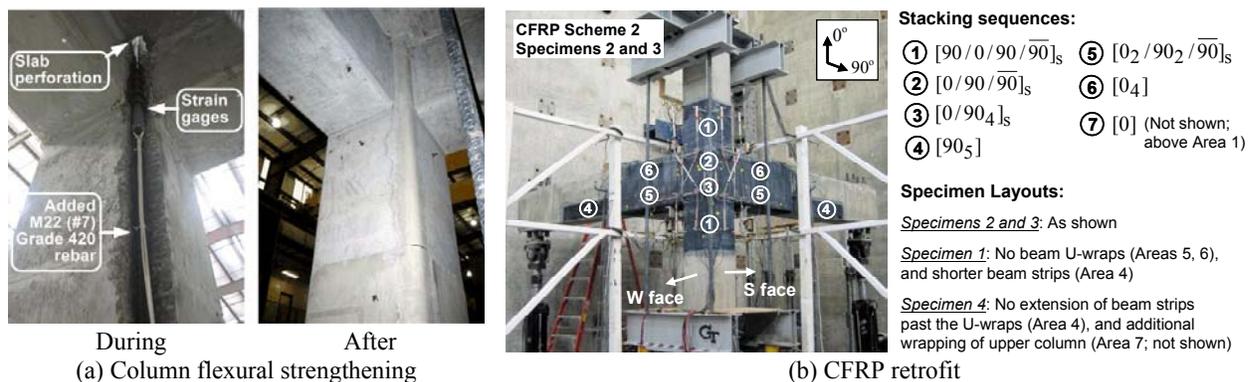
Figure 5 – Retrofit procedure.

The retrofit procedure consisted of three steps. In Step 1, which was applied only to the previously damaged Specimens 1 and 2, all cracks wider than 0.3 mm were injected with a high-modulus, low-viscosity epoxy. In Step 2, the column inside (NE) corner was strengthened for flexure to delay/prevent the observed extensive localized yielding at this corner. A 50 mm x 50 mm portion of the column inside corner was removed, including a small perforation in the slab, a M22 (#7) steel reinforcing bar with $f_y=445$ MPa was added, and a polymer-modified cementitious mortar ($f_c=49.6$ MPa) was cast (Fig. 5a). In Step 3, a multi-layer CFRP system tailored from a relatively light (300 g/m²) unidirectional carbon fabric was bonded externally to improve the joint shear strength, positive moment capacity of the beam (i.e., beam bottom bar anchorage), and confinement of the column and beam ends. The CFRP had the following design properties: tensile strength=370 N/mm/layer, ultimate strain=1.00%, and thickness=0.5 mm/layer.

While Step 2 was identical for all specimens, modifications were made to the CFRP schemes used in Step 3 to maximize the improvements in behavior as the testing program progressed. This resulted in the use of three different CFRP schemes as listed in Table 1 and one of which (Scheme 2) is shown in Fig. 5b. In this particular scheme, three 90° (perpendicular to column axis) and two 0° layers were used in the joint panels and extended onto the columns to increase the joint shear strength, five layers of 180 mm-wide CFRP strips were placed around the outside corner of the joint and extended onto both beams 2080 mm to delay/prevent the loss of anchorage of beam bottom bars, the beam ends were U-wrapped with two layers to prevent debonding of these strips, and the column ends were fully wrapped with two layers to improve ductility, improve the anchorage of the sheets extended from the joint panels, and to improve the anchorage of the steel reinforcing bar added at the inside corner of the column. The CFRP layups labeled 1 through 7 in Fig. 5b represent the combination of all these CFRP sheets stacked in a sequence that would result in a symmetric layup in all areas. The differences between the three schemes are also listed in Fig. 5b. In Scheme 1, used for Specimen 1, the horizontal strips placed around the joint were extended onto the beams by only 710 mm with no beam U-wrapping.

Modifications created the improved Scheme 2 (Fig. 5b): longer extension lengths of beam strips (areas 4 and 5), and U-wrapping of these strips near the beam ends (areas 5 and 6). The efficacy of Scheme 2 was then tested on the previously moderately damaged Specimen 2, and on the undamaged Specimen 3. These two tests allowed direct assessment of the effect of prior damage on the efficacy of the CFRP retrofit since Specimens 2 and 3 were identical, even in terms of concrete strength (same batch). Scheme 2 eliminated the drawbacks of Scheme 1 up to a drift ratio of $\theta_{EW}=\theta_{NS}=+2.6\%$ ($\theta_b=+3.7\%$) toward peak 13b at which point the full capacity (rupture) of the CFRP beam strips placed around joint was developed (Fig. 6b,c), and the seismically desired beam positive moment capacity of at least half the negative moment capacity was achieved. The previously damaged Specimen 2 exhibited an additional 22% increase in the peak loads in the upper half of the force-drift hysteretic curves and a 21% increase in the overall energy dissipation compared to the values obtained for the retrofitted Specimen 1 (Fig. 7a vs. Fig. 4a). The ductility of the beam negative moment hinges that formed during downward loading was also remarkable with the beam top bars mobilizing their entire yield plateaus.

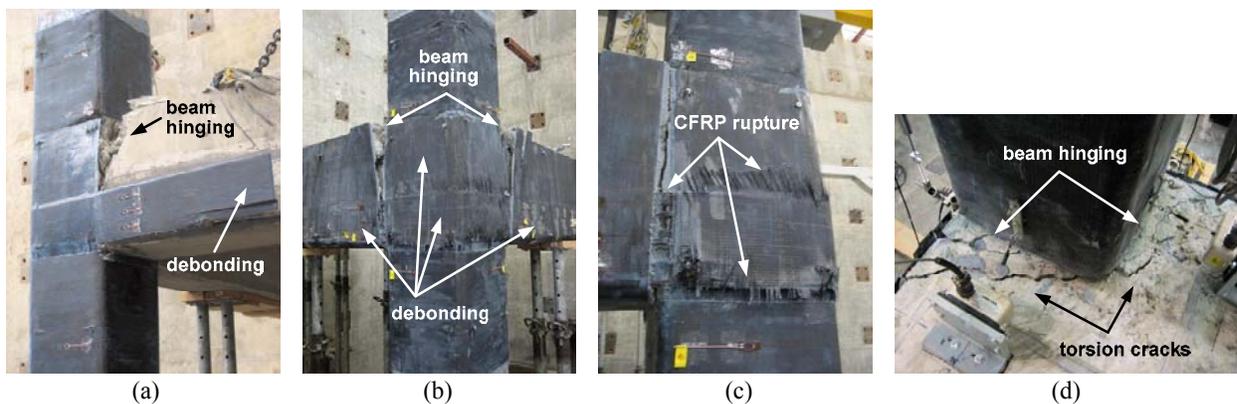
Figure 6 – Damage modes after retrofit: (a) Specimen 1, (b, c) Specimen 2, and (d) Specimen 3.

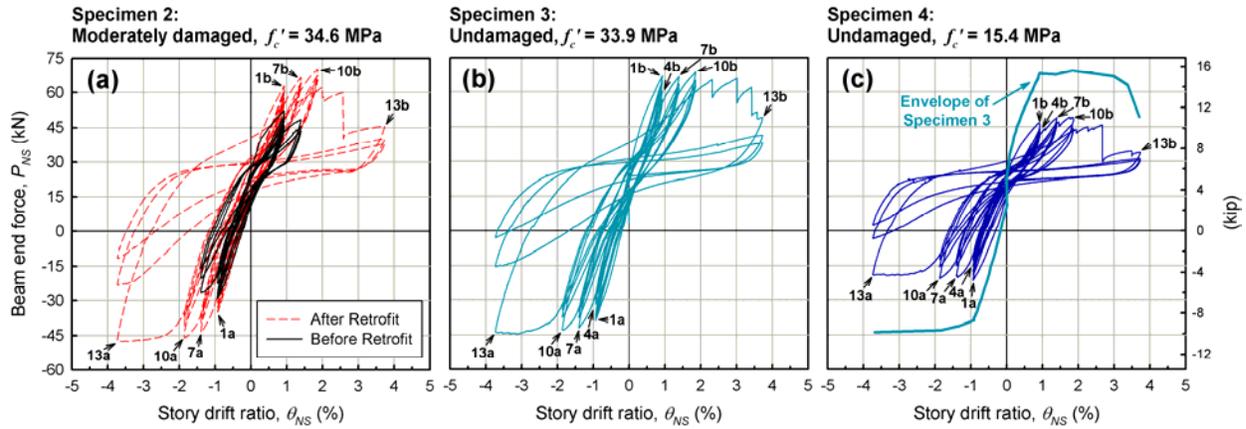
Figure 7 – Force-drift hysteretic response of Specimens 2, 3, and 4 in the NS direction.

When Scheme 2 was applied to the undamaged Specimen 3, the additional improvements in the force-drift response compared to that of Specimen 2 were limited to an 8% increase in the initial stiffness, up to 10% increase in peak loads in the first three cycles, a more progressive failure of CFRP toward peak 13b, and a resulting increase in the energy dissipation capacity of only 2% (Fig. 7b vs. Fig. 7a). The increase in the joint shear strength was also limited; an 8% additional increase was obtained over that of Specimen 2 ($\tau'_b = 1.15\sqrt{\text{MPa}}$ vs. $1.06\sqrt{\text{MPa}}$). Such changes did not indicate a clear benefit of pre- over post-damage retrofit. Pre-damage retrofit showed improved behavior in that the joint was able to maintain much of its improved strength through larger drift levels as evident from a comparison of Fig. 8a and Fig. 8b. While the previously damaged Specimen 2 lost it much of its improved strength after cycle 10 ($\theta_{EW} = \theta_{NS} = 1.9\%$; $\theta_b = 2.7\%$), the undamaged Specimen 3 exhibited a τ'_b value of $1.03\sqrt{\text{MPa}}$ even at peak 13a ($\theta_{EW} = \theta_{NS} = -3.7\%$; $\theta_b = -5.2\%$).

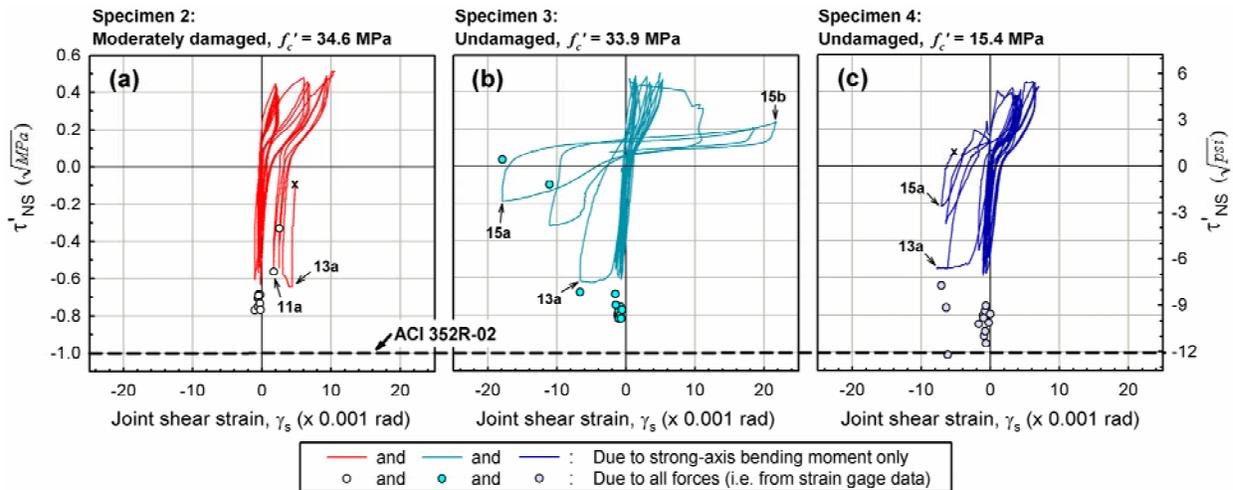
Figure 8 – Normalized joint shear stress-strain hysteresis loops of Specimens 2, 3, and 4 in the NS direction.

Despite the low f'_c , Specimen 4 withstood a maximum normalized joint shear stress of $\tau'_b=1.41\sqrt{\text{MPa}}$ which was the largest value obtained in this project (Fig. 8c) and which was 41% larger than $\gamma_{\text{ACI352}}=1.0$. The CFRP-to-concrete bond was not any worse; complete debonding of the joint sheets did not occur any earlier; and rupture of the beam strips was still achieved. Such a remarkable joint response, however, did not translate into an acceptable overall behavior. All force-drift response parameters were significantly reduced relative to those of Specimen 3 as shown in Fig. 7c. The peak-to-peak stiffness of Specimen 4 was not only 32 to 44% lower than that of Specimen 3 throughout the test, it was also 15 to 20% lower than that of the as-built Specimen 2. The cumulative dissipated energy was 37% less than that of Specimen 3. Such reduced overall properties were due to the fact that a strong column/weak beam behavior could not be achieved because of the lower column-to-beam strength ratio and reduced anchorage of beam top bars within the joint. It was concluded that in such cases of low f'_c , more invasive techniques may be necessary to improve the overall lateral stiffness and the reinforcement anchorages so that the improved joint strength can be mobilized.
