VERIFICATION OF SEISMIC REINFORCEMENT ON OLD WOOD HOUSES BY USE OF E-DEFENSE

ABSTRACT:

KEYWORDS: Seismic diagnosis, Seismic Reinforcement, E-Defense, Old wooden house

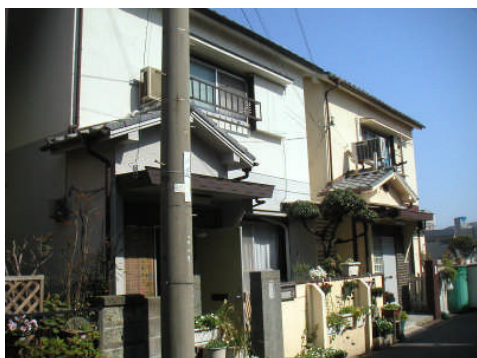
Photo. 1 Exterior view of tested house.

Houses to be reconstructed and subjected to the shaking table test were collected from the public. Of over 200 houses, the two houses which were satisfied with the conditions, as mentioned above, were the same in the built year, structures and specifications, and were located on the site which had spaces for executing dividing works were selected. The selected houses were two about 30-years old two-storied wood post and beam houses built in Akashi City, Hyogo (hereinafter referred to as Akashi Houses A and B). Exterior and interior views of the houses are shown in Photo. 1 and 2, and plans and elevation views are shown in Figs. 1 and 2, respectively. The left side in Photo. 1 was House A. The specifications of each part are shown in Table 1. The houses were slightly different from each other due to improvement works, but had almost the same room arrangement. The houses were typical wood houses built in the Kansai District in this period.

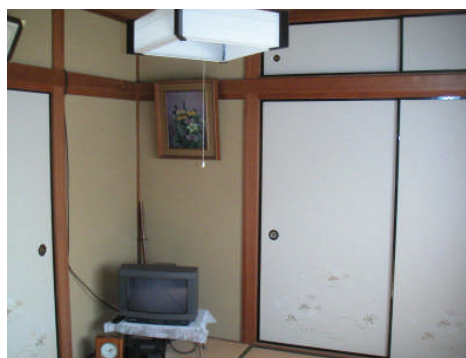
Photo. 2 Interior view of tested house.

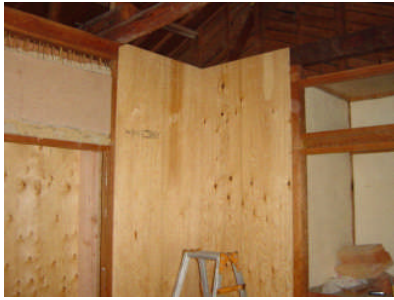
Photo 3. Reinforcement for transporting.

Based on these concepts, the houses were cut, divided to four portion and transported to the E-defense. The removing and reconstruction procedures involved 1) cutting the exterior and the interior wall, 2) reinforcement of the walls with plywood for transporting the houses (Photo. 3), 3) cutting the structural frame and jacking up the houses, 4) lifting and loading the part of the house onto trailers (Photo. 4), 5) reconstructing the houses, 6) repairing the cut members (Photo. 5), 7) restoring the floor and installing live loads, and 8) restoring the exterior mortar wall and filling the interior walls. The houses set on the shaking table are shown in Photo. 6. The microtremors were measured before and after the reconstruction of Akashi Houses, and the results are shown in Fig. 3. The measurements showed that the reconstruction made the initial stiffness a little bit low in consideration of the effects of the decline in the weight of the houses.

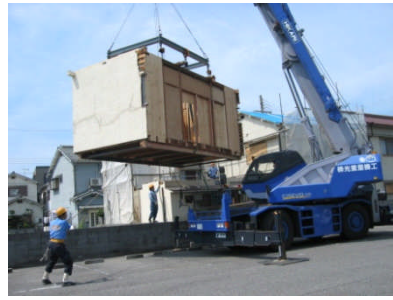
Photo 4. Lifting and transporting.

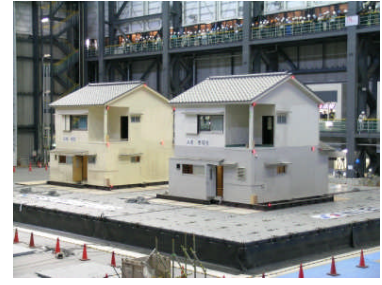
Photo 6. House specimens set on a shaking table.

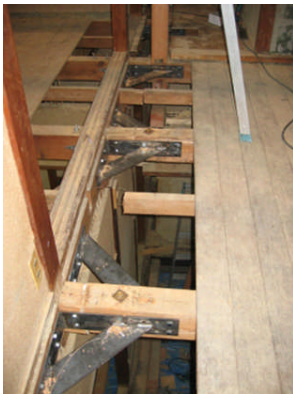
Photo 5. Repairing the cut beams.

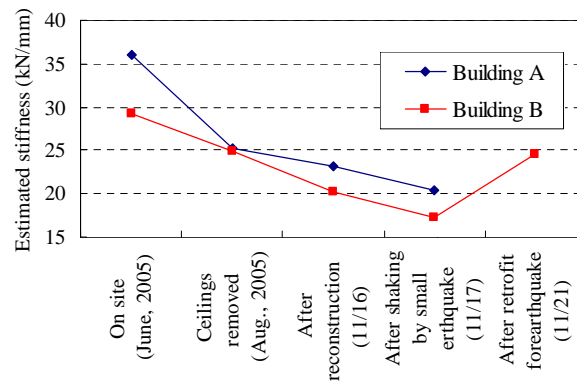
Fig. 3. The Stiffness of the tested houses estimated from weights and dominant frequencies of microtremor.

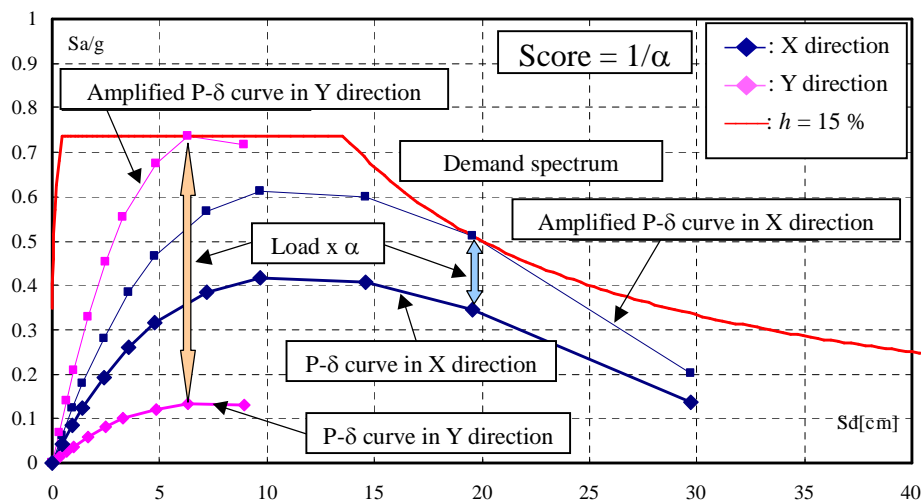
Fig. 4. Method of precise seismic diagnosis 2 (Response and limit capacity method)

Response and limit capacity method were conducted to the House A and B. The load-displacement relations were obtained by the contraction of the building to a single degree of freedom. The load-displacement curves were compared with the demand spectrum and amplified to just contact with the spectrum, as shown in Fig. 4. The reciprocal number of amplification rate, α at that time was defined as the score of precise seismic diagnosis 2 (Response and limit capacity method). The scores of the diagnosis were shown in Table 4.

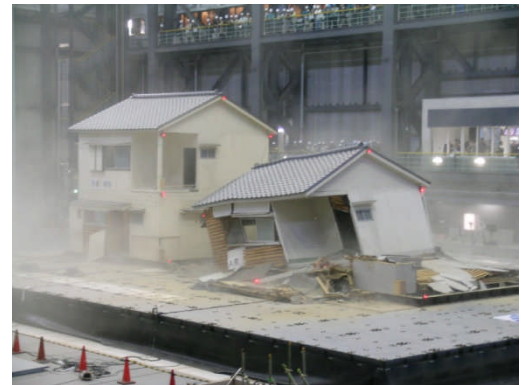
Photo. 7. Collapse behavior.

toward the other direction on the 1st story and collapse (Photo. 7) before the displacement returned to the negative side. House B deformed to a relative story displacement of 180 mm on both sides and did not collapse. However, large cracks occurred on the exterior mortar wall on the first story, parts of which came off. Some of the structural plywood and braces added for reinforcement failed off, some joint connectors became loose, and some screws pulled out. In House A, which collapsed, many tenon joints were not broken but pulled out. After shaking, a precise seismic diagnosis of House B was conducted by considering the damages to the house. The score of the 1st story in the Y-direction was 0.86 (1.57 before shaking), so it was clarified that the seismic performance of House B was declined by the JR Takatori full scale shaking.

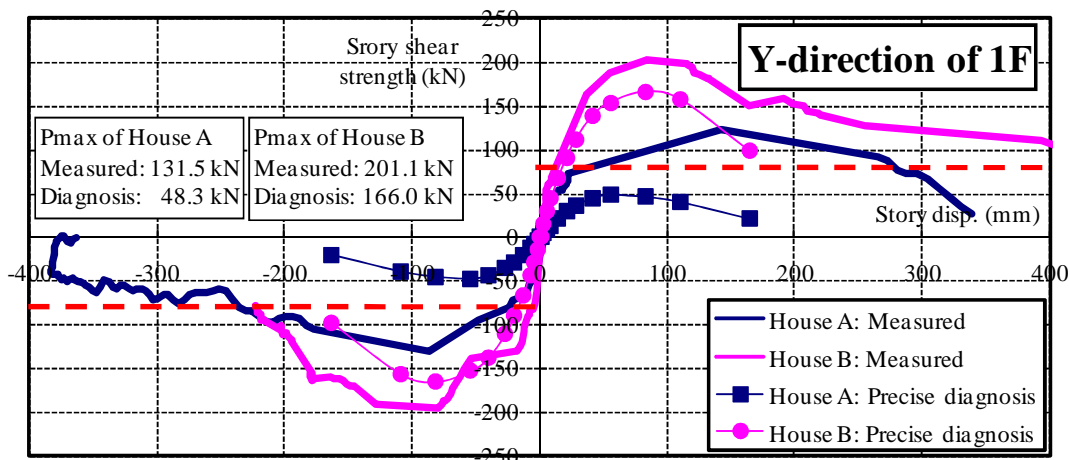
Fig. 7. Comparison between the results of the precise seismic diagnosis and the shaking table test.

The relationships between load and deformation were calculated by the precise seismic diagnosis method 2 based on Horizontal load-carrying capacities. A comparison between the calculated and monitored relationships is shown in Fig. 7. The dotted lines in the figure show the required ultimate strength calculated using the horizontal load-carrying capacity method. The calculated relationship between load and deformation using the precise seismic diagnosis method was far smaller than the required ultimate strength in House A, which collapsed. The all calculated values were smaller than the measured values, so the precise seismic diagnosis method 2 based on Horizontal load-carrying capacity was on safety side. The difference between the calculated and measured values was slightly larger in House A, which was not reinforced, than in House B, which was reinforced. Because the shear wall with plywood or brace, which was relatively new seismic elements and had datum enough to evaluate, could be evaluated exactly, but those with the mud wall and *Nuki*, which was relatively old seismic elements and didn't have enough datum, couldn't be evaluated. The experimental values at which the houses lost the restoration capacity were also larger than the calculated values in both houses.
