FULL SCALE EARTHQUAKE RESPONSE
OF A REHABILITATED BUILDING

The ambient, harmonic vibrator and earthquake response of a three story concrete shear wall building has recorded and analyzed. The harmonic response was measured prior to and after a major strengthening rehabilitation. This paper summarizes the response data analysis to date.

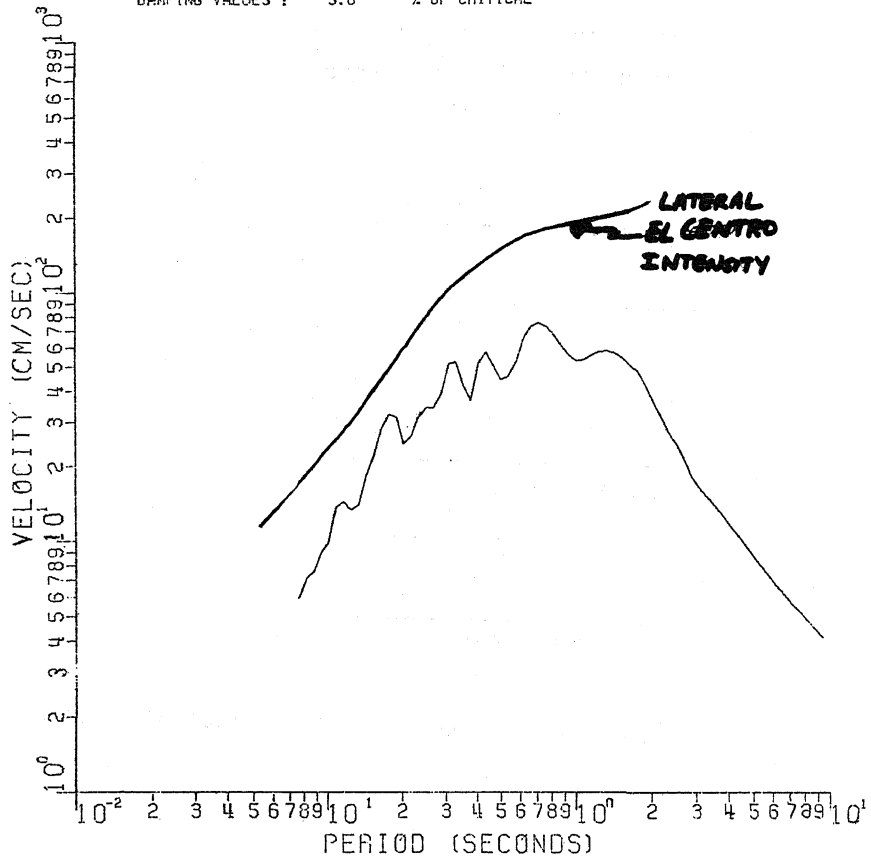
Figure 4

RESPONSE SPECTRUM

SANTA BARBARA EARTHQUAKE OF 13 AUGUST 1978 2254
DMG 213 SANTA BARBARA UCSB NORTH HALL S/N 115 TR. 1
DAMPING VALUES : 5.0 % OF CRITICAL

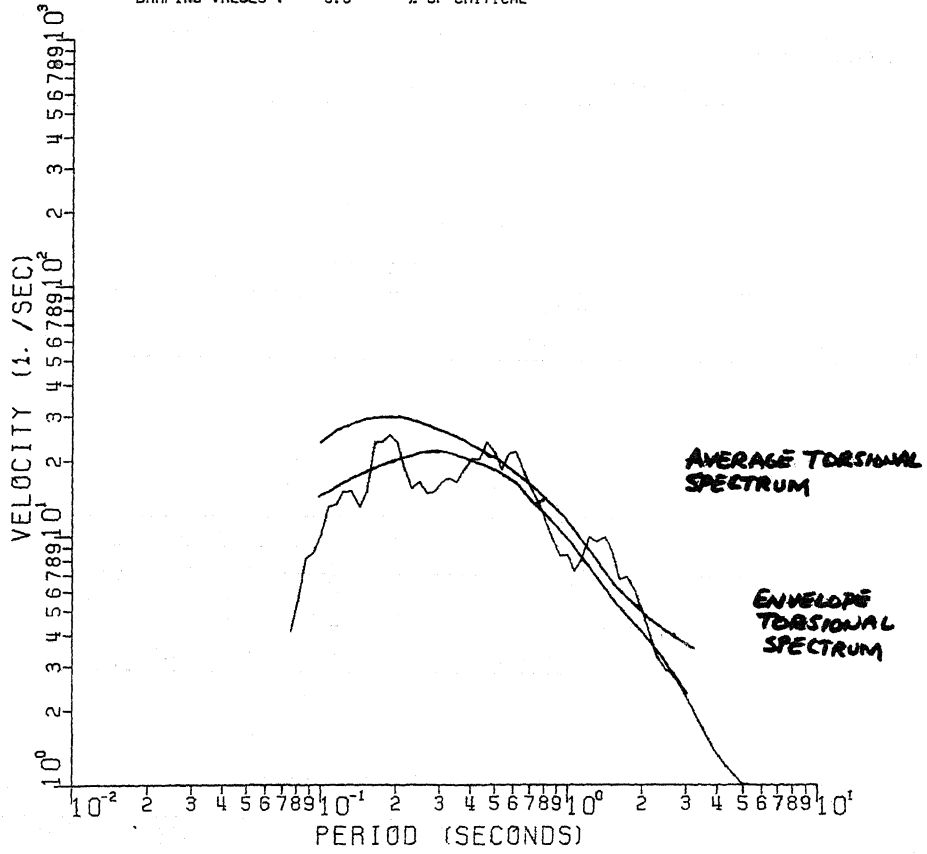
Figure 5

RESPONSE SPECTRUM

SANTA BARBARA EARTHQUAKE OF 13 AUGUST 1978 2254
DMG 213 SANTA BARBARA UCSB NORTH HALL S/N 115 1000 * (TR.4 - TR.1) / XDL
DAMPING VALUES : 5.0 % OF CRITICAL
