FULL SCALE TESTING AND SEISMIC QUALIFICATION
OF CEMENT MORTAR LINED CARBON STEEL PIPE

SUMMARY

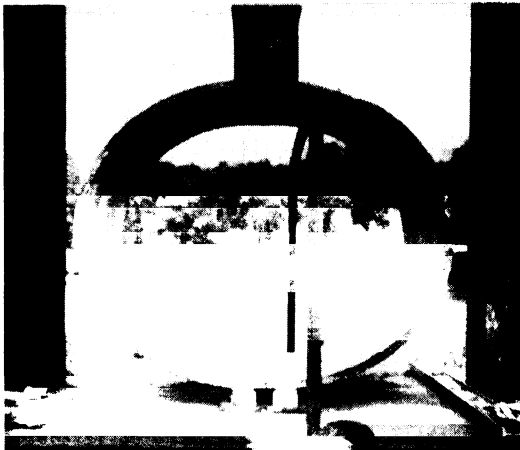
Photo 1-Cyclic test-30" pipe, fully cured (32 days)-after 20 cycles to 7k

were observed at start of the test. The pipe was loaded to 4 kips first, unloaded and then cyclic loading was applied. Shortly after applying the static load, a hairline crack appeared in the bottom at 1-kip load and a second in the top at 2 kips. Bond break at the top was also observed at 2 kips. At 4 kips a crack close to 0.01 inch appeared in the bottom. The pipe was then cycled 20 times to 4.0 kips. At the eleventh cycle bond break between lining and pipe was indicated by a loud bang. The pipe was then cycled another 20 times to 7.0 kips. The 0.01-inch crack appeared in the bottom during the first cycle to 7 kips. More bond break occurred during the first cycle. More cracks appeared at top and bottom. The condition of the specimen at this stage is shown in Photo 1. The pipe was then cycled another 20 times to 10.0 kips and bond break developed at the eleventh cycle. Also, cracks and spalling appeared in top and bottom. Then the pipe was cycled four times to 12 kips. The top lining started to fall during the second cycle and more failure at top occurred after four cycles. Test was stopped after complete failure of the liner.
