## SEISMIC BEHAVIOR OF REINFORCED MASONRY WALLS

Carl LUDERS Sch.<sup>1</sup> and Pedro HIDALGO O.<sup>1</sup>

<sup>1</sup>Department of Structural Engineering, Catholic University of Chile,  
Santiago, Chile

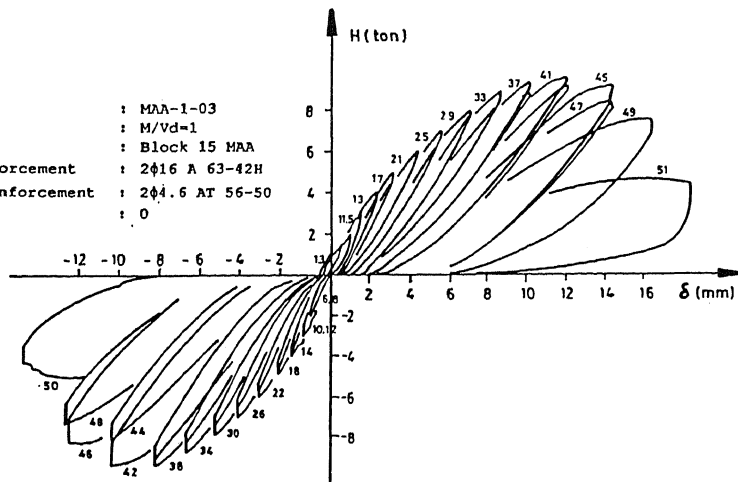
SPECIMEN : MAA-1-03  
 Aspect ratio : M/Vd=1  
 Type of units : Block 15 MAA  
 Vertical reinforcement : 2 $\phi$ 16 A 63-42H  
 Horizontal reinforcement : 2 $\phi$ 4.6 AT 56-50  
 Axial load : 0

FIG. 6 TYPICAL LOAD-DISPLACEMENT CURVES OF PIERS THAT FAILED IN A SHEAR MODE

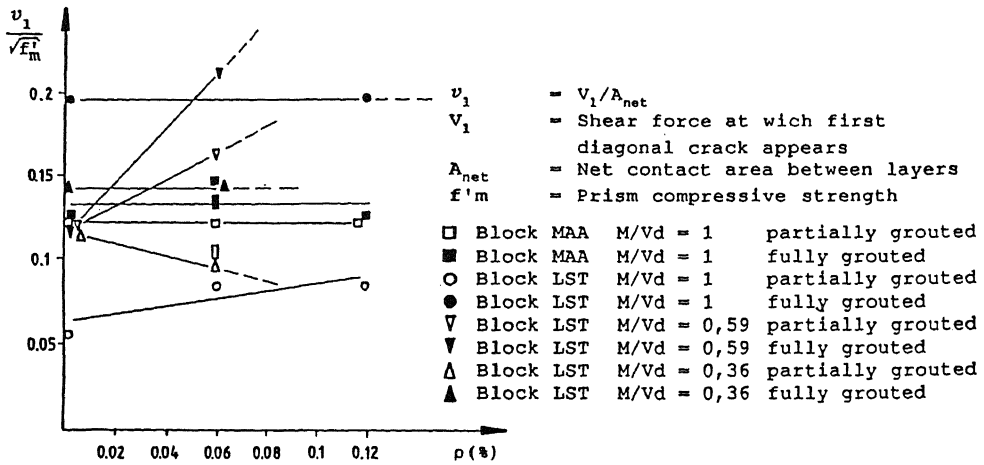
FIG. 9 INFLUENCE OF THE HORIZONTAL REINFORCEMENT ON THE INITIAL SHEAR CRACKING

Initial Shear Cracking The nominal shear stress corresponding to the onset of diagonal cracking is independent of the amount of horizontal reinforcement (Ref. 6). Fig. 9 shows the experimental values obtained in this program, which fall in the range  $0.08\sqrt{f'_m}$  to  $0.20\sqrt{f'_m}$  (MPa).

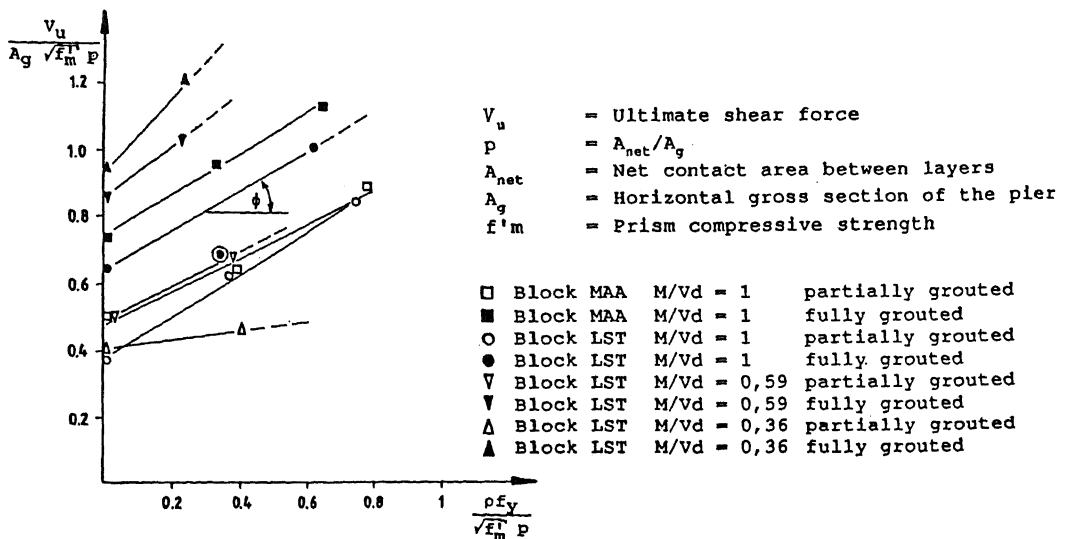
FIG. 10 INFLUENCE IN STRENGTH OF HORIZONTAL REINFORCEMENT

Influence of Horizontal Reinforcement in Pier Strength Interesting results have been obtained as to the influence that horizontal reinforcement has in the strength of walls. Due to the fact that the shear crack that develops across the wall varies greatly in width along its length the horizontal bars are subjected, from one another, to very different elongations. If the steel used is brittle, and bond does not deteriorate, some bars break before the rest of them start to yield. This triggers a chain of local failures that negates the possibility of developing the sum of the strengths of all the bars available. Fig. 10, reflecting these results, allows the derivation of the following formula for the additional strength provided by horizontal reinforcement:
