## EVALUATION OF TECHNIQUES TO REPAIR MODERATE EARTHQUAKE DAMAGE

Catherine E. FRENCH<sup>1</sup>, WenJen TSAI<sup>2</sup> and Greg THORP<sup>3</sup>

### SUMMARY

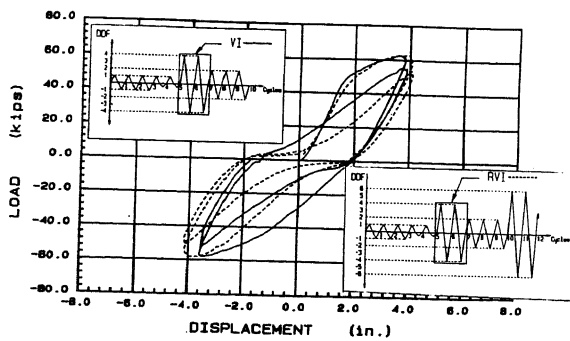
Fig. 5 Load-Deflection Response of VI and RVI - Cycles 6-7  
(1 in. = 25.4 mm, 1 kip = 4450 N)

Largest Cycles (6-7) The superimposed load-deflection histories for VI and RVI are shown in Figure 5 for the largest lateral displacement comparison. During Cycle 6, the stiffnesses and strengths attained by both the original and repaired structures were quite similar. As evidenced from the slight pinching of the load-deflection curves and from results obtained with instrumentation used to measure bar slippage, the bond between the reinforcement and the concrete suffered major deterioration during Cycle 7 for VI and during the negative displacement of Cycle 6 for RVI. The measurements mentioned above regarding bar slippage were obtained by attaching a stiff wire to the beam reinforcement in the joint. This wire passed through the joint in a greased tube and was connected to a linear voltage differential transformer (LVDT) at the exterior

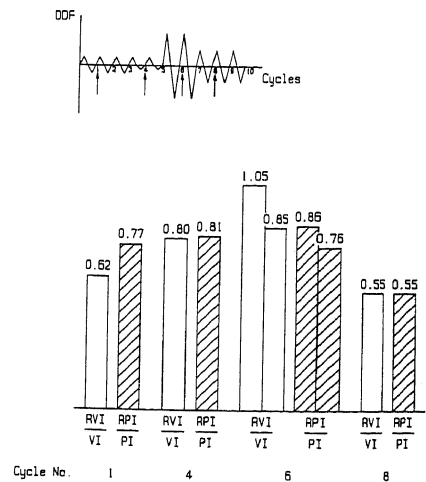
Fig. 6 Energy Dissipation Ratio of Repaired to Original Models

Figure 6 shows a comparison of the energy dissipation capacities observed in the tests. The comparison is made by observing the ratio of the energy dissipated by the repaired structures to that of the original structures for the first cycle to each new displacement level (1,4,6 and 8). It may be observed that in the beginning cycles, the pressure injection technique appeared to be more successful in restoring energy dissipation. The primary reasons for this are that the epoxy drained from interface crack with the vacuum impregnation technique and the column had suffered some deterioration (cover spalling) in later cycles of the test of VI which caused a reduction in the initial stiffness of RVI.
