REPAIR AND STRENGTHENING OF CONCRETE STRUCTURES DAMAGED BY EARTHQUAKES

Miguel Corazao¹, Ahmad J. Durrani² and Hank Taylor³

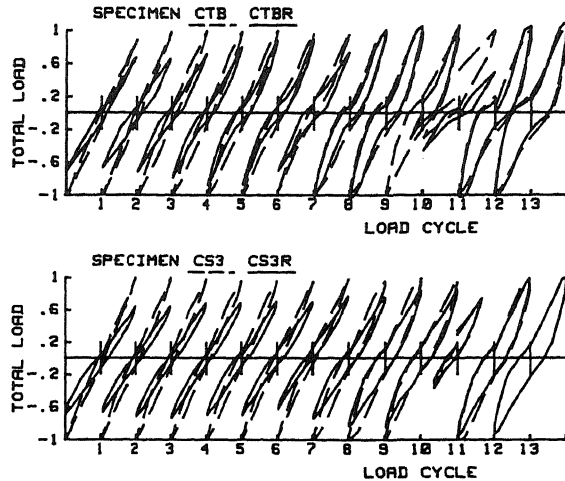
FIGURE 9. Load vs. Displacement Loops

Figure 9 shows the load vs. displacement plots of these two specimens before and after repairs. The plots are normalized with respect to load and displacement amplitudes of the first test. In both specimens the load amplitudes during the early cycles were smaller during the tests after repairs indicating a reduction in stiffness. The loops after repairs, in the case of specimen CS1R, were pinched near the zone of zero displacement. In specimen CS3R, however, the shapes of the loops after repairs were basically the same as those before repairs. The pinched shape of the loops of specimen CS1R indicates that the reduction in stiffness in this case was due to cracks that were not filled with epoxy and to slippage of reinforcing bars through the joint despite the injection of epoxy. In specimen CS3R, the epoxy mortar, which has a lower modulus of elasticity than the concrete it replaced, was the main reason for the observed reduction in stiffness. These results suggest that large variations in performance can occur depending on the quality of the injection work.

Epoxy Injection Specimens CS1R and CS3R were used to evaluate this repair technique. In specimen CS3R an effort was made to insure maximum possible penetration of the resin. The injection process was repeated if voids were observed after removing the surface seals.
