Repair of Damaged Circular Reinforced Concrete Columns By Plastic Hinge Relocation

S. T. Rutledge, M. J. Kowalsky, R. Seracino, and J. M. Nau

15 WCEE
LISBOA 2012

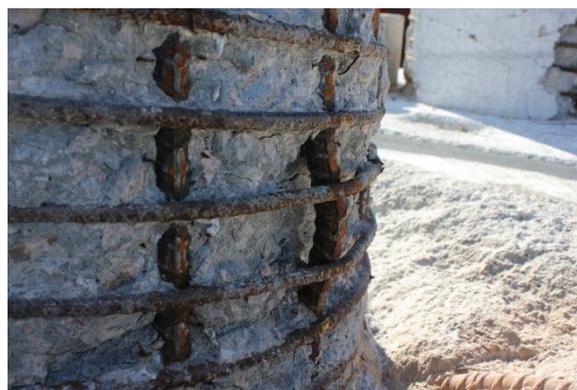
Figure 1.1. Buckled longitudinal reinforcement

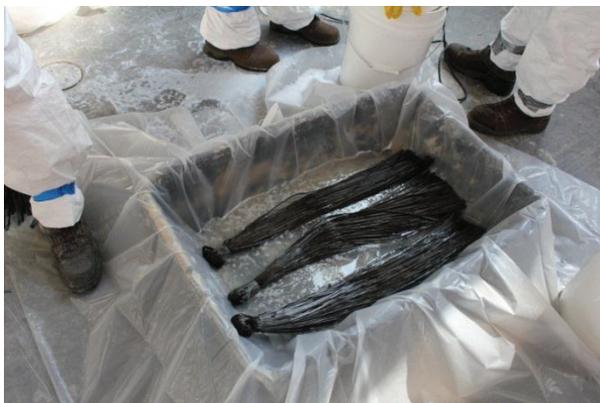
Figure 2.3. CFRP anchor impregnation

A single layer of vertical fibers was first placed on the column from the base up to 600 mm around the circumference. The dry carbon fiber anchors were then impregnated with the same epoxy and inserted into evenly distributed holes that were 38 mm in diameter and 350 mm deep that were previously drilled into the footing. Fig. 2.3 shows the carbon fiber anchors prior to impregnation and Fig. 2.4 shows the insertion of the anchors into the footing. The anchor fans were then splayed onto the column. Two more layers of vertical fibers, 600 mm long, were then applied to the repair region sandwiching the anchor fans between the layers of vertical fibers. The final step was to wrap the repaired region with six individual CFRP sheets with fibers in the hoop direction, each with a 300 mm overlap. As mentioned earlier, for column one only, six layers of hoop fibers were also wrapped around the 600 mm to 1200 mm region of the column to confine the expected new plastic hinge region as discussed in Section 2.3.

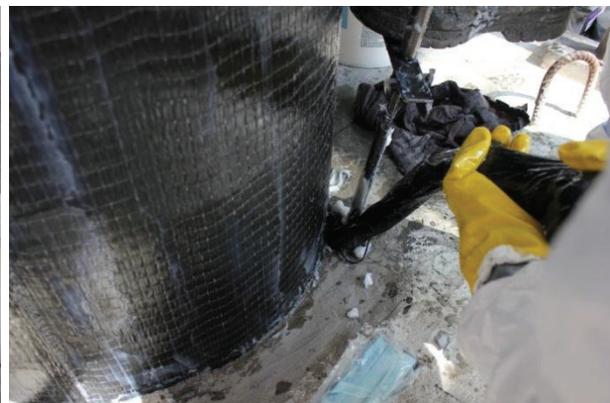
Figure 2.4. CFRP anchor insertion into footing

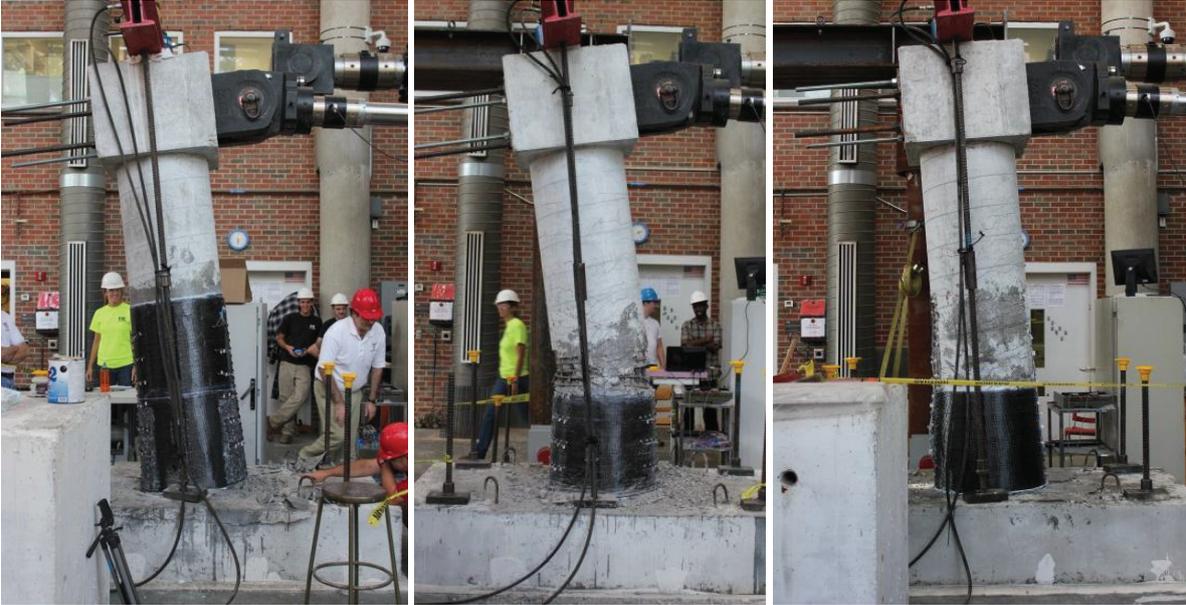
Figure 3.4. Peak Displacement: test one (left); test two (center); test three (right)
