A Novel Post-Earthquake Damage Survey Sheet: Part II- Masonry Buildings

Keywords: Post-earthquake damage assessment; Masonry buildings; Survey sheet

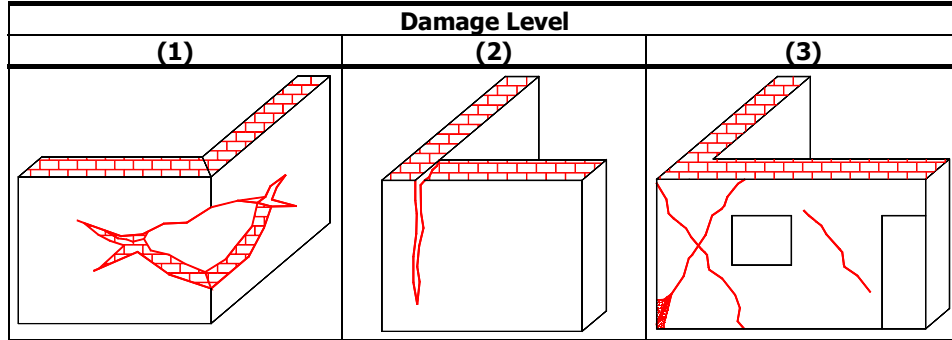
Figure 3.4. Heavy damage types that can be observed in periphery walls

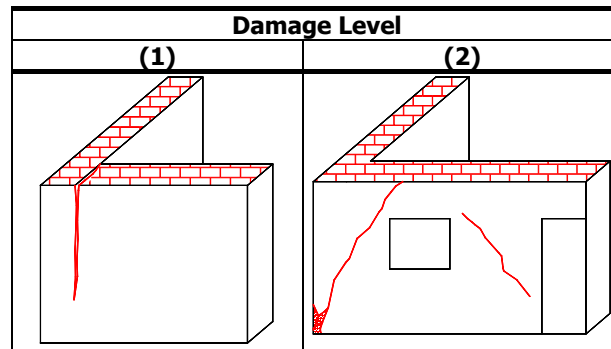
Figure 3.5. Moderate damage types that can be observed in periphery walls

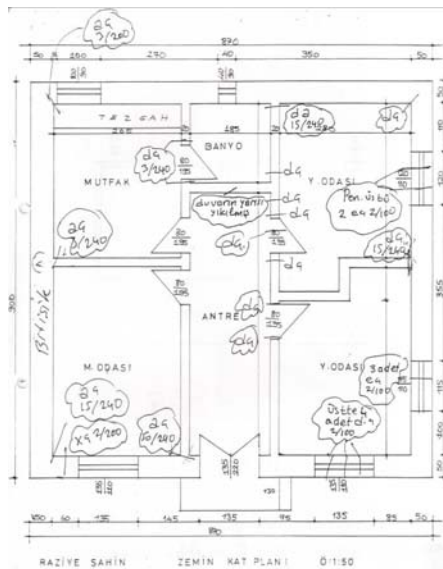
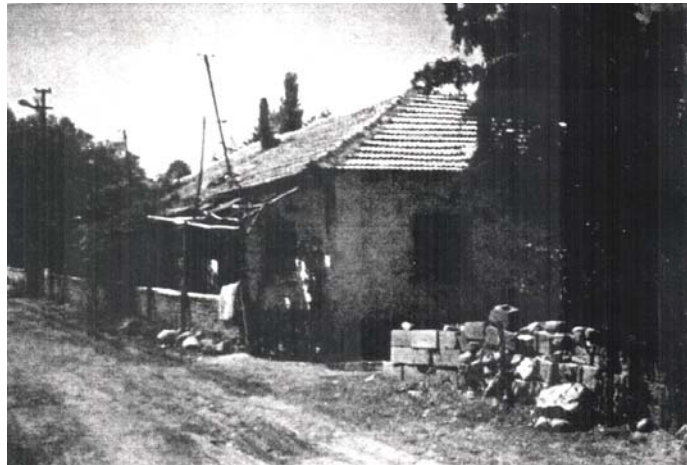
Building-A: is a single storey building experienced moderate damage during Dinar Earthquake. The structural walls' material is adobe with thicknesses of 50cm at the periphery and 20cm at the interiors. The story height is measured as 2.35m. The slabs and the roof are timber supported by timber tie beams. According to the damage report, out-of-plane collapse of gables is observed. Shear cracks are seen in most of the interior structural walls. Furthermore, separation of walls on the left side and the central regions of the façade are observed as well as diagonal shear cracks at the corners of window and door openings. Similarly, three shear cracks at the central regions of the right-side façade are seen. As given in Fig. 4.1, almost half of a 1.85m long wall has been heavily damaged during the shake. The Overall Structural Damage THO is calculated as 42.0 indicating Moderate Damage rank.

Figure 4.1. Building-A: Damage sketch on the layout plan (left) and photo of the building (right)

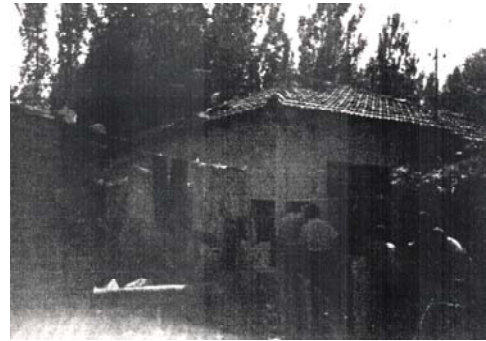
Building B: is a single storey building experienced moderate damage during Dinar Earthquake. The exterior and interior structural walls are made up off briquette with thicknesses of 20cm. The story height is measured as 2.70m. The roof is timber supported by timber tie beams; however the timber slabs are directly placed on briquette walls. According to the damage report, diagonal shear cracks are observed at the rear façade of the building and vertical separation of perpendicular walls either on the

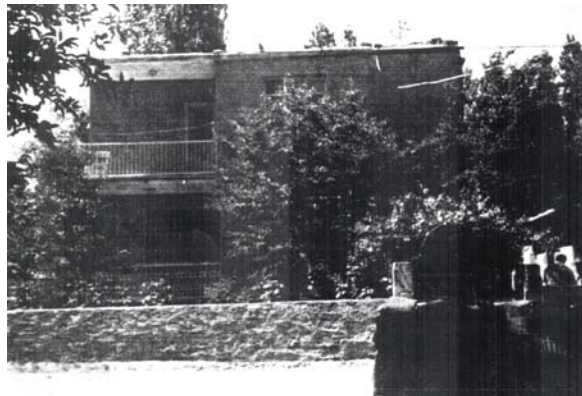
Building C: is a two storey building experienced moderate damage during the same earthquake. The exterior and interior structural walls are made up off solid brick with thicknesses of 30cm and 20cm, respectively on the ground floor, which is the most damaged storey. The story heights are equal and measured to be 2.70m. The roof also serves as a terrace and therefore slab system at each storey is RC supported by horizontal RC tie beams. According to the damage report, there were no structural damages in the first storey, however on the right side of the façade X-type and diagonal shear cracks were seen both at the corners and central regions. Furthermore, shear cracks at the corners of window and door openings on the frontal façade walls were observed. Fig. 4.3 shows the damage sketch of the building on a layout plan and the photo taken during the damage assessment. The Overall Structural Damage THO is calculated as 56.0 indicating Moderate Damage rank.

Figure 4.3. Building-C: Damage sketch on the layout plan (left) and photo of the building (right)
