Assessment of Seismic Performance of Adobe Structures in Pakistan and Portugal

SUMMARY:

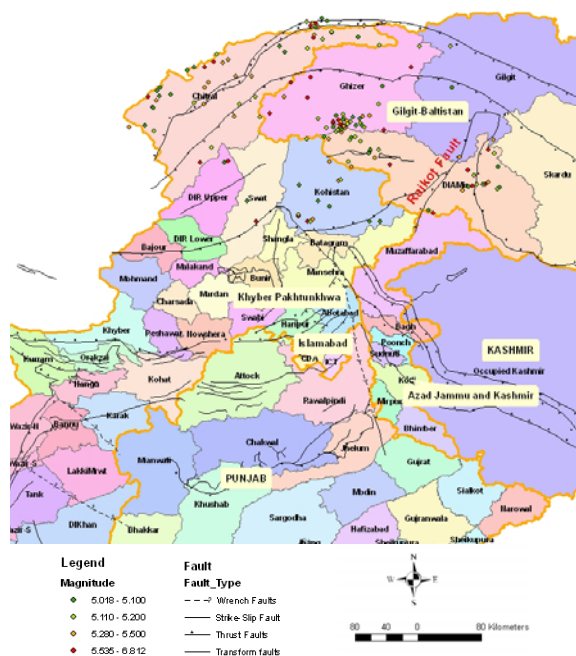
**Figure 2.1.** Faults and recorded earthquakes around Gilgit-Baltistan**Table 2.2.** Building Typology in Portugal (INE 2001)

The fault system around Gilgit-Baltistan is shown in Figure 2.1. It is noted in Figure 2.1 that the region is surrounded by several active faults. Hindu Kush and Pamir are considered to be seismically active regions (Nowroozi, 1971). The earthquakes of magnitude 5 and above in this region are also illustrated in Figure 2.1. These data have been taken from different sources such as International Seismological Centre (ISC), National Earthquake Information Center (USGS), Pakistan Meteorology Department (PMD), British Geological Survey (BGS), etc. No damage to adobe buildings due to earthquake has so far been recorded in the area. This may partly be attributed to the ground characteristics of this mountainous region.

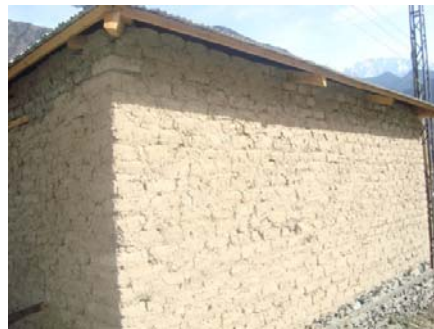
Figure 4.2. View of adobe house in Chitral

Access to the living room is provided through a lobby. A door is provided at the entrance of the lobby to avoid loss of heat from the house. The kitchen attached with the living room is utilised during summer only. A roof opening of 600x600 mm is usually provided in the middle of the roof of living room for sunlight. The other rooms are provided with windows and ventilators. Guest room may also be used as animal stable in order to keep the house warm during winter. A view of adobe house is shown in Figure 4.2. The details of adobe house construction are discussed in the forthcoming sections.

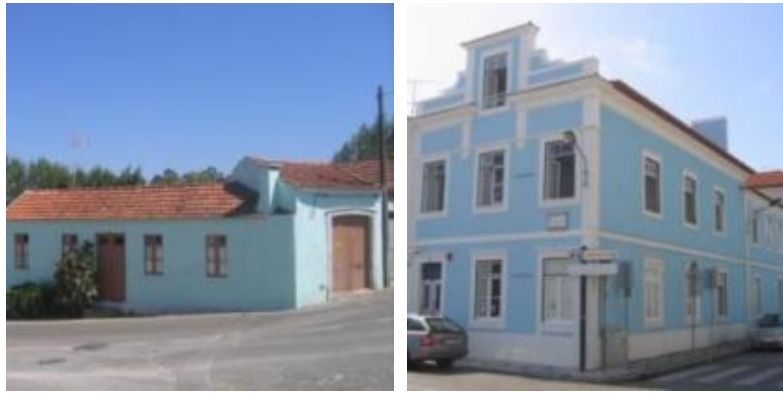
Figure 4.3. Single and double storey adobe houses in Aveiro

In urban areas most of the buildings consist of one or two floors and, in rural areas, buildings with only one floor predominate (Silveira, 2010; Silva, 2010) (Fig. 4.3). Most buildings present simple geometry, with a rectangular geometry in plan, and regular configuration in height. The details of construction are discussed as under.
