Assessment and retrofitting of façade elements of 19th century buildings

A. Kolbitsch

Vienna University of Technology

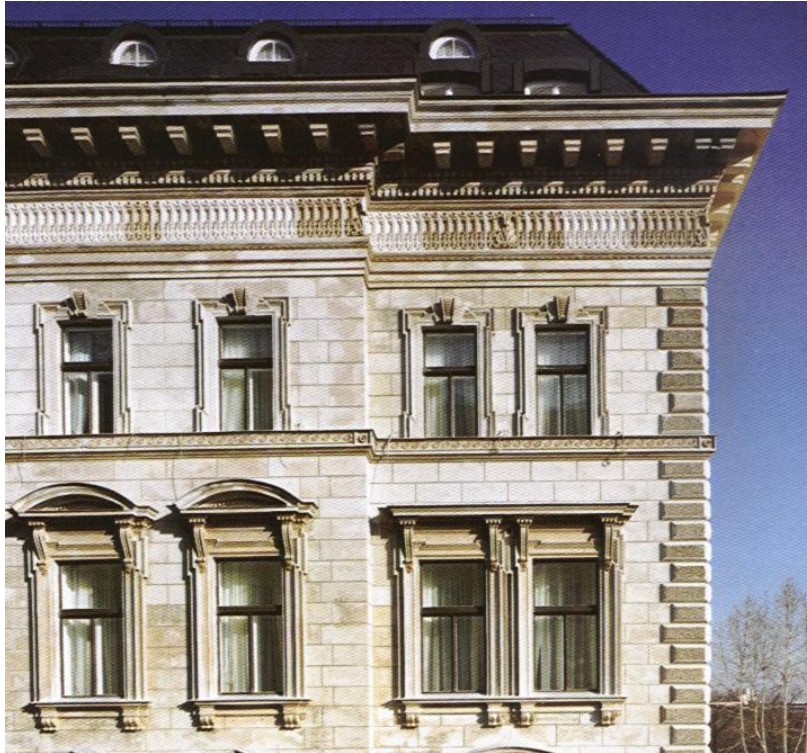
Figure 2. Palais Leitenberger, 1871/1872 with typical façade elements.

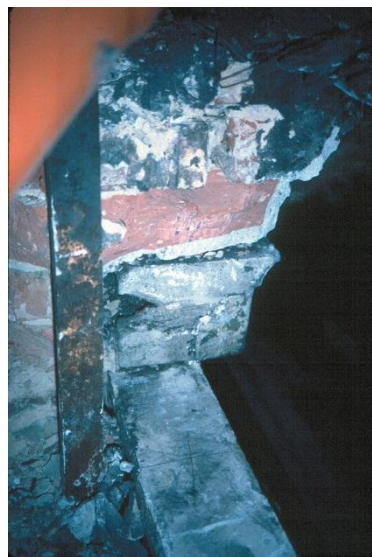
Figure 4. Partly collapsed cornice construction

Iron Cornice constructions often showed premature corrosion damages as depicted in figure 4.

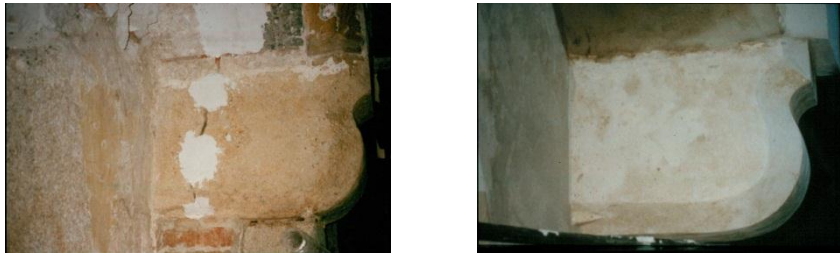
Figure 8 shows the assessment of a cracked cantilever construction in a baroque façade. The stone construction was prestressed by a single anchor rod and afterwards injected with resin grout.

Figure 7. Assessment of a natural stone and metal cornice construction, before and after restoration
