EARTHQUAKE RESISTANT EARTHEN BUILDINGS?

Marcial BLONDET¹, Gladys VILLA GARCIA²

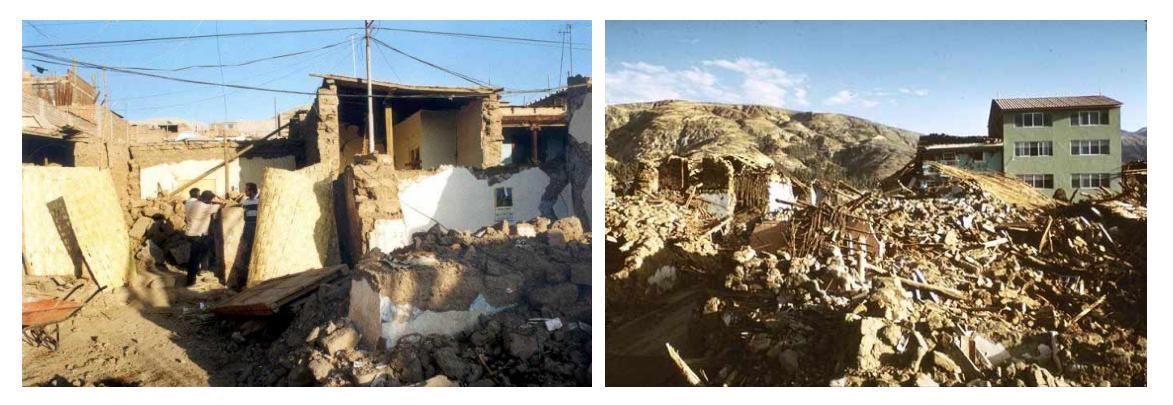
Figure 2. Destruction of adobe buildings during earthquakes

As a construction material, soil is heavy, weak and brittle. During seismic motion heavy walls develop large inertia forces, which they are unable to resist, and thus they suddenly fracture and many times collapse, preventing evacuation and causing death and material loss (Fig. 2).

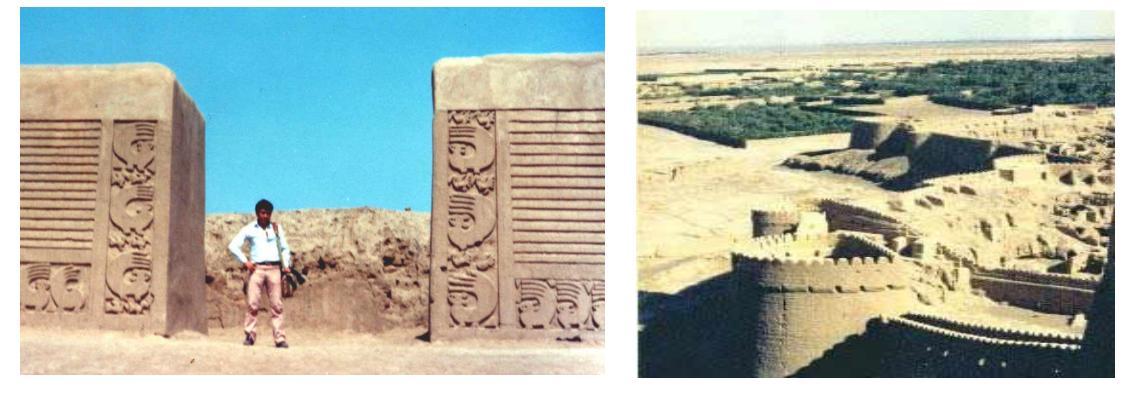
Figure 3. Ancient earthen citadels of Chan-Chan and Bam (from Moallemian [2])

In Peru, several historical earthen constructions have been able to withstand severe earthquakes because of their massiveness and regular configuration. For example, the Chan-Chan archeological site (1200 - 1400 A.D.), located on the coast of Peru, and occupying 20 km², is considered to be the world's largest mud citadel, and has survived many severe earthquakes during the past 600 years. Decorated boundary earthen walls (Fig. 3, left) up to 9 m tall and 3 m wide at the base can be found in the citadel. Many long walls without buttresses and with slenderness ratios smaller than 3 are still standing. On the other hand, the latest earthquake in Iran (December 2003, M_w 6.6), has destroyed not only thousands of poorly made adobe houses but also important ancient historical monuments such as the earthen citadel of Bam (Fig. 3, right). This seriously questions the argument of massiveness as a guarantee for earthquake endurance. The architectural design of the Bam citadel and surroundings includes upper thin walls standing over thick base walls, irregular plan configurations, and high wall densification. It seems that slender walls have collapsed, impacting adjacent walls and constructions, causing total destruction of the site, in spite of its massiveness.

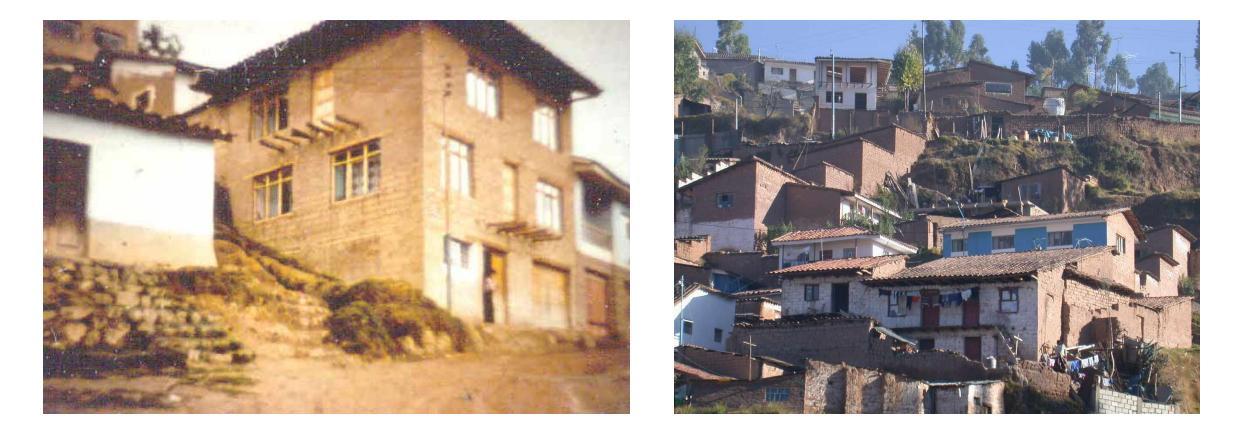
Figure 4. "Modern" adobe houses in Peru

"Modern" earthen dwellings in many countries are built to imitate the architectural features of clay brick masonry houses. Thus earthen houses are built without any structural reinforcement, with several stories, thin walls, large window and door openings and irregular plan and elevation configurations (Fig. 4). These buildings are extremely vulnerable to earthquakes. When an earthquake occurs, the out-of-plane seismic forces produce large vertical cracks at the corners, and in-plane shear forces produce diagonal cracks in the walls. The walls are thus broken in large independent pieces, which fall down, causing in turn the collapse of the roof.

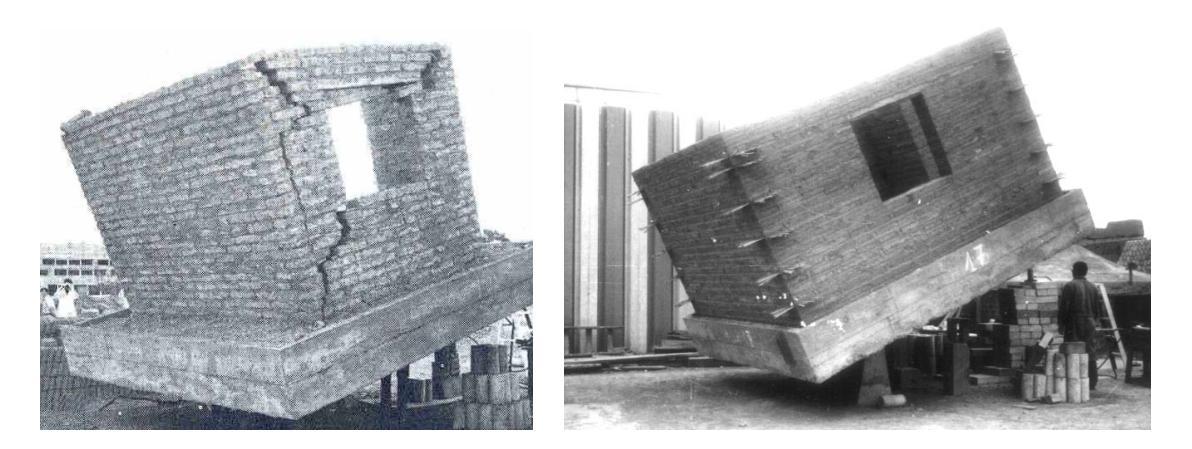
Figure 5. Full-scale adobe modules over tilting platform

The M_w 7.8 Huaraz earthquake of 1970 caused the death of around 70 000 people, about half of them buried under their adobe houses. This tragedy raised the consciousness in Peru about the need to investigate the problem of seismic strength of adobe buildings. Initially, research at the Catholic University of Peru (PUCP) was oriented towards the experimental study of several different alternatives of structural reinforcement using rural materials. This was done with a 4x4 meter reinforced concrete tilting platform used to test full-scale adobe modules (Fig. 5). The seismic force was represented by the lateral component of the weight of the modules. The main conclusion was that an interior reinforcement made of vertical cane, combined with an arrangement of horizontal crushed cane every fourth layer of adobe blocks substantially increased the seismic strength of the adobe modules (Corazao and Blondet [3]).

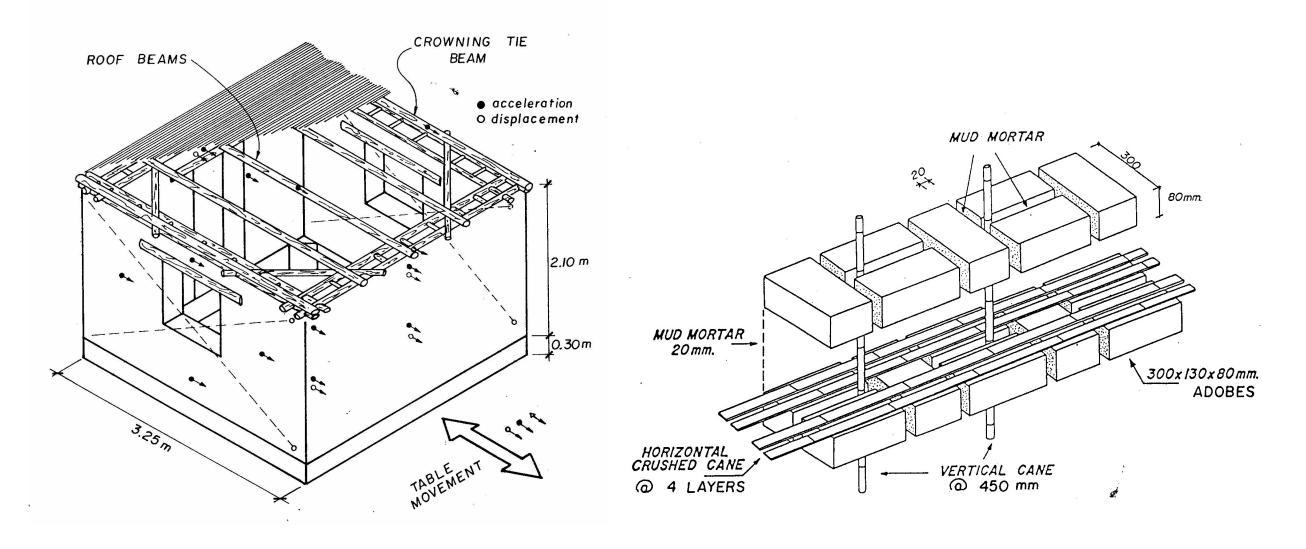
Figure 7. Vertical and horizontal cane reinforcement

An important research project was started in 1992, with the financial support of the International Development Research Center of Canada (IDRC). The seismic simulator of the Structures Laboratory of the PUCP was used to perform dynamic testing of full-scale adobe modules. Figure 6 shows the test setup. The modules had variations in the constructive technique, in the cane reinforcement system and in the configuration of wall openings. The command signal of the simulator was derived from the longitudinal displacement component registered in Lima during the May 31st, 1970 earthquake. This signal is typical of Lima's stiff soil conditions. All the modules were subjected to the same sequence of tests, with increasing intensity until collapse or significant damage was produced. The main conclusions of this project were that improvement in the construction technique (quality of materials and labor) by itself increased the strength and stiffness of uncracked walls, but had negligible influence after significant cracking occurs. During severe shaking, only the presence of the horizontal and vertical cane reinforcement shown in Figure 7, combined with a solid collar beam, were able to prevent the separation of the walls in the corners, thus maintaining the integrity of the structure. In consequence, this reinforcement is effective in preventing or delaying the collapse of the building (Ottazzi *et al.* [5]).

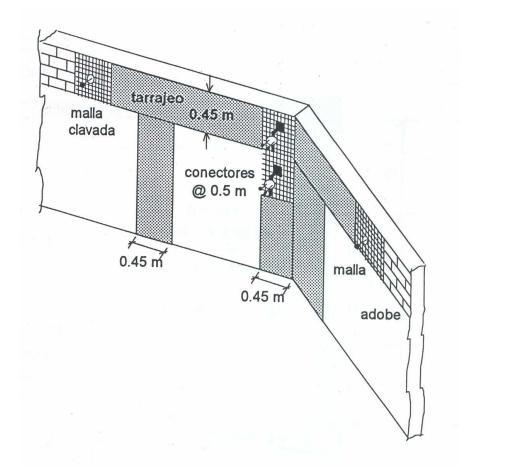
Figure 8. Welded wire mesh (from [8])

After more than twenty years of adobe research in the PUCP dedicated to the improvement of the seismic behavior of new adobe dwellings, an experimental project was funded in 1996 by the Deutsche Gesalischft für Technische Zusammenarbeit (GTZ) to develop simple techniques to reinforce existing adobe buildings. "U" shaped walls were tested on the seismic simulator with different reinforcement materials like wooden boards, rope, chicken wire mesh and welded mesh. The best results were obtained with welded mesh (1mm wires spaced at 20 mm), nailed with metallic bottle caps against the adobe and covered with cement-sand mortar. The mesh was placed in horizontal and vertical strips, as shown in Figure 8, simulating beams and columns. After successful testing of four full-scale modules on the seismic simulator, this solution was applied to the reinforcement of existing adobe houses located in different regions of Peru (Fig. 9, Zegarra *et al.* [6]). In 2001, a strong earthquake (magnitude 8.4)

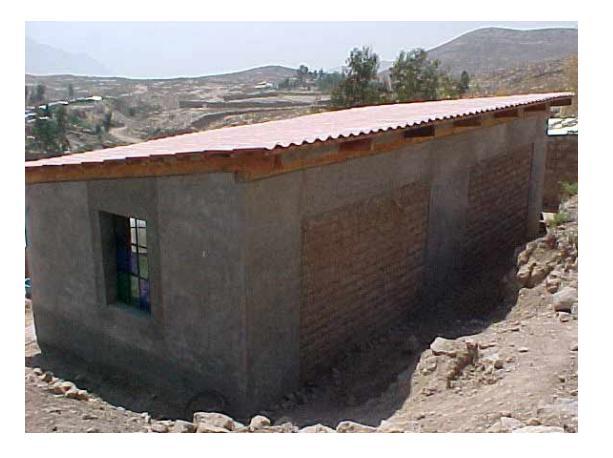
Figure 9. Reinforced house (from [8])

occurred in Southern Peru and destroyed most adobe houses in the affected region. However the houses located in the region that were reinforced with welded mesh suffered no damage at all and were used as shelters (Zegarra *et al.* [7]).

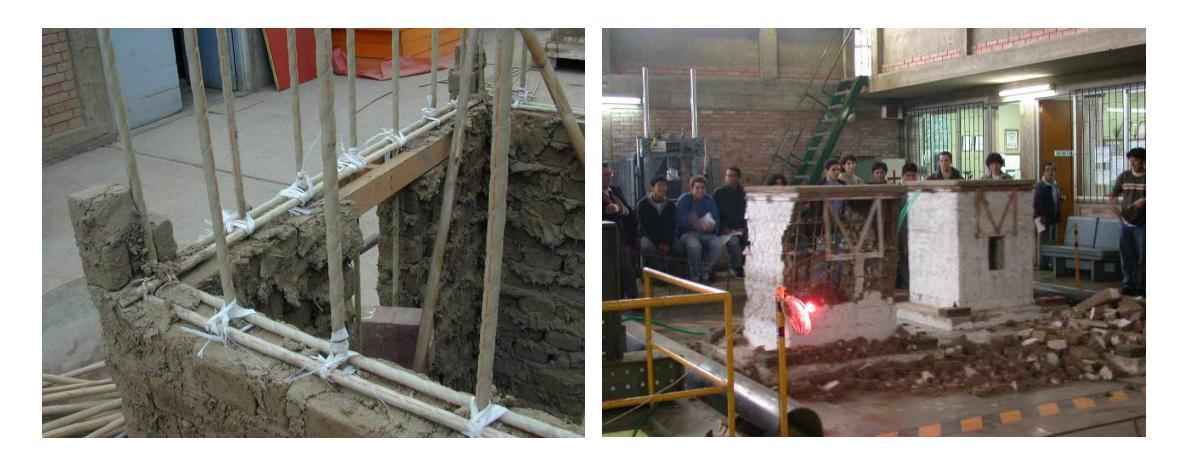
Figure 10. Seismic testing of small-scale adobe modules with FRP reinforcement

During 2003 a first attempt towards the application of Fiber Reinforced Polymer (FRP) rods as replacement for cane reinforcement was carried out during an academic earthen construction workshop at the PUCP (Fig. 10). Five small size adobe modules $(0.95 \times 0.95 \times 1.15m)$ with the same geometrical characteristics but with different reinforcement configurations were tested on the seismic simulator. For comparative purposes, the command signal was the same one used in previous research with full-scale modules.

A traditional unreinforced module and another one with interior cane mesh were tested as baselines. The other three had different FRP reinforcement patterns. The results confirmed that the traditional adobe module collapsed and the cane reinforced adobe module was able to withstand the strongest tests with only a low level of cracking. Although the FRP reinforced modules did not collapse, they were severely damaged. FRP rods are stiffer than cane and during shaking they push the adobes out of place. Besides, the bond between FRP rods and mud is lesser than the bond developed between cane and mud (Villa García *et al.* [9]) These results as well as the cost associated with FRP rods in developing countries suggest that FRP reinforcement is not an adequate replacement for cane.

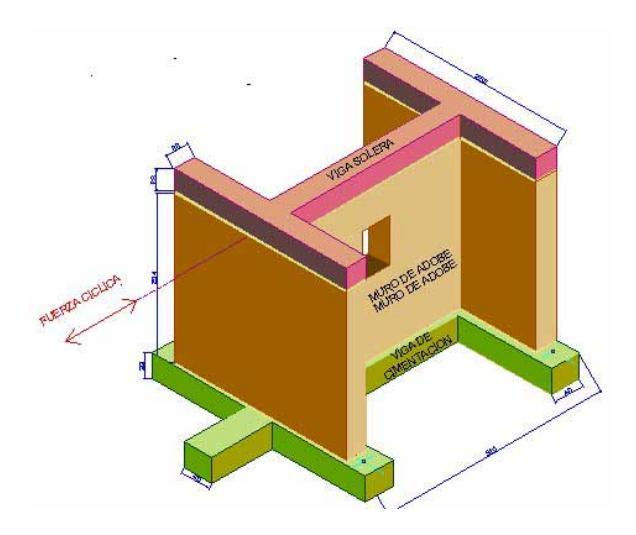
Figure 11. Geometric configuration of walls

A preliminary research project is currently being developed (March 2004) with the objective of studying the technical and economical feasibility of using locally available industrial products such as wire, plastics and geosynthetics in the seismic reinforcement of adobe houses. Six "I" shaped full-scale adobe walls (Fig. 11), with and without reinforcement, are being constructed at the Structures Laboratory and will be tested under horizontal cyclic loading. The geometric configuration, including a small central window, and the overall dimensions are similar for all the walls. Three baseline walls include one traditional unreinforced, one with interior cane reinforcement and one with welded mesh placed externally simulating beams and columns. The reinforcement proposals include:

- 1. Adding ¹/₂" diameter PVC water pipes as inner vertical reinforcement, combined with a low-cost ¹/₂" plastic mesh embedded horizontally in the mortar every fourth layer. Both reinforcement elements are tied together with plastic string. The PVC pipes are anchored in the foundation beam and in the upper tie beam, both made of concrete.
- 2. Placing vertical ¹/₂" diameter corrugated steel bars inside the walls at the corners, with no horizontal reinforcement.
- 3. Fixing a geosynthetic mesh externally to the walls, simulating columns and beams. The covering is made of mud mixed with straw.

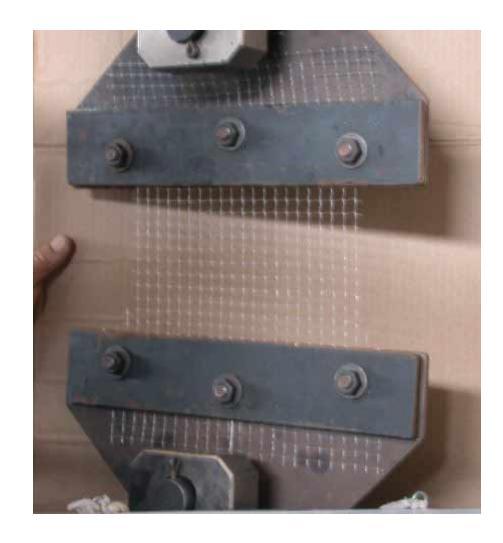
Figure 12. Plastic mesh

To select the products to be used as reinforcement materials for the walls, several locally available plastic and geosynthetic meshes have been tested for their bond with the mud mortar as well as for their tensile behavior (Fig. 12). Adequate bond will guarantee integration of adobe masonry. Unit elongation of the mesh has to be small because it is expected to keep together the adobe units after cracking occurs.
