# MODAL PARAMETER TRANSITION OF A LOW-RISE RC BUILDING DURING RETROFITTING WORKS

Transition of dynamic characteristics, such as natural frequency, damping ratio, and mode vectors, was investigated by using a long-term ambient vibration test on a low-rise existing building. The measured building is a 4-story reinforced concrete (RC) building, which has been seismically retrofitted by adding concrete walls, foundations and piles. The ambient vibration had been continuously measured for nine months, from "before retrofitting" to "after retrofitting" in order to evaluate effect of the seismic retrofitting work, as well as to study on the ambient vibration test based structural health monitoring. The modal parameters are estimated by a cross-spectrum based modal identification scheme, therefore, which can be evaluated as included soil-structure dynamic interaction. By evaluating the ambient vibration records we found that the effect of seismic retrofitting on the modal parameter of the low-rise building can be clearly detected from the mode vectors, even though the natural frequency does not give a clear indication. For instance, with progresses of the retrofitting works, the natural f

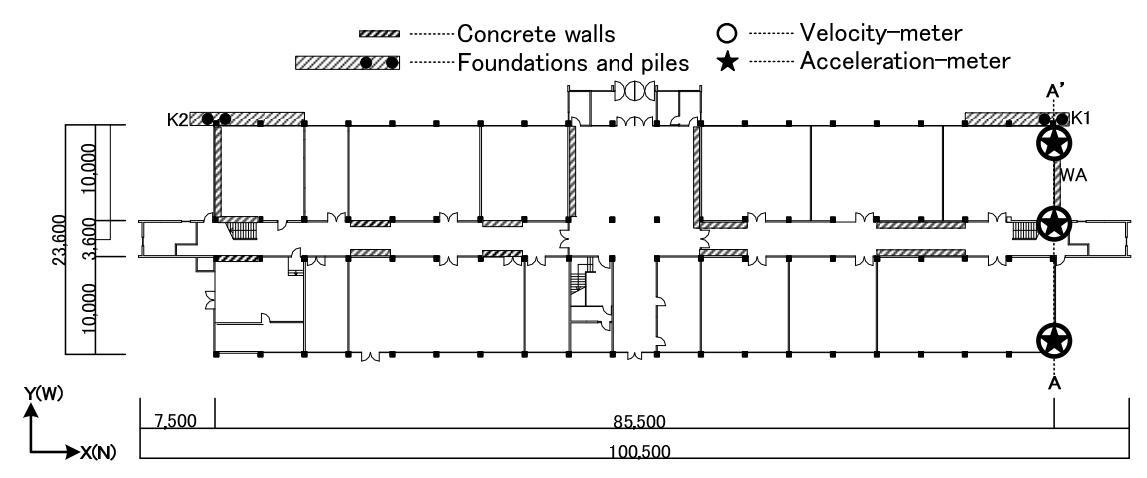
Fig. 1 Plan on the first floor of the retrofitted building

Ambient vibration tests were conducted by two methods of the high-dense observation test (HD-test) and long-term continuous observation test (LT-test). Measurement installations are shown in Figs. 1 and 2. The HD-tests were conducted before (30 minutes, July 28, 2006) and after the seismic retrofit (20 minutes, December 22). In the HD-tests, 8 sets of three-component accelerometers were installed on every floor and its sampling frequency is 200 Hz. On the other hand, the LT-test was conducted from July 1, 2006 to April 9, 2007. Velocity responses were measured and its sampling frequency is 200 Hz. The measure points of the LT-tests are set to the landing between the fourth floor and the roofs, the bottom of the first floor stairs and the east- and west-outside columns.

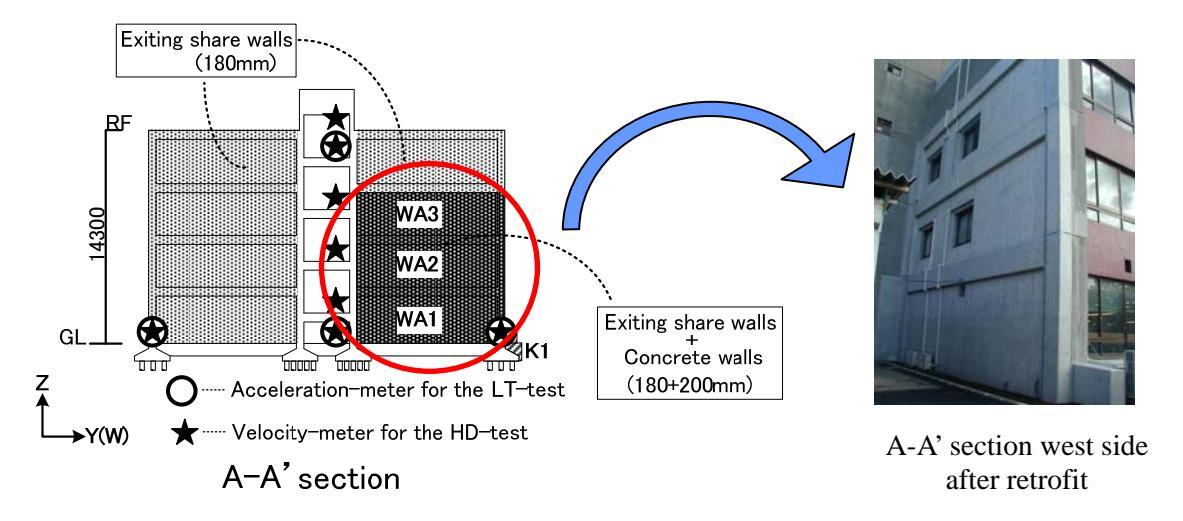
Fig. 2 A-A' section of the building after retrofit and measurement installations for ambient vibration test

A building treated in this study is a low-rise school building in Noda Campus of Tokyo University of science, Japan. It is a 4-story reinforced concrete building on pile foundations. In order to improve the seismic performance of the building, it has been seismically retrofitted by adding concrete walls from first to third floor, foundations, and piles. These reinforcement points are shown in the floor plan of Fig. 1. The retrofitting works were carried out step by step from first to third floor, whose construction period was from August to December, 2006. In this study, transition of dynamic characteristics of the building is investigated on the point aimed at the A-A' section of the north side. This section has exiting share walls (thickness 180mm), and has been newly installed concrete walls (thickness 200mm) from the first to the third floor at one span of the west side, foundations and piles. This section of the building after retrofit is shown in Fig. 2.

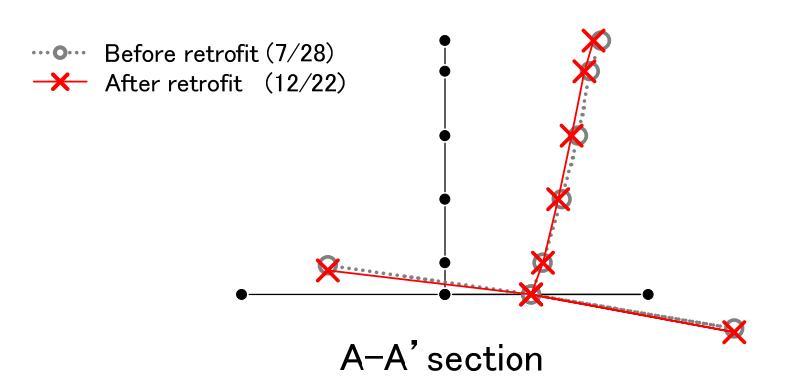
Fig. 3 Estimated mode shape in A-A' section

The translational mode shapes before and after the retrofitting works are well-estimated from the record of the HD-tests. In the Fig. 3, the comparison of the mode shapes are shown. The figure is obtained by using the ARMA model based on modal identification procedure from ambient vibration records on the HD-tests. The translational mode does not change largely before and after retrofit, and in the both states the sway and rocking motions are larger than the super-structure deformation. The fact shows that the soil and foundation are softer in comparison with the super-structure. From the figures of two mode shapes before and after the reinforcement, it is difficult to distinguish the effect on the retrofitting works. In such a way, we can hardly detect the clear change before and after the retrofitting works in the case of a low-rise building with soft foundation. In such a case, we can clearly detect the slight change of the mode shape, by using the long-term monitoring as show in the next section.

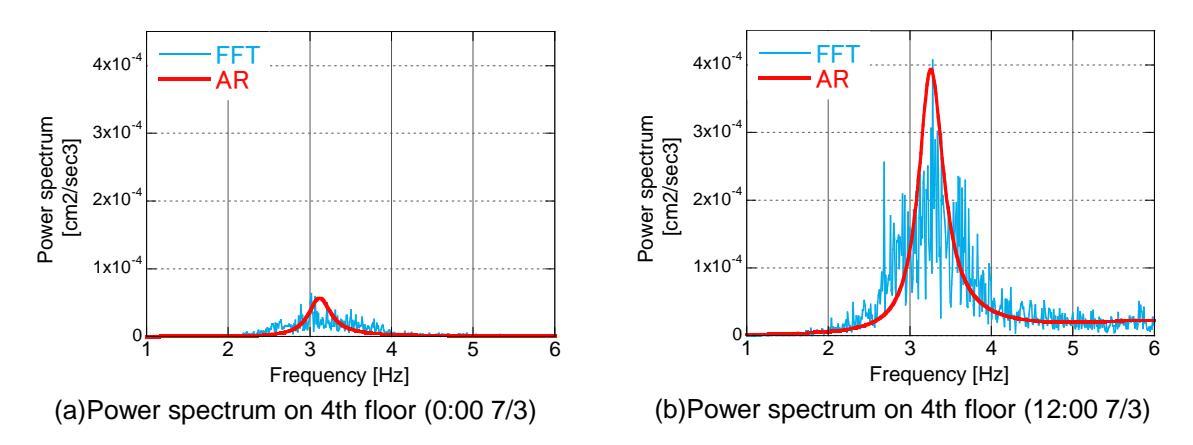
Fig 4 Power spectrum of response on 4th floor

In fig. 4, power spectrum density functions (PSDF) are estimated by the fast Fourier transform (FFT) and the ARMA-burg model of responses on the 4th floor in east-west direction at 0 o'clock and 12 o'clock July 3, 2006. As shown in the figures, the PSDFs for responses both the FFT and the ARMA-burg have peaks at around 3 Hz. In addition, as compared with the night and the day, absolute values are different greatly, which are caused by different amplitude levels of the acceleration response.

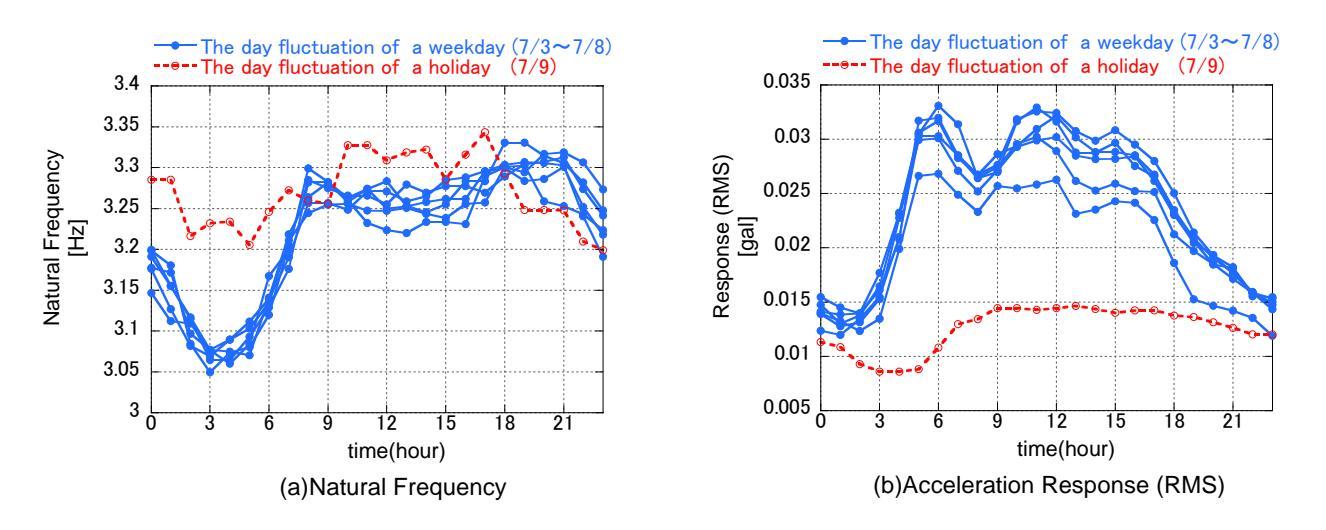
Fig 5 Day fluctuation of natural frequency and acceleration response

Fig. 5 shows natural frequency transitions of the fundamental mode on the east-west (EW) directions and the root-means-square of the acceleration response on the 4th floor for a week from July 3 to 9. In the figures, the natural frequencies in a weekday become higher in the daytime and lower in the night, and such day fluctuations are confirmed clearly. On the other hand, the natural frequencies in a holiday seem to fluctuate in almost constant, and the change width is small. A big difference between a weekday and a holiday was found in the middle of night at 0 to 7 o'clock. These changes of the natural frequencies are not correlated with the changes of the amplitude of the acceleration response. Based on the above considerations, a long-term transition of modal parameter will be discussed with three different categories in the middle of the night of a holiday, in weekday the middle of the night, and in the daytime.

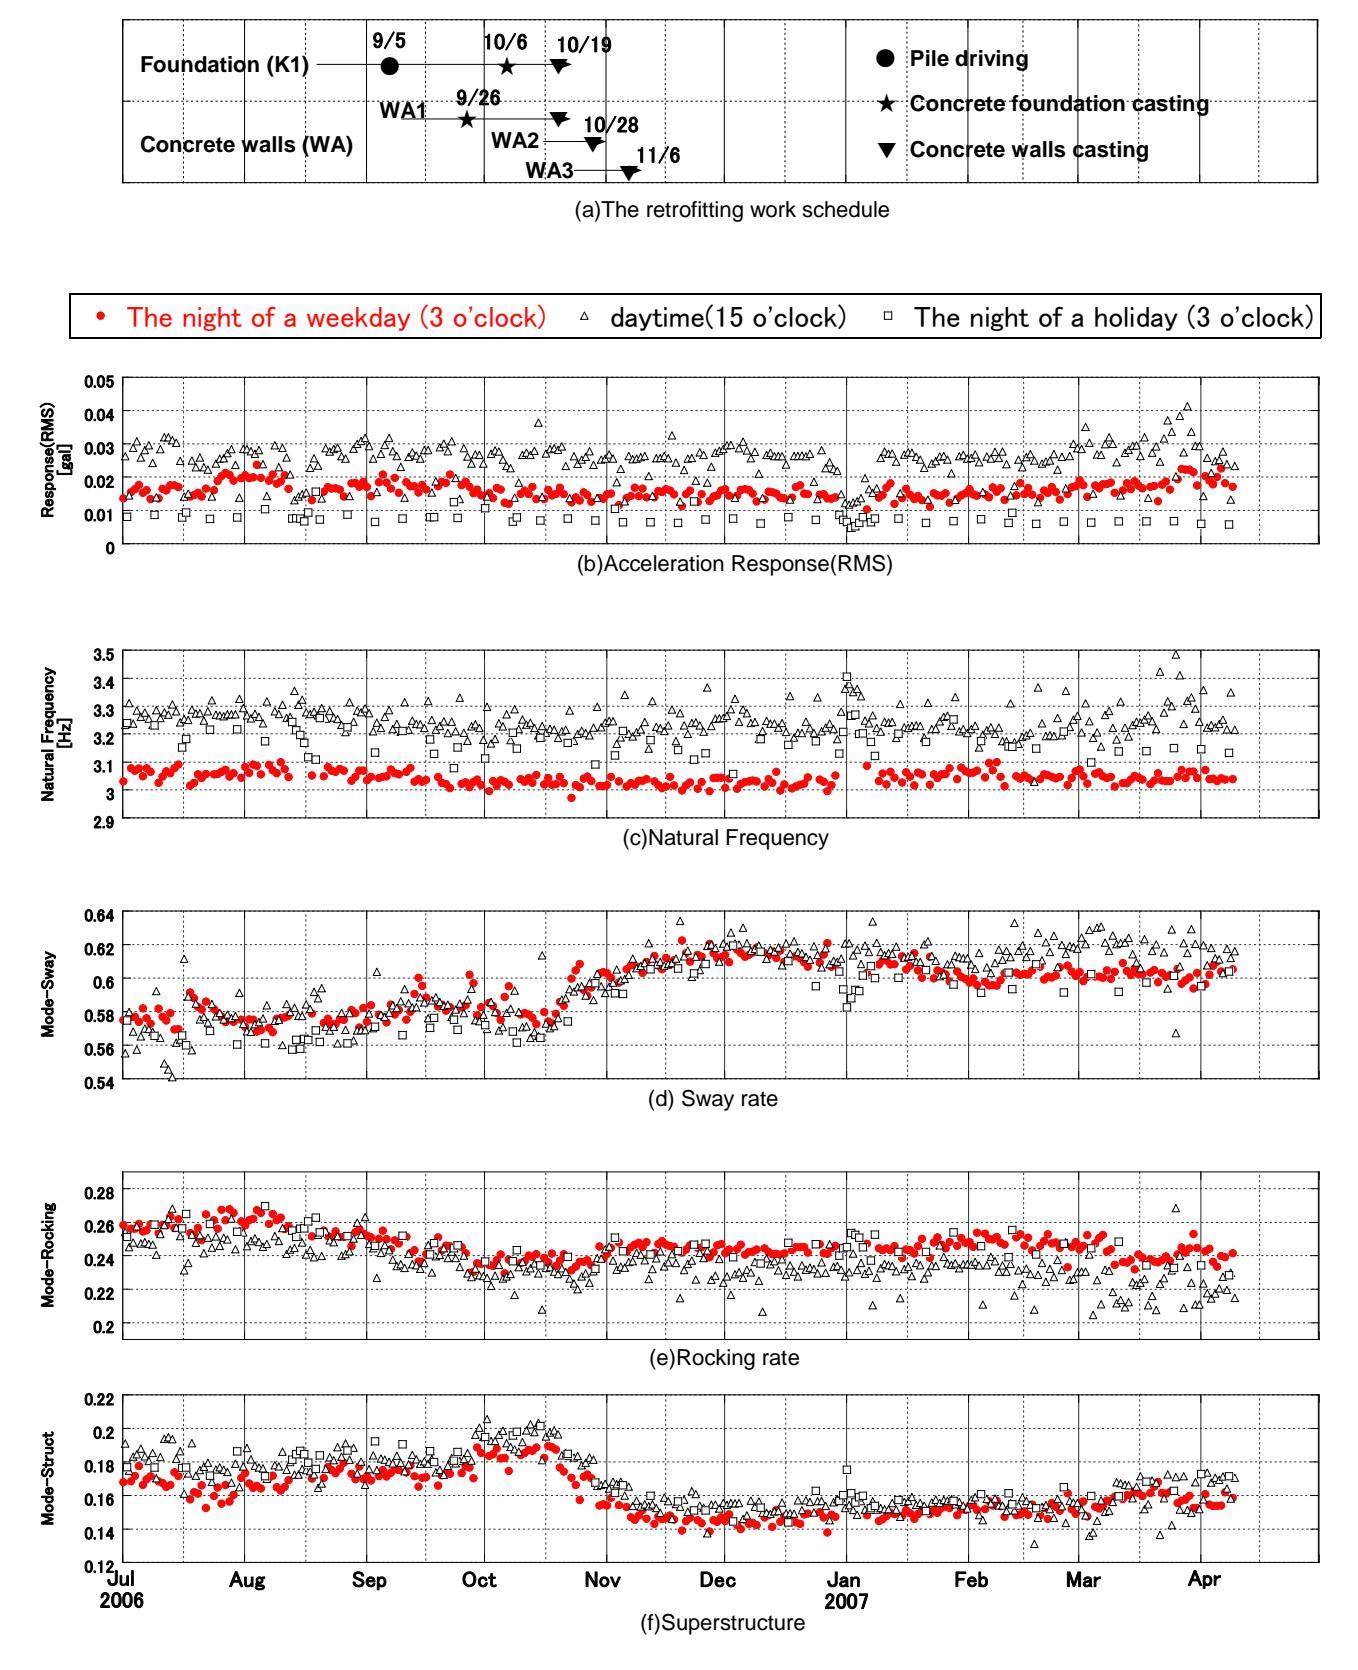
Fig. 6 shows a retrofitting work schedule (a), root-means square of the acceleration response (b), natural frequency transitions (c), and the mode rotation calculated by the mode vectors (d,e,f) on the EW directions from July 1, 2006 to April 9, 2007. And, to analyze a difference of a vibration characteristic by the above mentioned three categories, three kinds of marks are plotted. Thus, in the fig. 6, the weekday middle of the night at 3 o'clock and the daytime at 15 o'clock and the middle of the night at 3 o'clock of a holiday are plotted by  $\bullet$ ,  $\triangle$ , and  $\Box$ , respectively.

Fig 6 A retrofitting work schedule, acceleration response (RMS) at the roof floor, natural frequency, sway rate, rocking rate, and superstructure rate on the EW directions.

As shown in the fig. 6 (c), the natural frequencies are different with the three marks of the evaluation hours, but each natural frequency in the same category is almost constant. And, focusing on the weekday middle of the night ( $\bullet$ ), it is found that a long-term transition is easy to read. In detail, natural frequency decreases slowly from September to October, and a tendency to increase a little in around December. However, there is not clear of these changes with the reinforcement work. In addition, to the end of the year and in the beginning of the year (from December 31 to January 3), natural frequency suddenly increases, however, the reason of the rapid increase cannot be clarified here. In such a way, it is easy to investigate the effect of a long-term transition with screening natural frequency categorized by evaluation hours. However we cannot clearly confirm correlations between the change of the natural frequency and the retrofitting works.

To investigate the change of the mode vectors, the transitions of the mode vectors are show in Fig. 6 (d) to (f). In the figure, the mode vectors are shown as three deformation rate; sway rate  $\phi_s$ , rocking rate  $\phi_k$  and superstructure rate  $\phi_k$ . The three deformation rate of modal vectors are defined as follows :

As show in Fig.6 (d),(e),(f), the changes of modal vectors can be clearly detected with the progress of the retrofitting works. We pay focus on the result of weekday middle of the night ( $\bullet$ ), and evaluate the long-term changes. The sway rate increased with casting the exterior wall reinforcement after the middle of October. Then the superstructure rate decreased, and the rocking rate remained in constant. In the details, the sway rate increased from 0.57 to 0.62 in October 18 to December 4, and the increasing ratio reached to about 5 percent. During the same period, the superstructure rate decreased from 0.19 to 0.14 and the decreasing ratio equaled to about 5 percent. These changes of the modal vectors were caused by adding the story stiffness owing to the concrete walls casting on the first to the third floors. Another change of the modal vectors can be detected in September, 2006. In this month, the rocking rate gradually decreased from 0.26 to 0.24. This decreasing might be caused by the foundation reinforcement.
