# FAILURE OF SHOWA BRIDGE DURING THE 1964 NIIGATA EARTHQUAKE: LATERAL SPREADING OR BUCKLING INSTABILITY?

A. A. Kerciku<sup>1</sup>, S. Bhattacharya<sup>2</sup>, Z. A. Lubkowski<sup>3</sup>, and H. J. Burd<sup>4</sup>

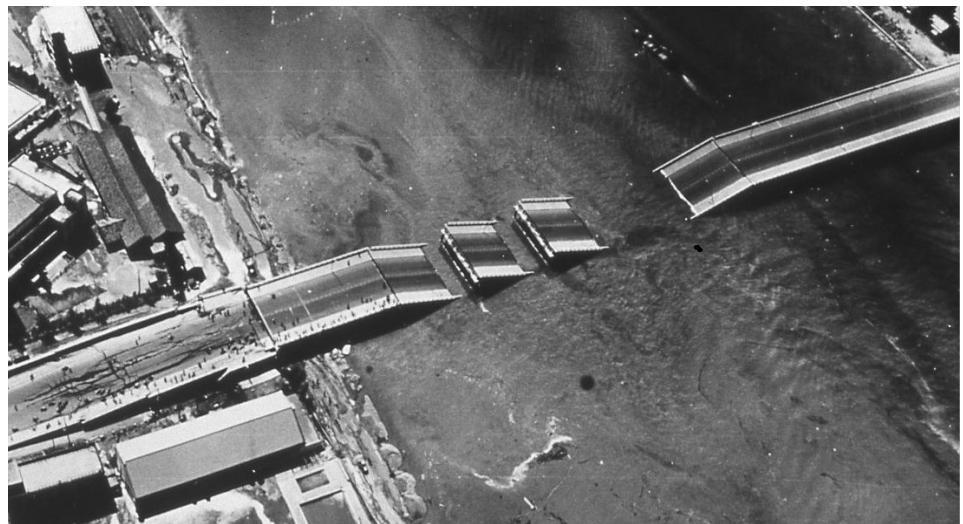
Figure 1: Aerial photograph of the Showa Bridge after the 1964 Niigata Earthquake, from Towhata (1999).

The Niigata earthquake occurred on the 14<sup>th</sup> of June 1964 and registered 7.5 on the Richter scale. Located some 55km from the epicentre, the Showa Bridge which crosses the Shinano River was one of the worst instances of damage (Figure 1). The 1964 collapse of the Showa Bridge has been, throughout the years, an iconic case study for demonstrating the devastating effects of the lateral spreading of liquefied soil (Fukuoka, 1966; Hamada and O'Rourke, 1992, and Yasuda and Berrill, 2000, Kramer, 1996). In this paper the events and circumstances that led to the collapse of the bridge have been reanalysed. The authors have critically re-evaluated the effects of lateral spreading on the bridge pier-piles. Using tools derived by Kerciku et al. (2008), the depth fixity of the piles in liquefied soils has been derived, and its structural performance calculated. Finally, we have shown that these calculations provide an alternative explanation for the failure of the Showa Bridge.

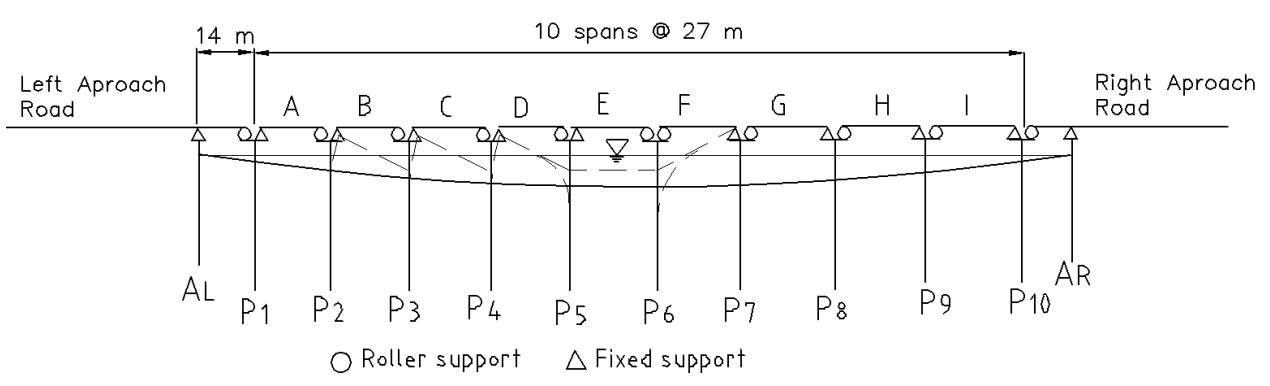
The bridge girders rested on movable and fixed joints to allow for thermal expansion of bridge, as shown in Figure 2. The construction of the bridge was completed just one month before the earthquake. Figure 2 shows the structure of the Showa bridge – the dashed lines describing position of the girders and piles after the collapse. Judging from how the expansion joints were bent and the eyewitness reports, Horii (1968) suggests that girder E was the first to fall in the water. Pier-piles  $P_5$  and  $P_6$  collapsed, consequently, bending above the riverbed by about 90° in opposite directions, as shown in Figure 2. Judging from eyewitness's testimonies in Horii (1966), we can conclude that immediately after the collapse of girder E, in a "domino effect", girders F, D, C, and B slipped off their movable joints on pier-piles  $P_6$ ,  $P_5$ ,  $P_4$  and  $P_3$  respectively, and partially collapsed into the river. Hamada and O'Rourke (1992) concluded that the soil liquefied to a maximum depth of 10 m below the Showa Bridge riverbed, as shown in Figure 3.

Figure 2: Showa Bridge detail, showing movable and fixed joints. Adapted from Ishihara (1984)

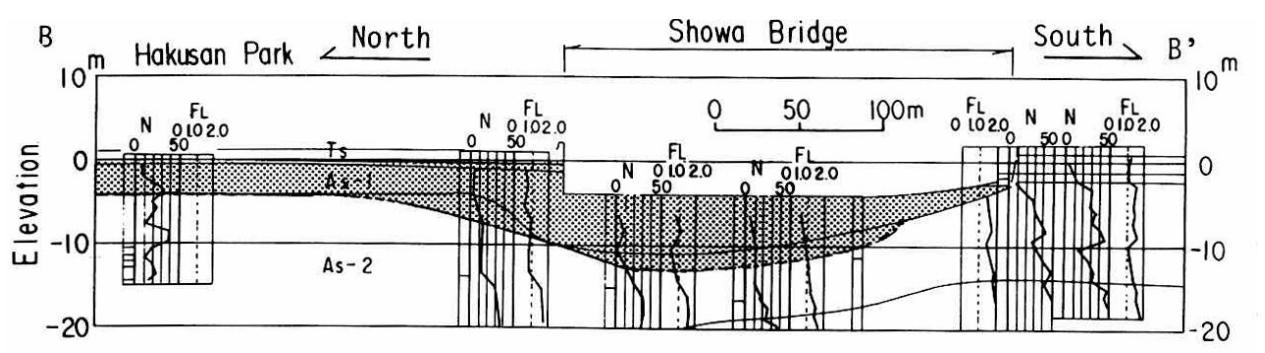
Figure 3: Showa Bridge detail: Soil Liquefaction profile (in grey). From Hamada and O'Rourke (1992). The soil behind the left abutment is subjected to lateral spreading and creates a hinge near the abutment.

The depth of liquefaction, h, estimated from Figure 3, for pile P<sub>5</sub>, is approximately 9 *m*. From Kerciku et al. (2008) we can then derive the depth of fixity of the pile:

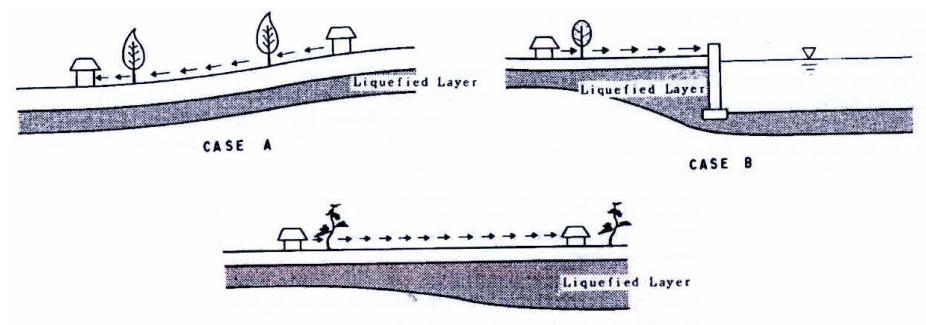
CASE C

Figure 4: Ground types for lateral spreading after Hamada et al (1986). Type A: slightly inclined "gently sloping", Type B: discontinuity "free face", Type C: inclined boundary.

Whilst it is clear that lateral spreading occurred on the left riverbank, there is no evidence that the riverbed soil (directly underneath the bridge) was significantly affected by lateral spreading, as hypothesised by Hamada and O'Rourke (1992) and Fukuoka (1966). Hamada's conclusion regarding lateral spreading of the riverbed is based on the categorisation of lateral spreading ground-types (topographical circumstances leading to lateral spreading), defined in his 1986 work (Hamada et al., 1986; as shown in Figure 4). Following these ground categorisation, the riverbed overlain by the Showa Bridge would correspond to a type "C" ground surface, whilst the soil mass behind the left abutment would be a type "B" ground (free-face) as shown in Figure 5.

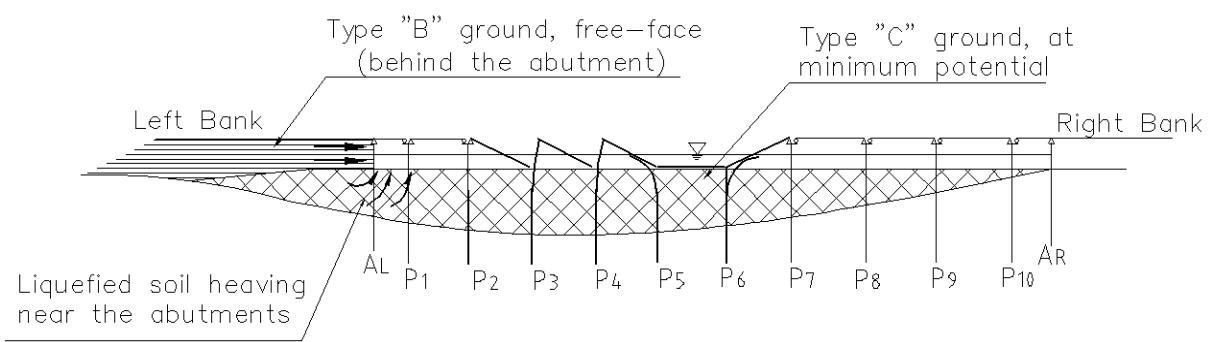
Figure 5: Showa Bridge Liquefaction profile divided into ground types defined by Hamada et al. (1986) cases (B) and (C). The soil profile has been adapted from Hamada (1992)

than the shear strength of the soil in its liquefied state, the liquefied soil mass will attempt to flow towards a lower potential energy form/location. Therefore, liquefied soil on a slope will flow to the bottom of the slope; and liquefied soil behind a discontinuity (such as a retaining wall) will tend to flow across the discontinuity. As shown in Figure 5 the liquefied soil of the riverbed (directly underneath the Showa Bridge piers) could not have flown laterally because is already in its lowest potential energy from. It is likely that some of the riverbank soil heaved near the left abutment due to pressure from the soil above the abutment, as shown in Figure 5, but it is reasonable to believe that the riverbed soil did not move significantly.

This paper shows that the riverbed soil directly underneath the Showa bridge could have not spread laterally. The riverbed soil was at its lowest potential energy and it remained static. The riverbank soil did laterally spread, but it probably heaved near the abutment (See Figure 5). The movement of the riverbank soil could not have caused any significant loads on the central pile rows, due to the negligible thickness of the spreading soil.

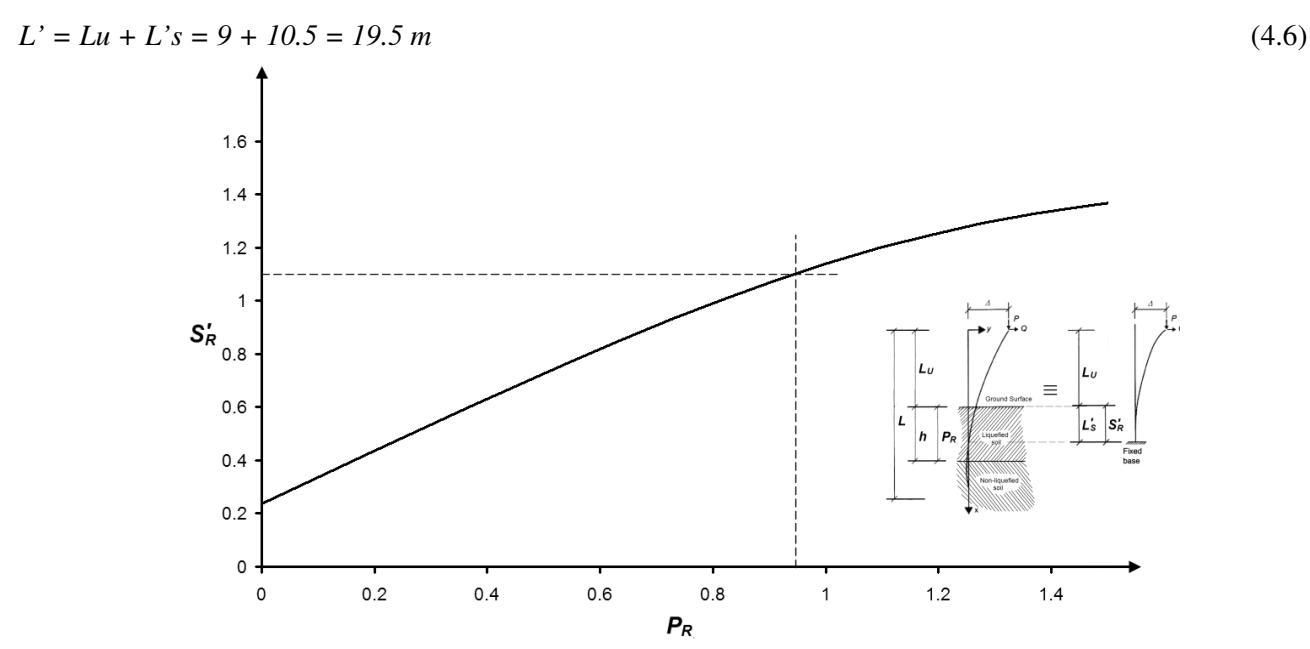
Figure 6: Extracted from Kerciku et al. (2008) for  $0 < S_R < 1.6$  and  $0 < P_R < 1.4$ , from curve  $\delta = 0.5$

The value of  $S'_R$  can be derived from Figure 6. From Figure 6,  $S'_R = 1.1$ . Therefore, the depth of fixity  $L'_s$  is:

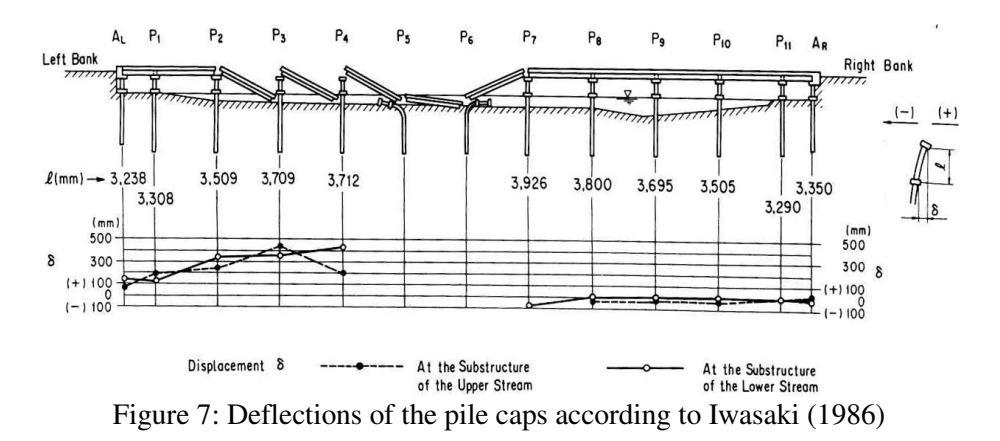
The earthquake caused a permanent lateral deformation of the piles,  $\Delta$ . These permanent deformations were documented by Iwasaki (1986), as shown in Figure 7. The quasi-static lateral load, *F*, responsible for this displacement, may be derived by solving the moment-curvature differential equations, as suggested by Kerciku et al. (2007) (for no lateral restraint, *k*=0), and may be derived from Eqn. 4.7.

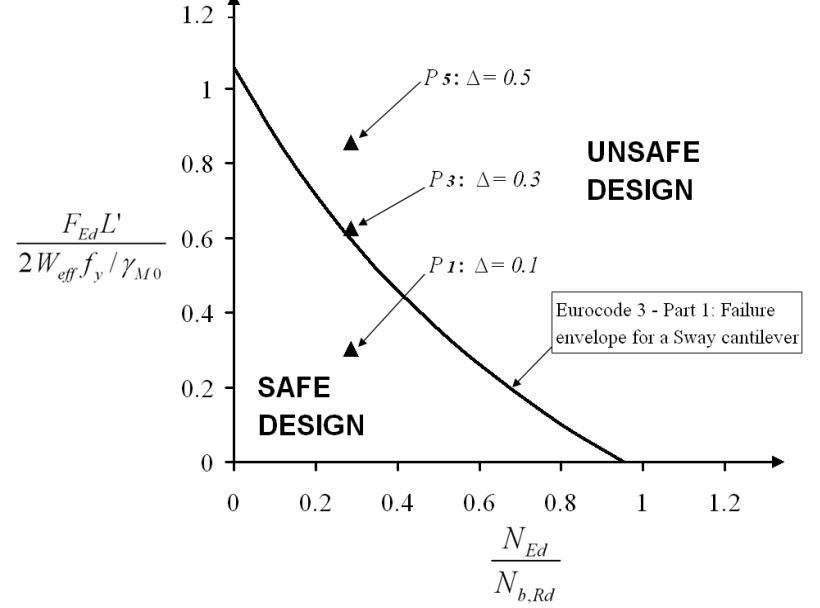
Value	Numerical Values			Reference
	P <sub>1</sub>	P <sub>3</sub>	P <sub>5</sub>	
				Iwasaki
$\Delta$ (m)	0.1	0.3	0.5	(1986)
				Bhattacharya
N <sub>Ed</sub> (kN)	750	750	750	et al. (2005)
				Hamada and
				O'Rourke
EI (MNm <sup>2</sup> )	160	160	160	(1992)
				Kerciku et al
L' (m)	20	20	19.5	(2008)
F <sub>Ed</sub> (kN)	19	39	55	Equation1
W <sub>eff</sub> f <sub>y</sub>				Bhattacharya
(kNm)	629	629	629	et al. (2005)
$N_{b,Rd}$ (kN)	2623	2623	2623	Eurocode 3
F <sub>Ed</sub> L/				
$2W_{eff}f_{y/\gamma_{MO}}$	0.30	0.62	0.80	
NEd/ Nb,Rd	0.28	0.28	0.28

Figure 8: Design performance for pile  $P_1$ ,  $P_3$  and  $P_5$  of the Showa Bridge after the earthquake, assuming a liquefied effective length of 19.5m. Chart adapted form Eurocode 3 – Part 1 (1995) section 6.2.9.9.

The section geometry and material properties used in this calculation are given in Bhattacharya et al. (2005). The axial and bending utilisation of piles  $P_1 P_3$ , and  $P_5$  have been calculated and data-points are plotted in Figure 8. It can be observed that pile  $P_1$  is a safe design, whilst pile  $P_3$  and  $P_5$  are outside the failure envelope and therefore prone to failure. Since this is an elastic analysis and the plastic moment capacity generally is 20% higher than the elastic one, pile  $P_3$  can also be considered as a safe design.

The failure of the piles was caused by to the combined effect of the axial loads, and second order P- $\Delta$  moments (caused by earthquake-residual-lateral displacements) on the piles. As shown in Figure 8, pile P<sub>5</sub> had been displaced by a magnitude large enough to produce second order P- $\Delta$  moments responsible for 80% of the stress utilisation. This, combined with the reduced axial capacity of the pile due to the increased slenderness, produced stresses in the pile which surpassed the steel's elastic (and plastic) stress limit. The same analysis also shows how piles P<sub>1</sub> and P<sub>3</sub> did not fail, because the residual lateral imperfections were much lower and the second order P- $\Delta$  effects were non-catastrophic.
