AN EXPERIMENTAL STUDY ON ROCKING RESPONSE OF BRIDGE SPREAD FOUNDATIONS

H.H. Hung¹, K.C. Chang², K.Y. Liu¹ and T.H. Ho³

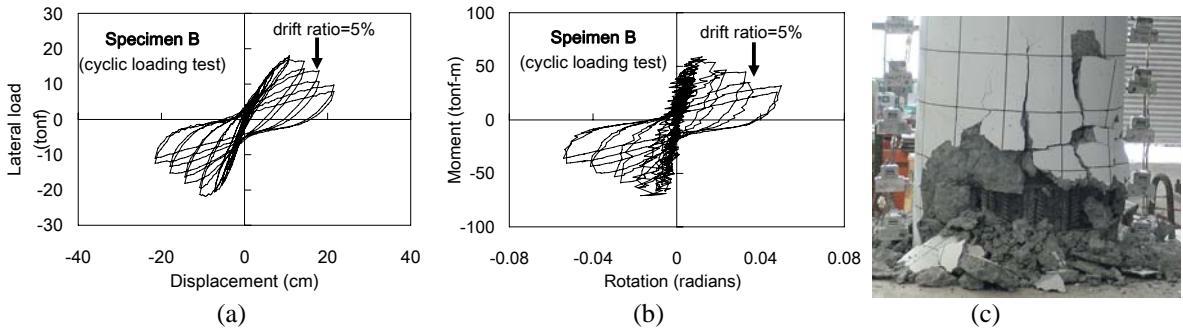
Following pseudo-dynamic test, a cyclic loading test was performed on the same specimen. The experimental results were shown in Fig. 6. As can be observed, it shows similar pattern of response behavior to specimen A and also exhibited sudden and significant loss of lateral resistance with low ductility under reversed cyclic deformation. However, if we further compare figure 4 and 6 at the same drift ratio 5%, we can find that rocking mechanism resulted in an increase of lateral load resistance in fig. 6(a) and a decrease of plastic deformation at plastic hinge zone in fig. 6(b).

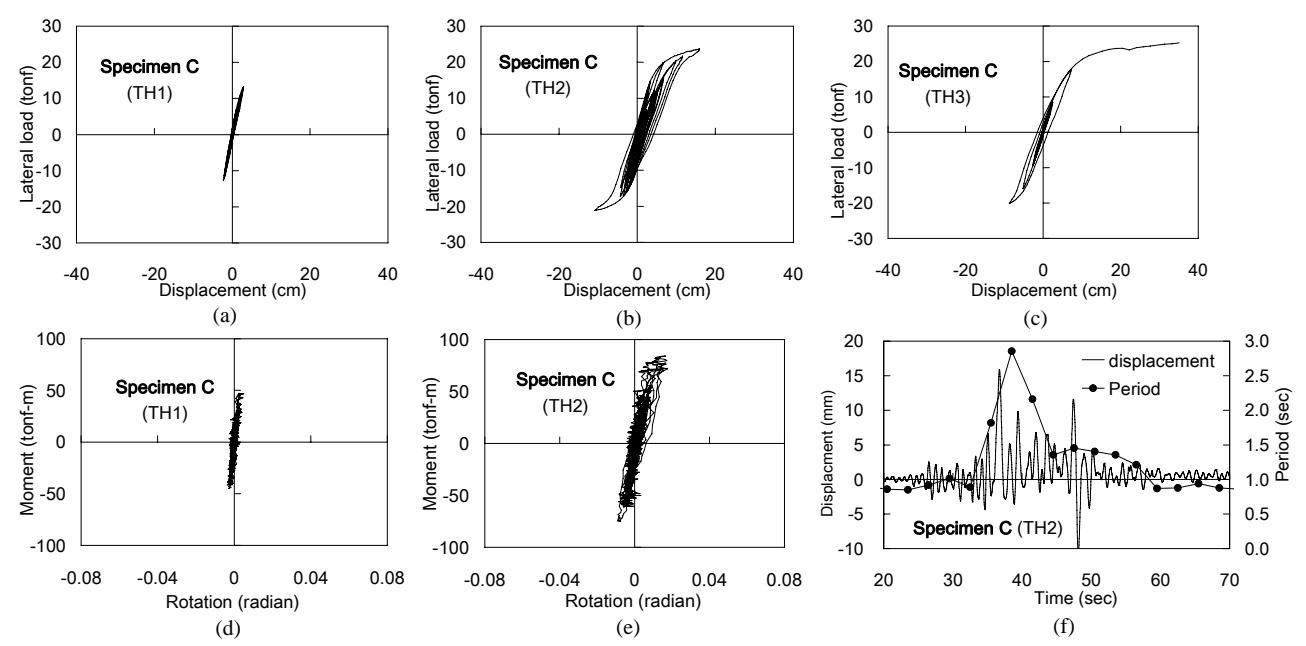
Test specimen C was a retrofitted column and rested on the neoprene pad without uplift restraint. As has listed in Table 2.1, specimen C was subjected to three pseudo-dynamic tests sequentially at first. The experimental results for these tests are shown in Fig. 7, where Figs.(a)-(c) represent hysteretic curves of lateral force vs. lateral displacement at the top of the column for each test, and Figs.(d) and (e) show moment vs. rotation at the column base for TH1 and TH2, respectively. Again, the moment-rotation curves in Figs.(d) and (e) can demonstrate the flexural behavior of column at plastic hinge zone. As can be observed in figure 7, for the case of medium earthquake (TH1), both force-displacement and moment-rotation hysteretic curves are almost linear, which indicates that the rocking behavior was not obvious and the plastic hinge was not formed during medium earthquake. On the other hand, the results for design earthquake (TH2) show an obvious nonlinear behavior on lateral force-displacement curve. It also demonstrates a satisfactory behavior that the residual displacement and the plastic deformation of the column were minor, and the seismic force was limited to 22tonf because the rocking can act as a form of seismic isolation. Figure 7(f) shows the time history of lateral displacement and its variation in structural period of the same test. As can be observed, rocking resulted in lengthening of the structural period of the pier system. For the last pseudo-dynamic test using TH3, a near field ground motion, the test was ended manually at T = 35 sec when lateral displacement reached a high value of 37 cm under consideration of safety, although no apparent damage was observed at that time. Another phenomenon can be found in these tests was that although time history TH2 and TH3 have the same PGA, the response behaviors of column C subjected to these two accelerations were totally different. The displacement induced by TH3 was obviously larger than that by TH2, the same result was also observed by authors in another study using analytical approach, which was not shown here. This result implies that the rocking behavior of piers under near fault ground motion may suffer a large lateral displacement at the deck level and further investigation on this issue is still needed.

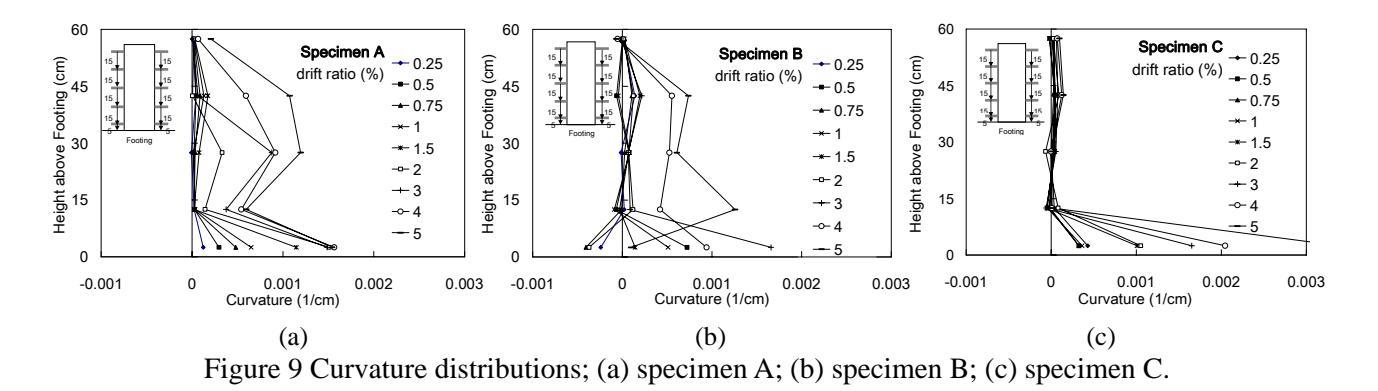
Five tiltmeters mounted on the neutral axis of test columns at potential plastic hinge zone allow the average curvature in this area to be estimated. Average curvature was obtained as the difference between the readings of two adjacent tiltmeters divided by the distance between them. Fig. 9 shows vertical distribution of curvature in the plastic hinge region for each test column under the reverse cyclic displacements. In which, only the results for push direction were plotted for brevity. As can be seen, for the columns that were not retrofitted (specimen A and B), the curvatures are both well distributed over the plastic hinge zone. But if we compare Figs. (a) and (b) more carefully, we can find that the curvature for the rocking base case (specimen B) was smaller than that of the fixed base case (specimen A), especially at the drift ratios smaller than 3%. This phenomenon can be further explained by Fig. 10(a), where uplift displacements at foundation of specimen B under the subjection of cyclic displacement loading were depicted. As can be seen, the maximum uplift occurred at drift ratio 3%. After that, the uplift displacement decreased with the increase of drift ratio. For instance, at drift ratio 6%, the uplift was only around 0.2 mm. Thus, at that moment, the response behavior of test specimen B was similar to that of the fixed base case of specimen A. Next, by comparing the curvature distribution of specimen C (fig. 9c) and specimen B, we find that the wrapping of the steel jacket made the plastic rotation for specimen C concentrate in a very short region close to the base of columns. Besides, the curvature in other location of specimen C was much smaller than that of the non-retrofitted one (specimen B). The uplift displacement for specimen C was also given in Fig.10 (b). By comparing figure 10(a) and (b), we find that the uplift displacements for the retrofitted case were much higher than that for the non-retrofitted case. The maximum uplift of which was around 2 cm. In addition, the uplift displacement stably grew with the increase of drift ratio until drift ratio reached 5%.
