DEFINITION OF CRITERIA FOR THE APPRAISAL OF THE CONSTRUCTION IN SEISMIC AREAS OF ARGENTINA

This paper presents the analysis in its most relevant aspects of two modern buildings of San Juan city. It considers their architectural and structural design as well as their conditions regarding their surroundings.

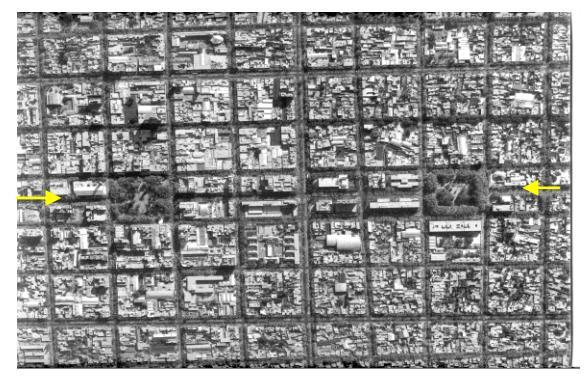
Figure 1 The Central Avenue

When the city of San Juan was reconstructed, the Central Avenue was designed and constructed, in east-west direction –Fig.1– its institutional character emphasized the own character of the buildings that settled down there. Indeed, many of the significant public buildings were established on the new avenue that constituted the institutional public-spirited core of the city.

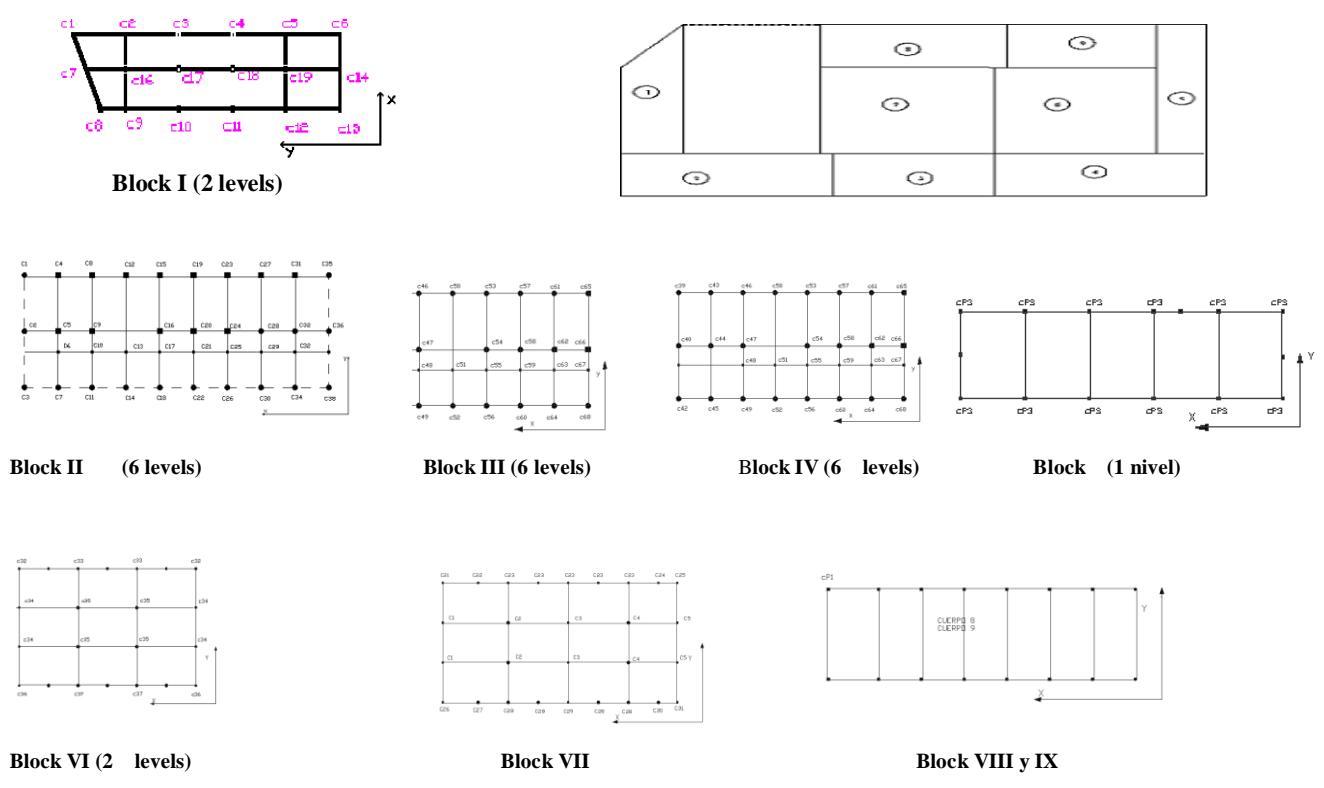
Figure20 9 Independent bodies

This building presents 9 independent bodies -Figure 20-, each one with different numbers of stories. The

building were analyzed by levels and for both perpendicular directions displayed in the schemes. The structural elements were considered extended in all the levels. We counted with detailed structural documentation, thereby was being able to compute the seismic capacity of the building, and it was superior to waited seismic demand, as in the case of the building of the Nation Bank.

The study of the structural typology of each block was settled like reinforced concrete frames in both directions.

For the study, it was considered valid the hypothesis, of beams and slabs rigid. The properties of the materials used in the construction were obtained from the documentation. We had to compute the ultimate strength and the ductility of columns and resistant vertical elements to compute the seismic performance of the building. The strength of vertical elements was calculated by applying equations that considered, design and structural typology. It was established the failure mechanism for the adopted hypothesis. It was contemplated the irregularities in plant and height. It was considered the deterioration in the time of the structure. Finally, an evaluation of the capacity of each body was realised.

As in the previous case, the analysis of all blocks showed a demand-capacity ratio bigger than one. Thereby and being this building, shook by M: 7.4 Caucete, San Juan, Argentina Earthquake November 23, 1977, without meaningful damage, we contrasted the results of its seismic performance.
