# Methods for characterising effects of liquefaction in terms of damage severity

S. van Ballegooy, P.J. Malan, M.E. Jacka, V.I.M.F. Lacrosse, J.R. Leeves & J.E. Lyth Tonkin & Taylor Limited

Keywords: Liquefaction vulnerability, Liquefaction Severity Number, Liquefaction Potential Index.

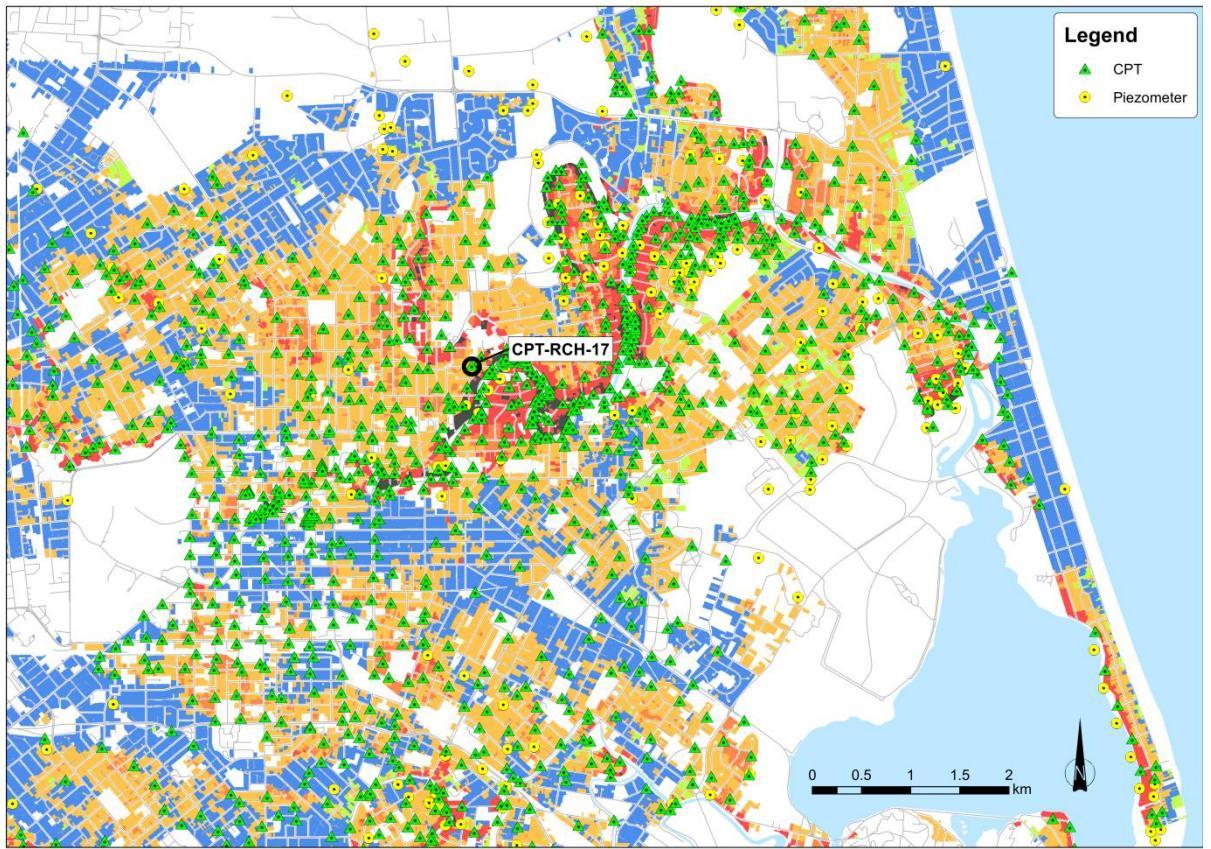
Figure 2. Investigation locations in eastern Christchurch and the worst observed residential land damage after 13 June 2011

The land damage mapping was supplemented by an extensive geotechnical site investigation programme comprising boreholes, cone penetration testing, geophysical testing and the construction and monitoring of piezometers<sup>2</sup>. The CPT soundings have been used as the primary tool to predict where liquefaction occurred in the soil profile and to derive parameters representing liquefaction vulnerability. The CPT locations in eastern Christchurch are shown in Figure 2, overlain on the worst land damage observed following the third of the destructive earthquakes in the sequence (13 June 2011). The colour categories are defined in Figure 1). Figure 2 also shows the location of piezometers used in the development of a regional upper unconfined groundwater model. The ground water model was used to determine the hydrostatic groundwater pressures which were used in the liquefaction triggering analyses from each CPT to calculate various vulnerability parameters. The parameters calculated from each CPT are discussed in Section 4 below.

The foundation damage to dwellings has been compiled into a database and the worst overall severity from the seven assessed damage categories (defined in Figure 1) was plotted on a map (refer to Figure 3 below). Comparison of Figures 2 and 3 show visually that areas with a high density of major foundation damage coincide with areas of more severe observed land damage. By contrast, areas with

A single CPT from Richmond, Christchurch (location shown in Figure 2) has been presented for illustrative purposes in this paper (Figure 4). This is a representative CPT that has been assessed using the seismic demand from the 4 September 2010, 22 February and 13 June 2011 earthquake events and uses the corresponding groundwater depth immediately prior to each event, based on the regional groundwater model. The results show the relationship between CSR and CRR with depth, the calculated FoS with depth and the calculated volumetric strains with depth. Figure 5 then shows the contribution of each layer to the selected calculated vulnerability parameters described in Section 4. Figure 5 also shows the difference in contribution from shallower layers for LSN compared to LPI.

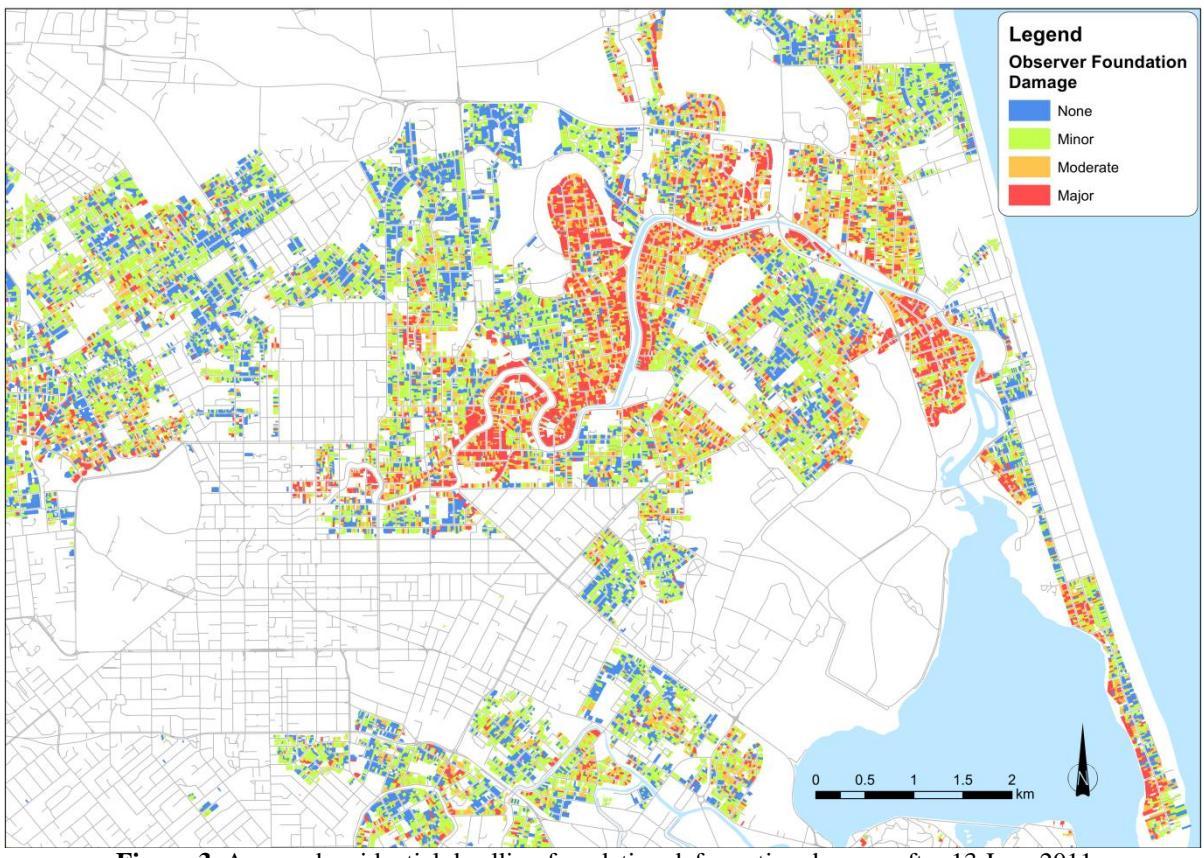
Figure 3. Assessed residential dwelling foundation deformation damage after 13 June 2011

a low density of foundation damage coincide with areas with none or minor observed land damage. This shows, not surprisingly, that land damage resulting from the triggering of liquefaction and foundation deformation damage of residential dwellings are strongly correlated.

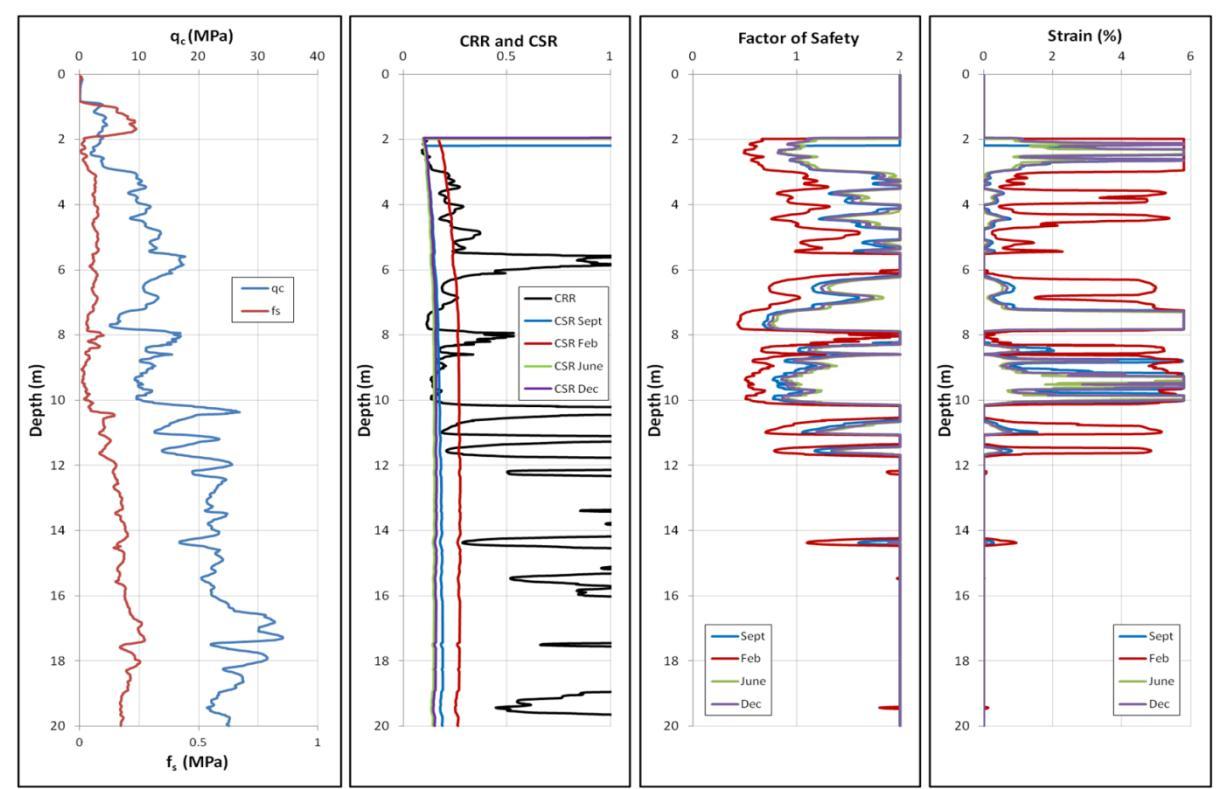
**Figure 4.** Liquefaction triggering analyses from CPT-RCH-17 with depth for the seismic demand from the 4 September 2010, 22 February and 13 June 2011 earthquake events.

Figures 4 and 5 show that the 23 February 2011 earthquake event caused the greatest amount of liquefaction triggering (and the highest CTL, LPI and LSN values) in the soil profile at the Richmond site, and the least amount of liquefaction triggering (and the lowest CTL, LPI and LSN values) from the 4 September 2010 event. This is consistent with the observed severity of land and dwelling damage caused by each event. The response of calculated parameters: crust thickness, CTL, LPI and LSN to variations in PGA are presented in Figure 6. It shows that there is a particular sensitivity in the PGA range of 0.15g to 0.25g, where layers within the CPT trace begin to drop below a FoS = 1.. Below 0.1g, LSN is insensitive to PGA and below 0.15g CTL and LPI are insensitive to the PGA. We

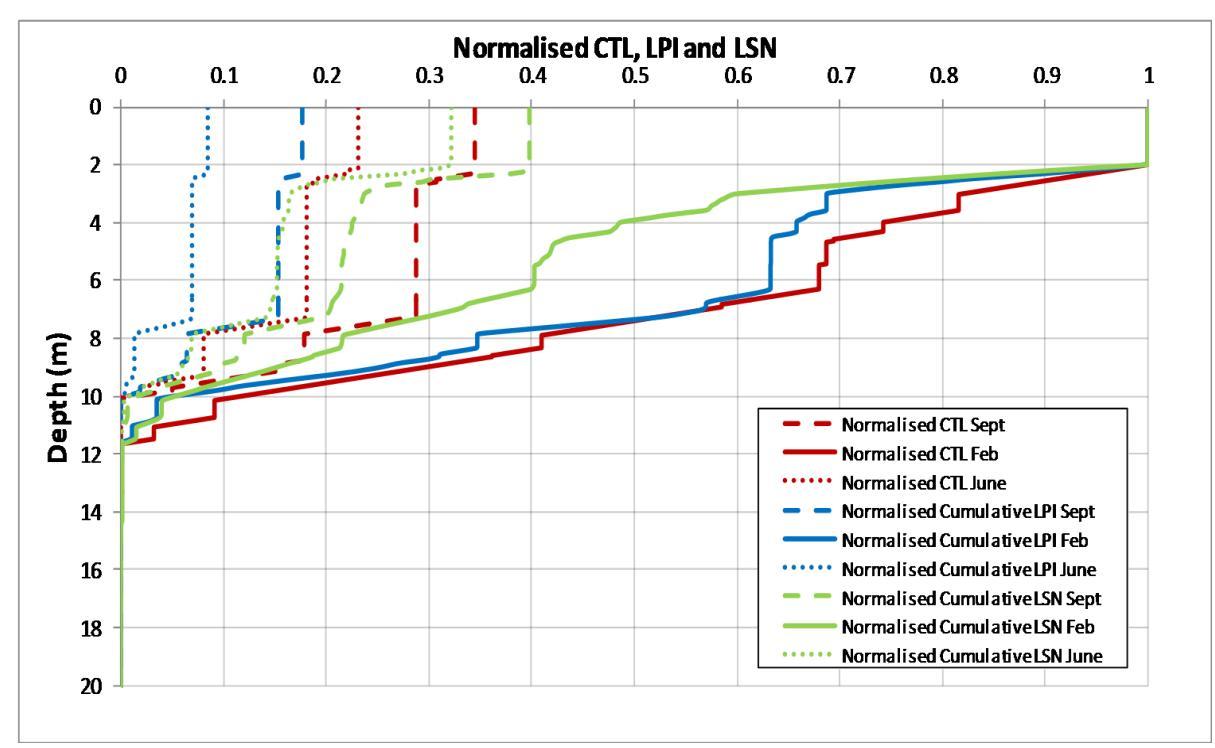
Figure 5. Site response at CPT-RCH-17 of calculated liquefaction vulnerability parameters with depth for the seismic demand from the 4 September 2010, 22 February and 13 June 2011 earthquake events, normalised to the calculated February 2011 event values

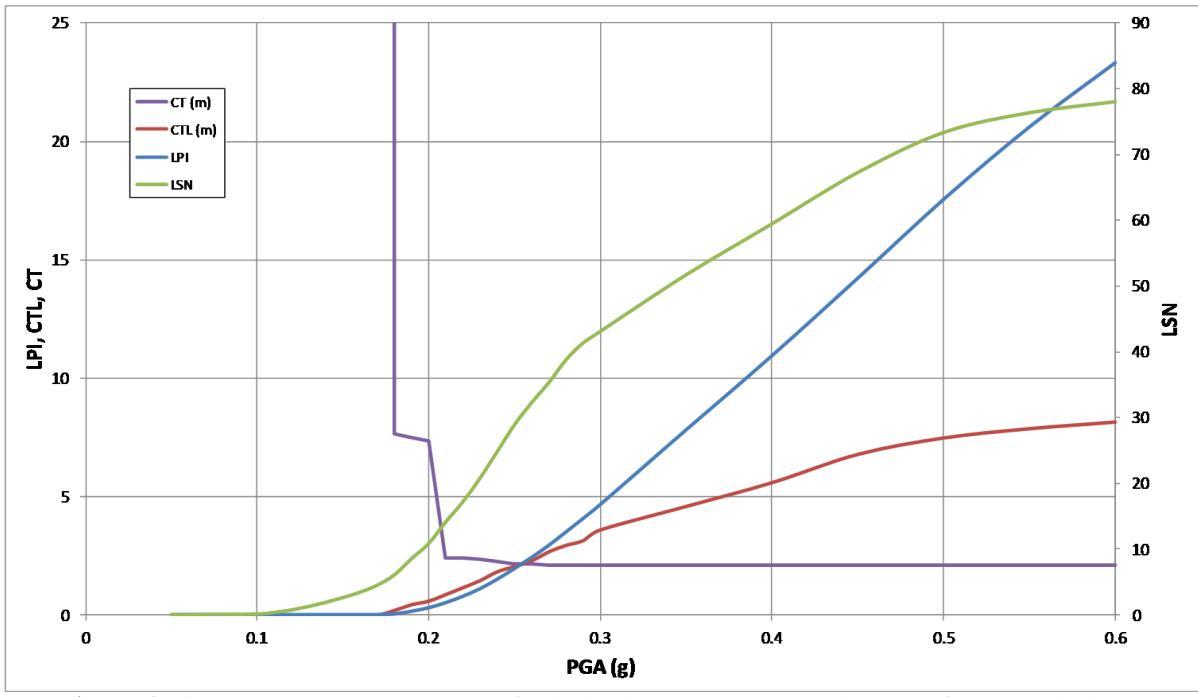
Figure 6. Site response at CPT-RCH-17 of calculated parameters to varying PGA for a magnitude 6.3 earthquake and pre 23 February 2011 ground water levels.

note that CTL and LPI continue to increase with increasing PGA, but the rate of increase in LSN steadily decreases with increasing PGA due to the strain limiting effect when FoS reaches a specified value.

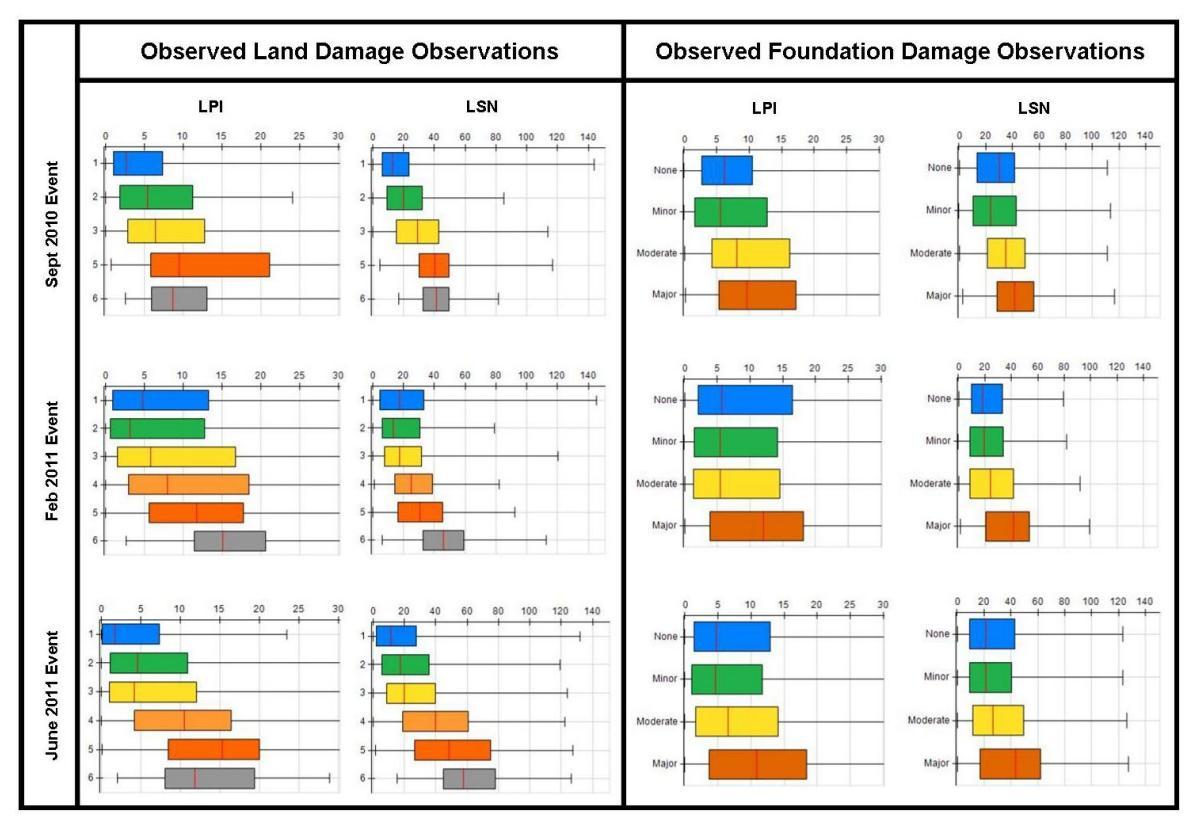
**Figure 7.** Box and whisker plots of LPI and LSN based on observed land damage and foundation deformation damage for the 4 September 2010, 22 February and 13 June 2011 earthquake events. For the land damage categories, 1 = blue, 2 = green, 3 = light orange, 4 = dark orange, 5 = red and 6 = black (as defined in Figure 1). For the foundation deformation damage categories, refer to Figure 1.

Figure 7 below shows preliminary comparison of the observed land damage and observed residential dwelling foundation deformation damage data, plotted against the calculated parameters LPI and LSN for the September 2010, February 2011 and June 2011 earthquakes as a series of box and whisker plots. The criteria for the damage categories are defined in Figure 1 and the geospatial distribution of the damage categories is shown in Figures 2 and 3. The results show that there are generally strong correlations with the two vulnerability parameters for the different damage categories.

A preliminary statistical data analysis of the results indicates that both LPI and LSN correlate with measured damage to land and house foundations. For the LPI parameter however, the slope is different for each event which indicates that the LPI correlation with land damage and foundation damage is event specific and produces inconsistent responses to the three events. The LSN parameter on the other hand appears to provide a more consistent fit to the measured land damage over the three different events considered, where a range of seismic shaking levels are experienced. This preliminary conclusion will be further tested and reported in more detail in subsequent publications.
