# Interlocking Compressed Earth Block Walls: Out-Of-Plane Structural Response

## SUMMARY:

Keywords: Compressed Earth Block Wall, Out-of-Plane Loading, Interlocking Masonry, Dry Stack

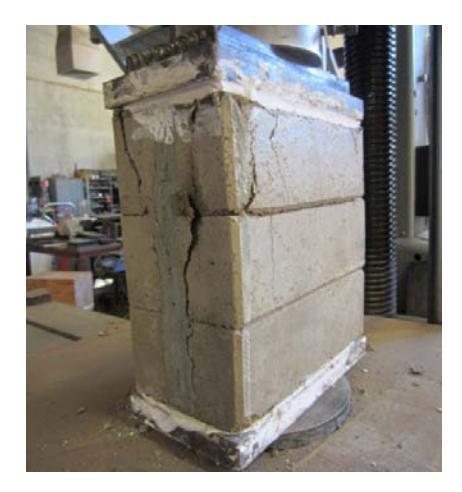
Figure 2.2: Standard Prism Test

Grouted ICEB prisms were tested for compressive strength for each wall built, see Fig. 2.2. Stacks of three blocks were used with a 2:1 height to thickness ratio. Prisms and test units were grouted simultaneously as construction progressed to ensure accurate values for masonry strength ( $f_m$ ). Table 2.1 shows average prism strength of 2.81 MPa, a value considerably lower than 10.3 MPa used for low strength concrete masonry units. The coefficient of variation (COV) was high compared to current masonry standards, indicative of the variation in mixture batches and curing conditions.

Based on stress and strain measurements during the prism tests, an average modulus of elasticity of 350 MPa was calculated. This modulus equals 125  $f'_m$ , which is much lower than the ACI 530 values of 700  $f'_m$  for clay masonry and 900  $f'_m$  for concrete masonry. The relatively high flexibility of the prisms is particularly caused by the gaps inherent in dry stacked masonry.

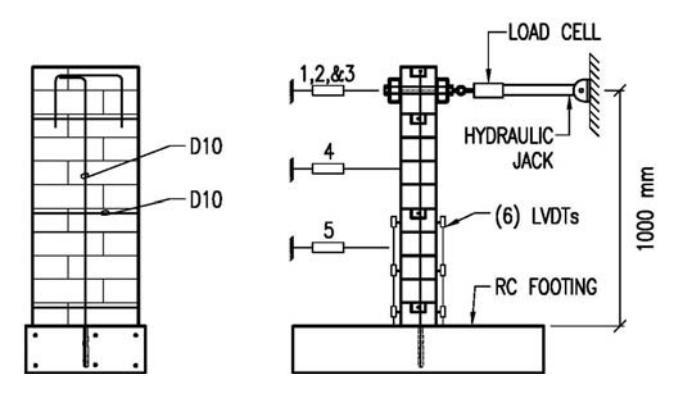
Figure 3.1: Cantilever Wall Test Setup

The cantilever walls were loaded cyclically using a hydraulic jack as suggested in Fig. 3.1. A loading sequence was selected to best observe the cracking and yielding behaviour, as well as the performance past yield. Each target load or displacement was achieved twice in both the push and pull direction.

Fig. 3.1 shows the cantilever wall test setup. At three heights, vertical displacements were measured on both sides of the walls in order to determine the curvature along the wall. A strain gauge was also applied to each bar 40 mm above the concrete footing. For the lap splice, an additional strain gauge was added to the midpoint of the splice.

Data from the vertical displacement measurements (see Fig. 3.1) can used to calculate the rotations and curvatures along the height of the cantilever walls. It is a goal of this research program to develop a moment-curvature relationship that will allow for accurate prediction of displacements.

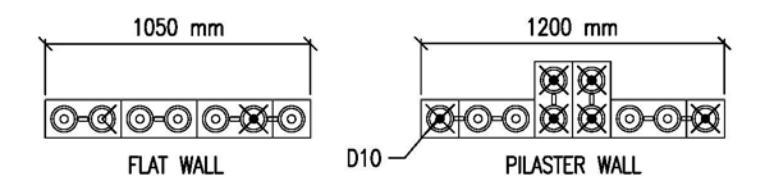
Figure 3.2: Full Scale Walls, Cross Section Layout

Layouts for the full scale walls were determined to best represent a typical ICEB structure in Thailand. Fig. 3.2 shows the wall cross sections and D10 reinforcement layout of each wall. The difference in width of each wall was to provide symmetry to each wall.

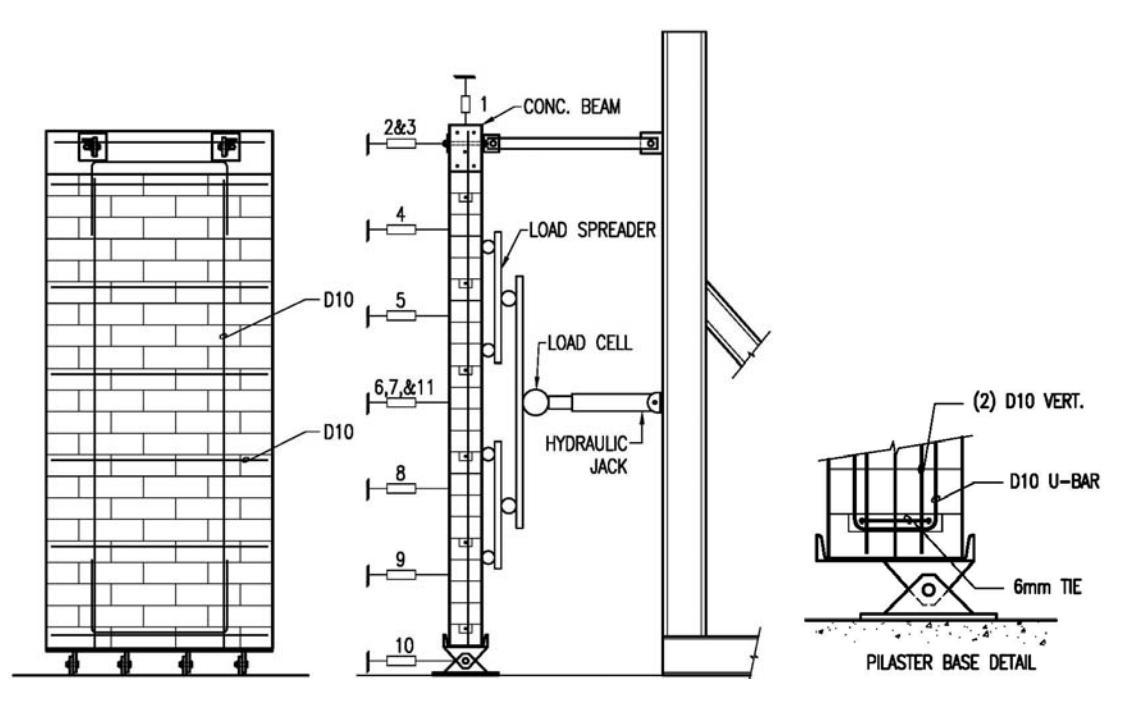
Figure 3.3: Full Scale Wall Test Setup

Each wall was 22 blocks tall, with a pin to pin height of 2.4 meters (Fig. 3.3). The first course was made from channel blocks and placed on a mortar base. Every fourth layer was made from channel blocks and included a horizontal D10 rebar. A concrete beam was cast in place at the top of each wall in order to transfer the load from the pinned connection to the wall. The top pin connection was achieved using two steel pipes that transferred the load back into the reaction frame.

A single load cell attached to the hydraulic jack measured the total load applied to each wall. A total of ten displacement transducers were used for each wall as shown in Fig. 3.3. Strain gauges were placed in each wall at mid-height. The flat wall had one strain gauge on each vertical rebar, while the pilaster wall had one on a tension rebar and another on a compression rebar.

Along with the shear cracks, uplift began between the first and second block layers. The vertical reinforcement and surrounding grout began to separate from the first layer of ICEBs. This uplift shows that the construction technique used at the base could have been improved by restraining the rebar from lifting away from the base. A detail of the base as built, with a bent D10 U-bar connecting two vertical D10 bars, is included in Fig. 3.3. Note that the reinforcement ends at the first course of blocks.

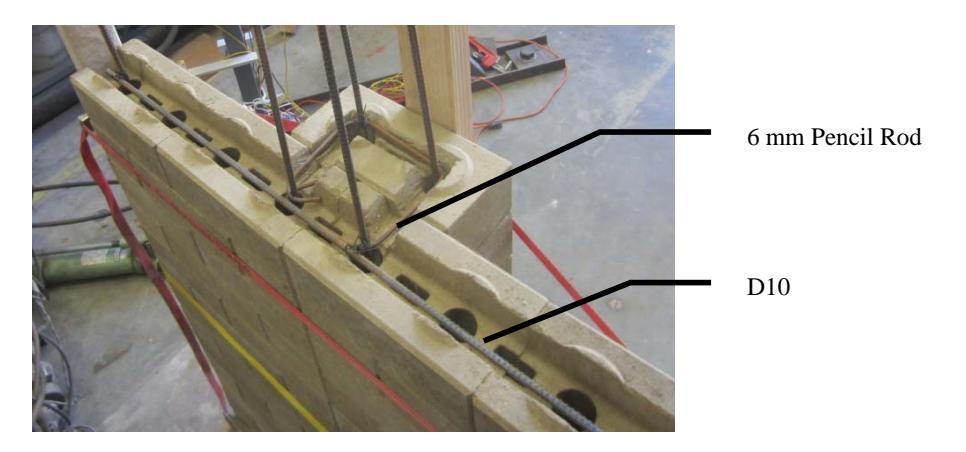
Figure 3.4: Pilaster Tie Placement

ICEB structures in Thailand and Indonesia contain shear reinforcement in pilasters and columns. For this experiment, ties were installed at every four blocks with the channel block layers. Smooth 6 mm diameter Gr. 60 (414 MPa) pencil rod bars with measured average yield strength of 435 MPa were used. A masonry saw was used to cut openings to fit the ties and a layer of grout, see Fig. 3.4.

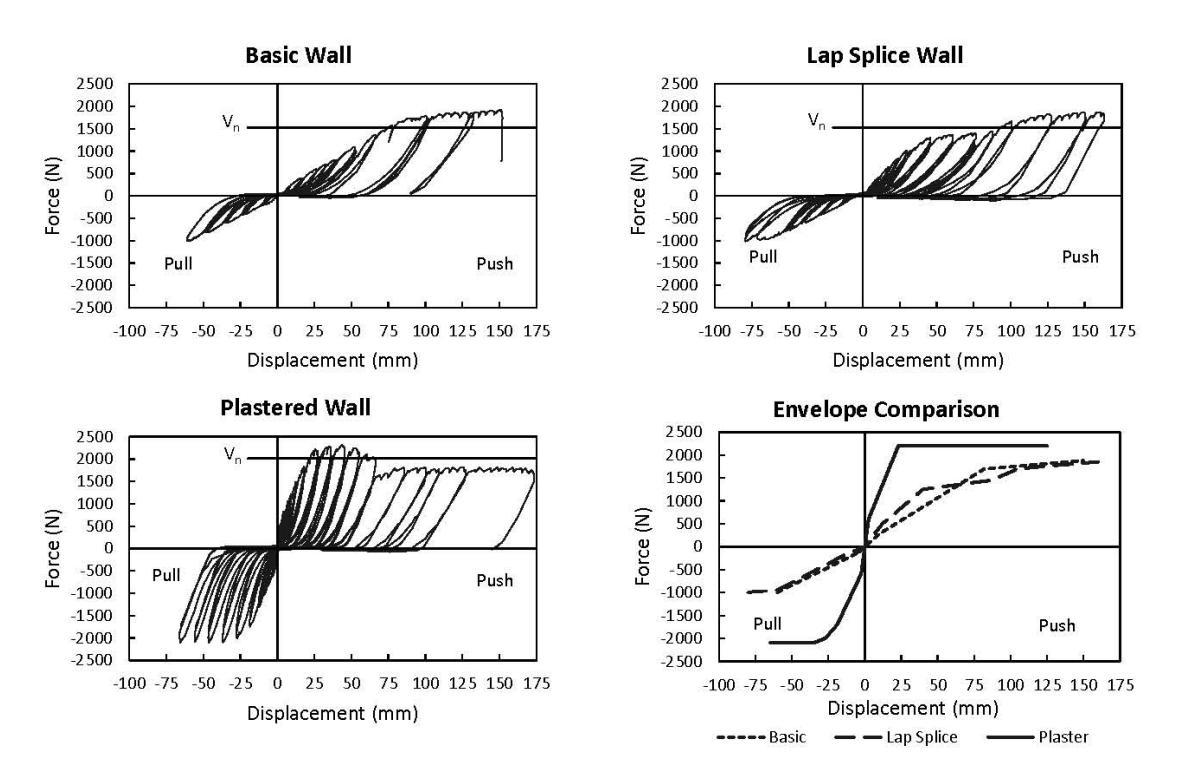
Figure 4.1: Hysteretic Curves of Cantilever Walls

The hysteretic behaviour of the cantilever walls is presented in Fig. 4.1.  $V_n$  corresponds to the predicted nominal flexural strength per ACI 530. It can be seen that each wall exhibited stable hysteretic behaviour, large displacement capacities and show large amounts of pinching throughout the tests. These results show flexure-dominated behaviour for ICEB walls under out-of-plane loading. On each hysteresis loop there are also distinct points of initial stiffness loss due to cracking and significant stiffness loss due to yielding. These points were used to create piecewise linear approximations to be used for comparing the walls (Envelope Comparison in Fig. 4.1).

The comparison shows a slight increase of initial stiffness in the lap splice wall compared to the reference wall. Despite the difference in stiffness, the flexural strength was similar to the reference wall. Compared to the reference wall, the plastered wall results showed a significant increase in stiffness, due to the plaster filling the cracks between the dry stacked blocks, and flexural capacity, due to the increased wall thickness. The plaster wall also showed a drop in flexural strength past being pushed 50 mm that coincided with the plaster spalling from the ICEB wall.

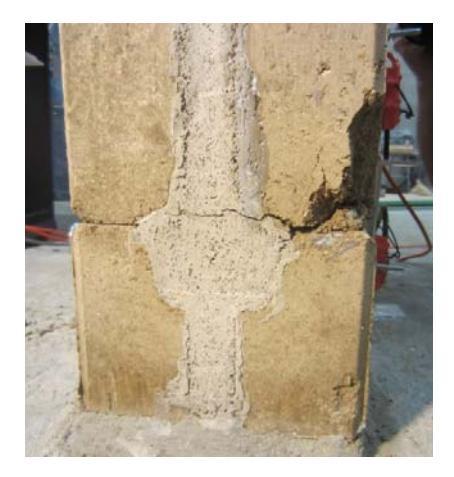
Figure 4.2: Common Flexural Cracking

Horizontal cracking in the grout cores initiated under low force levels at dry-stacked joints, see Fig. 4.2. The cracks were observed starting above the base layer of ICEBs and slowly progressing up the wall above each layer of blocks. On the plastered wall, cracks appeared in the plaster on each face of the wall in various locations, and not always at the dry-stack joints. The plastered wall had significantly more rotation at the base than the other cantilever walls.

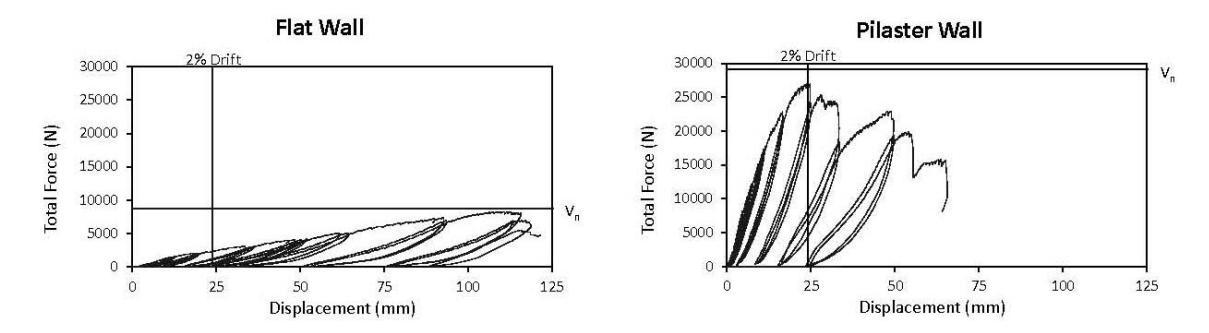
Figure 4.3: Hysteretic Curves for Full Scale Walls

The hysteretic behaviours of the two full scale walls are shown in Fig. 4.3. Dramatic differences in stiffness and strength are evident. As predicted from the outcome of the cantilever wall tests, the flat wall was found to be very flexible. The pilaster wall was observed to have an overall stiffness, calculated from zero load until significant strength degradation was observed, that was about 17 times greater than that of the flat wall. Table 4.2 shows a comparison of actual values versus ACI 530 expected values for nominal strength and stiffness. These values for stiffness were determined in

similar fashion to the cantilever walls. For these two walls, the predicted flexural strengths were not achieved. Uneven load distribution from the load spreader could have contributed to this.

Had a displacement limit of 2% been imposed on these walls, only a fraction of the flexural strength could have been developed for the flat wall (see Fig. 4.3). Conversely, a large amount of the pilaster wall strength would be developed with the drift limit. The 2% limit was quasi-arbitrarily chosen to limit the P-delta effects and to reduce the non-structural damage. Fig. 4.3 includes lines to illustrate where this 2% limit would fall on the hysteresis curves.

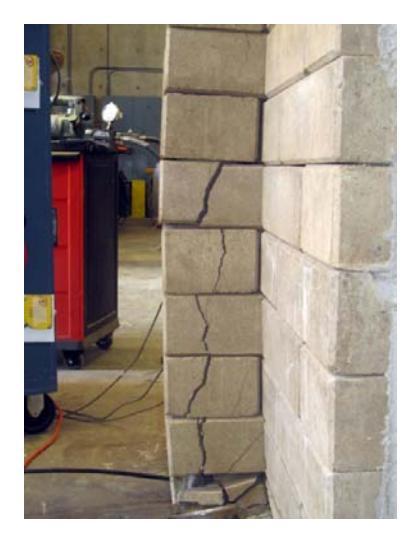
Figure 4.4: Shear Induced Cracking in Pilaster

The pilaster wall exhibited signs of shear dominated behaviour before any significant yielding could be observed by the strain gauges. The shear cracking started to form at a shear force of 8.7 kN, at a displacement of 10.9 mm. Fig. 4.4 shows cracks forming in the bottom few layers of the pilaster. The cracks were predominantly vertical along the lines of the reinforcement holes. These cracks are most likely caused by inadequate tie spacing. More ties, spaced closer together, would likely mitigate this issue.
