# Seismic Assessment of Traditional Masonry-Wooden Building in Taiwan

Yu-Chun Lin, Ja-Shian Chang, To-Nan Chen & Chung-Hsien Shih Department of Architecture, National Cheng Kung University, Taiwan

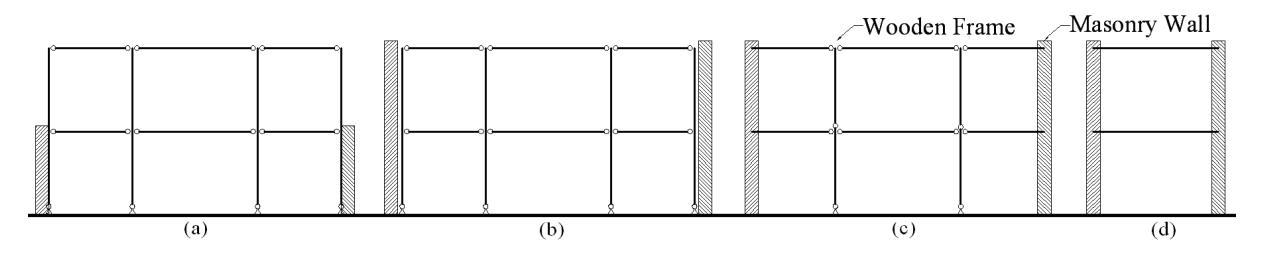
Figure 1. Typical structural systems of traditional 2-story masonry-wooden buildings in Taiwan

Most of the traditional historic buildings in Taiwan are constructed with mortise-tenon jointed wooden frames and surrounding masonry walls. Due to the shortage of long lumber, in these buildings, the multi-story cases are limited. In structural system, these existing multi-story cases can be divided into following 4 types (Fig. 1.), (a) wooden frames with continual columns confined by the surrounding masonry wall at lower story, (b) wooden frames with continual columns to bear vertical load and the surrounding masonry wall extending to 2-story, (c) wooden frames with story-divided columns and the surrounding load-bearing masonry wall, (d) multi story load-bearing wall and beams clamped. Nowadays in Taiwan, the conservation of these traditional buildings has highly caused attention; however, a reasonable method for the seismic assessment of these building is still unavailable. This study mainly focuses on the seismic assessment of these buildings which resist lateral loads by three main parts: mortise-tenon jointed frames, wooden panel partition walls, and masonry exterior walls. A 2-story case of type (a) which is called Yen-shuei Octagonal Hall had been evaluated in this paper, by push-over analysis with nonlinear hinges of these three main parts. Finally, the push-over curves were evaluated by capacity spectrum method to determine corresponding PGAs of various performance points.

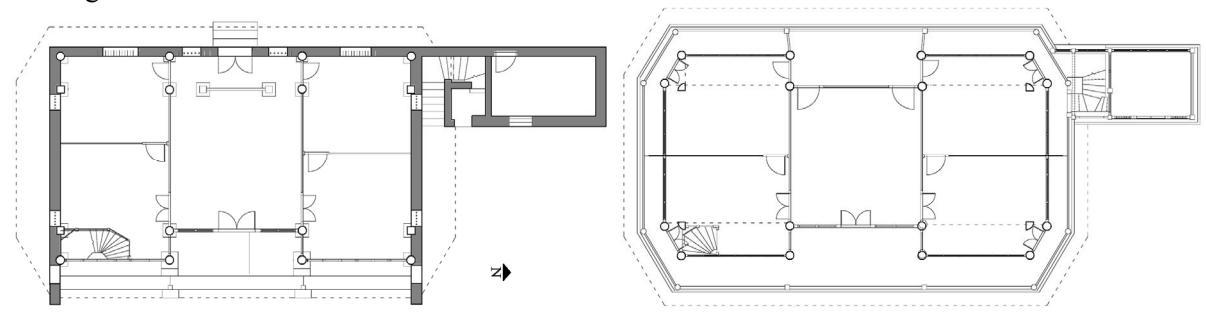
Figure 2. 1F and 2F plan

Octagonal Hall was built in 1847 and located in southern area of Taiwan. The first floor plan of the building is about 13.4m×7.6m, and the height of the 2<sup>nd</sup> floor and the roof ridges are 3.9m and 8.8m (Fig.2., Fig.3.). The structural system consists of surrounding 1-story-height masonry walls and four mortise-tenon wooden frames, as shown in fig. 3. The masonry walls are constructed by bricks in stretch bond for two side walls and dou-chi (box) bond for back wall. The thickness of two side walls is 39cm, and that of back wall is 36cm. The four wooden frames are parallel to the side walls which two sets were half-imbedded in each side wall and two middle frames divide the interior into three spaces. There are several perpendicular wooden tie beams which connect four wooden frames to make system stable. Then the slab beams and purlins are put on the "ta-tung"(girder) and the column tops of wooden frames as simply supported beams. The interior space is partitioned by wooden t&g wall panels whose thickness is about 1.5-3.0cm. And these panels were framed to infill into the wooden structural frames.

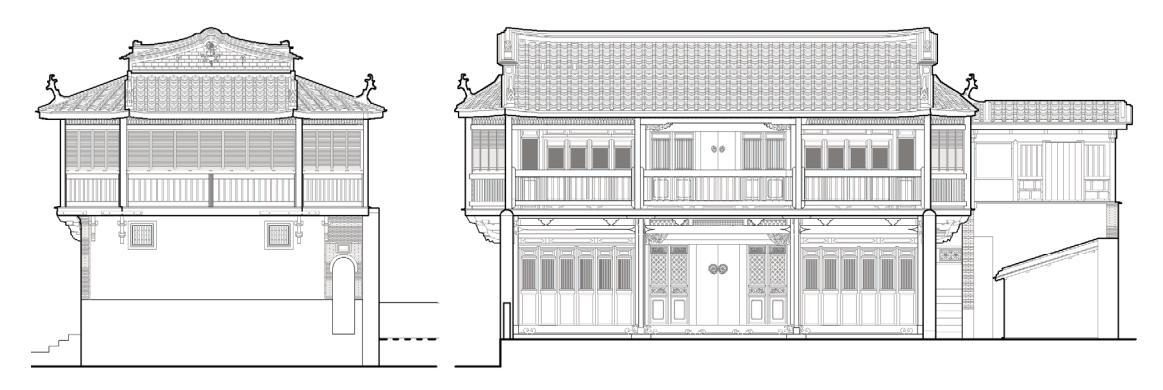
Figure 3. Southern and eastern(front) elevation

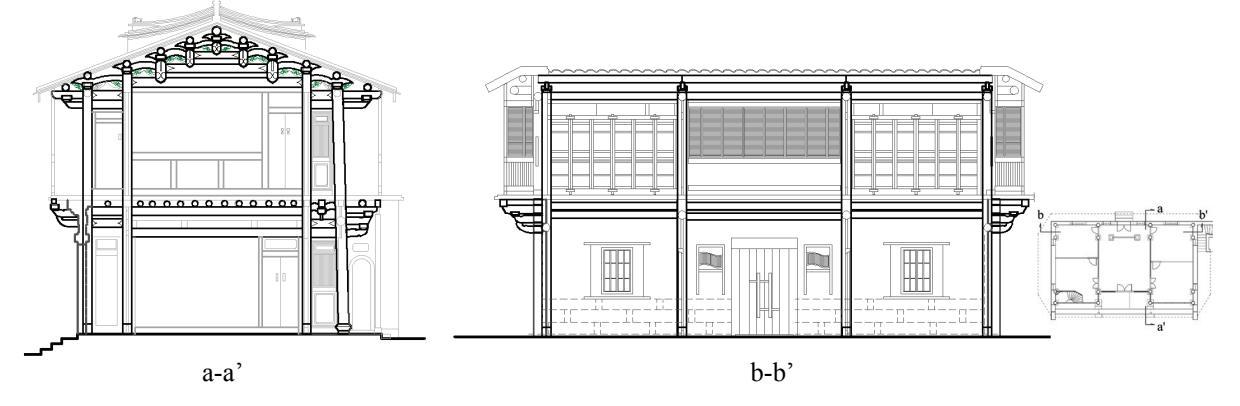
Figure 4. Section of a-a' and b-b'

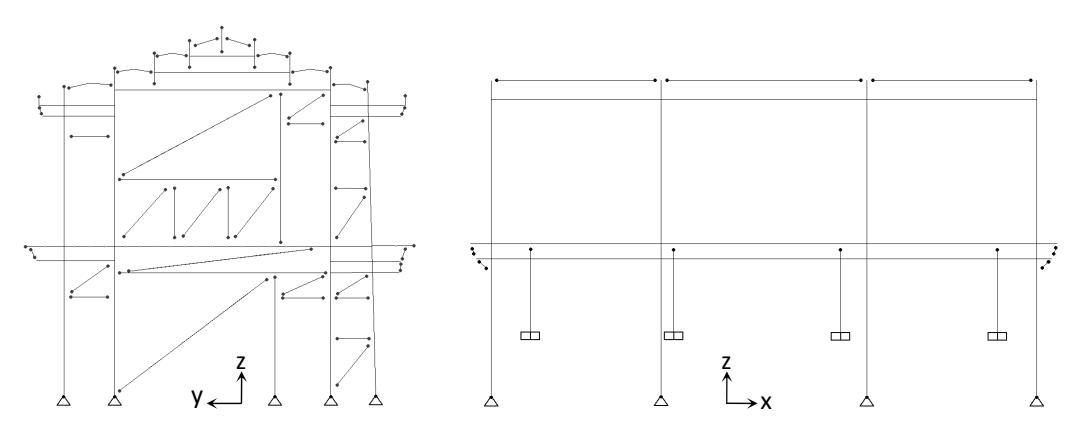
Figure 5. Moment release of the analytical model

A nonlinear 3D model was formed and analyzed by SAP2000 (Fig.7.). In order to assign nonlinear properties as nonlinear hinges, all of the structural elements were modelled as frame elements, also including masonry walls and wooden panel walls. For brick walls, they were modelled as columns and each section is assigned as thickness and width of the wall. And the nonlinear bending and shear hinges were assigned to the wall bottom and mid-height to simulate the out-of-plane bending and in-plane shear resistance (Fig.8., Fig.9.). For wooden partition panel walls, they were modelled as diagonal compressive members. And the cross section and the elasticity were transformed to equivalent values, and the nonlinear axial hinge was assigned to the midpoint to simulate shear resistance of the panel wall (Fig.10). For the mortise-tenon members of wooden frames, the nonlinear bending hinges were assigned to both two ends of major members (Fig.11). The other minor members of wooden frame were simplified to release both ends of moment resistance as tie members as shown in Fig.5. and Fig.6.

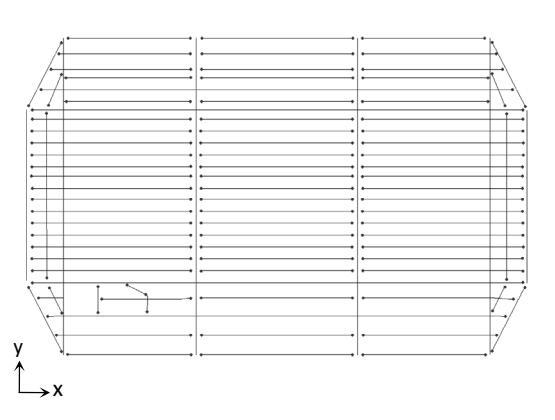
Figure 6. Moment release of floor beams

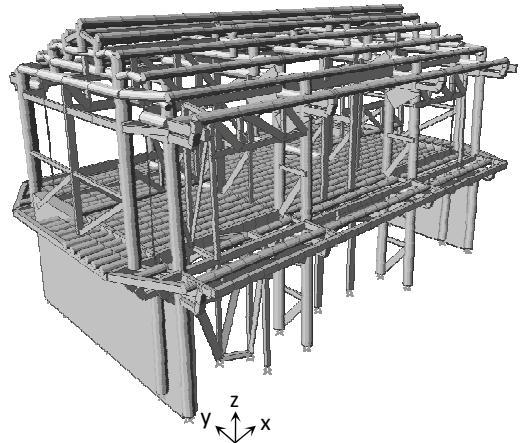
Figure 7. 3D view of analytical model

The analytical model is shown in Fig.7. and totally there were 1853 elements in this model. The mechanical properties of the brick wall and wood material were showed as Table 1. Some dead loads of roofing material, roof ridges, floor and other finishing were applied to the corresponding bearing members. And no live loads were applied to the model in order to evaluate the limit resistance of this building.

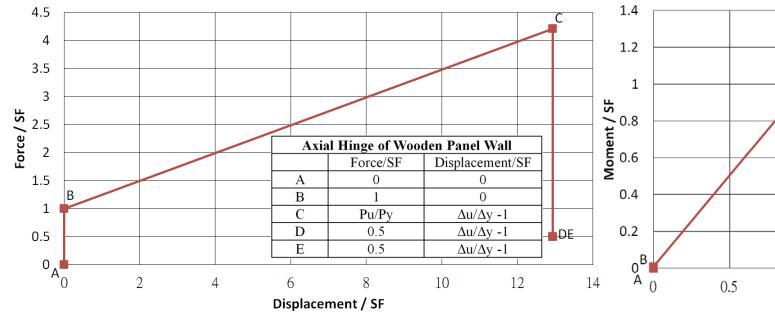
Figure 10. Hinge property of wooden-panel wall

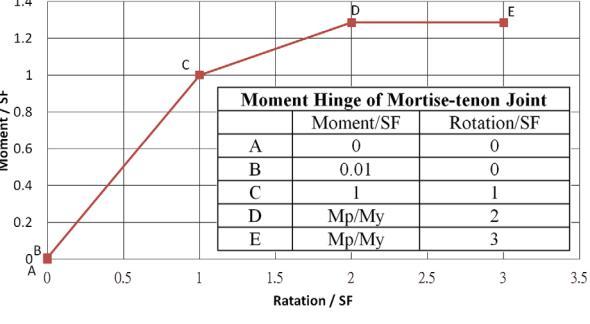
Figure 11. Hinge property of mortise-tenon joint

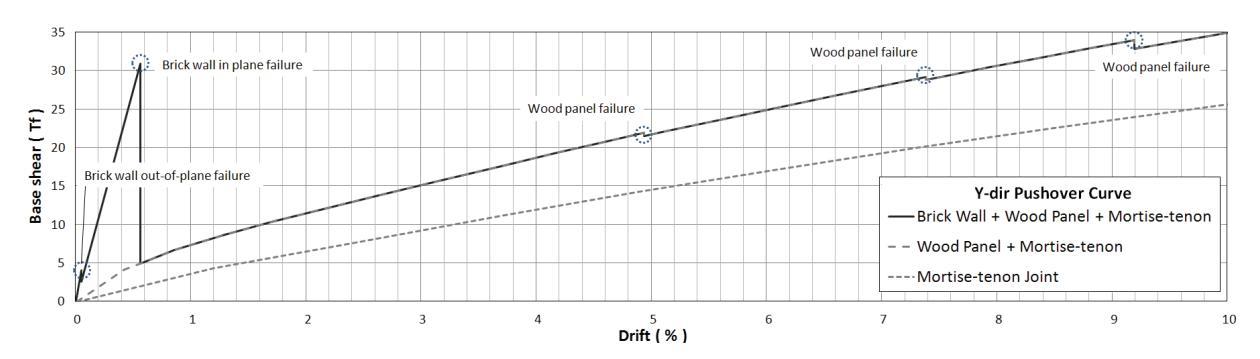
Figure 12. Pushover curve of y-direction

The pushover lateral load is applied by the referring 0.1g static earthquake coefficient and under displacement control. And Fig.12. and Fig.13. show the results of analysis in y-direction and x-direction. In y-direction, as Fig.12. shows, there are 5 significant peaks in the pushover curve. The first peak is due to out-of-plane failure of the back brick wall, and it occurred at the drift of 0.05%. This failure made quite slight effect to the initial stiffness of structure. The next peak is the maximum base shear about 32tf at the drift of 0.59%. The corresponding behavior is the shear failure of two side brick walls, and then the base shear resistance of structure is down to about 5tf changing to a flexible system. The stiffness of this system is controlled by the behavior of wooden panel walls and mortise-tenon joints. The first failure of wooden panel wall is located under the front window of the middle frame in the first floor until the drift of 4.9%. The coming next two failures of the wooden panel wall occurred in quite larger drift to 7.4% and 9.1%. For the behavior of mortise-tenon joints, the first yielding location is near front and back area in the first floor, and the corresponding drift is about 4.2%. Fig.12. also shows the contributing proportion of lateral resistance after the failure of brick walls. There is about 60% by the mortise-tenon joints and 40% by the wooden panel walls in y-direction.

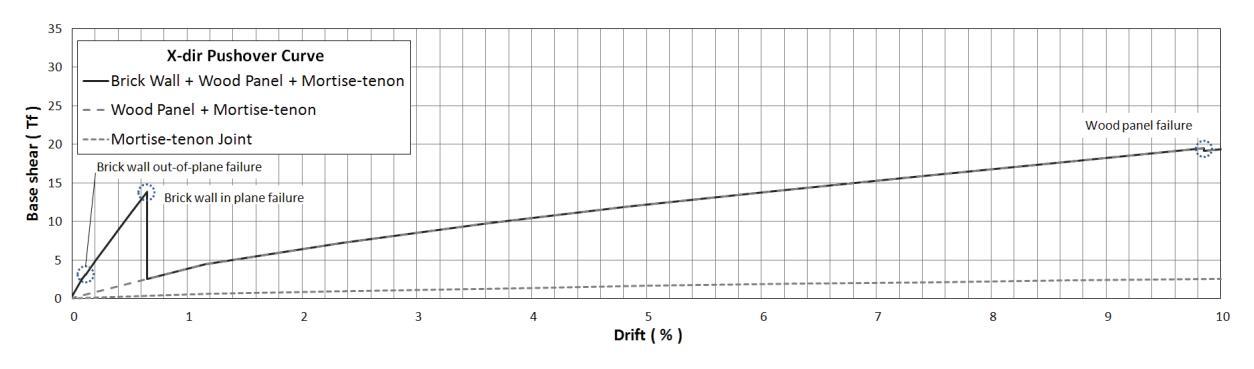
Figure 13. Pushover curve of x- direction

In x-direction, as Fig.13. shows, the lateral resistance of the structure is much weaker than that in y-direction. The behavior is quite similar as in y-direction. The out-of-plane failure of two side brick walls occurred in the drift of 0.12%, and the in-plane shear failure of the back brick wall occurred in the drift of 0.62%. The corresponding max base shear is about 14tf. For the behavior of the wooden panel wall, the first failure occurred in very large deformation of 9.9% drift. This is resulted in the discontinuity of the partition panel walls between lower and upper floor in x-direction, and the more critical problem is that these partition walls are not connected directly with main columns of wooden frames. Nevertheless, these panel walls still play an important role in x-direction because of the less number and the weakness of mortise-tenon joints in this direction. The lateral stiffness contribution of mortise-tenon joints is only 14% after the disable of brick walls.

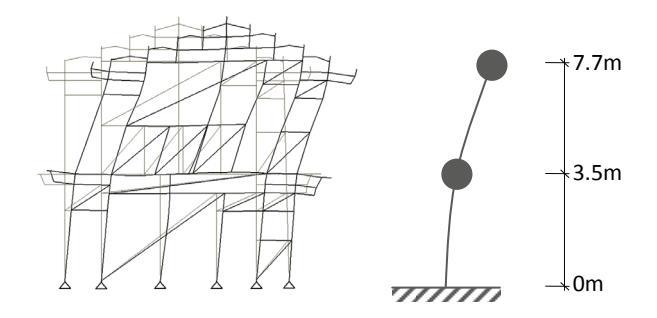
Figure 14. Simplified CSM model of 2 d.o.f system

In order to apply CSM method in this study, we have to simplify the analytic model to a 2-d.o.f story-lumped system as Fig.14. shows. The story displacement is averaged by displacements of eight main columns on the story level (Fig.15.). This displacement simplification yielded the results of 1<sup>st</sup> mode shape as Fig.16. and Table.2. shows. The mode shapes are obviously different before and after the shear failure of brick walls. When the stiffness of 1<sup>st</sup> floor decayed, the displacement of 2F increased and also made the modal mass coefficient  $\alpha_1$  increase, and the modal participation factor PF<sub>1</sub>(displacement relationship between modal and roof) was also changed. The following ADRS conversions of capacity spectrum were calculated by different  $\alpha_1$ s and PF<sub>1</sub>s before and after shear failure of brick wall.

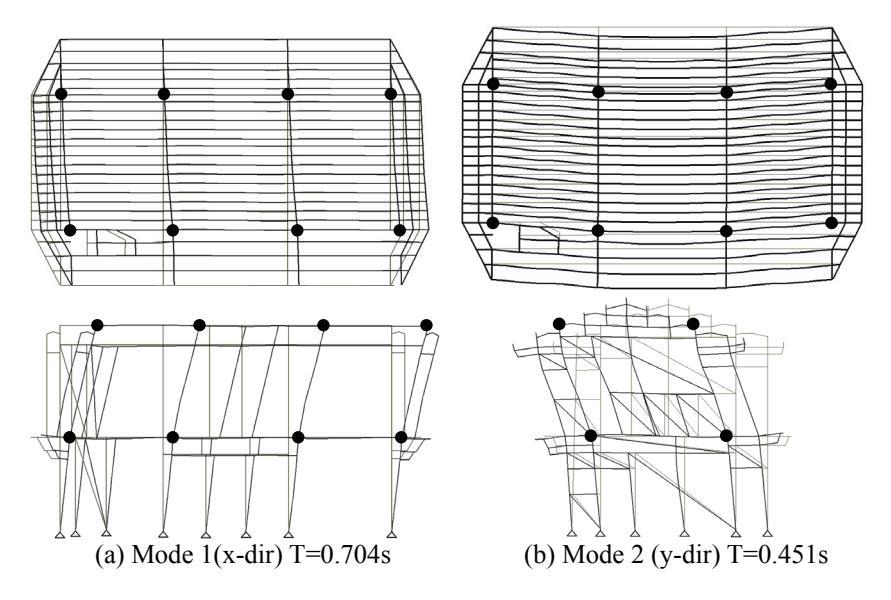
Figure 15. Mode shapes and corresponding modal period

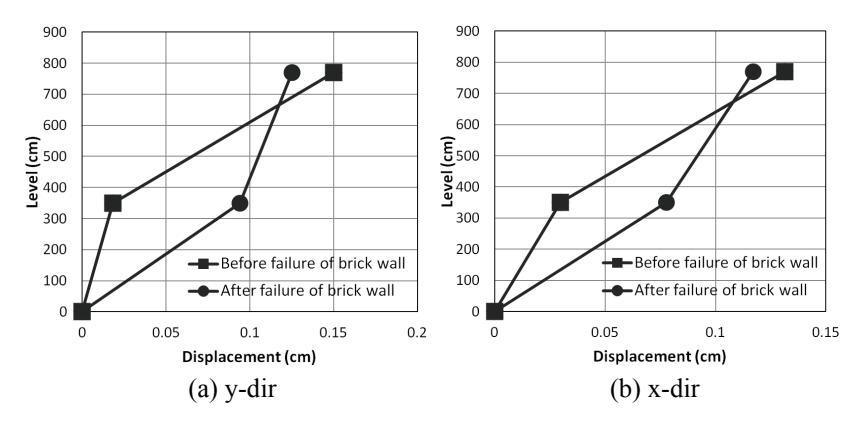
Figure 16. Mode shapes comparison before and after the failure of brick wall

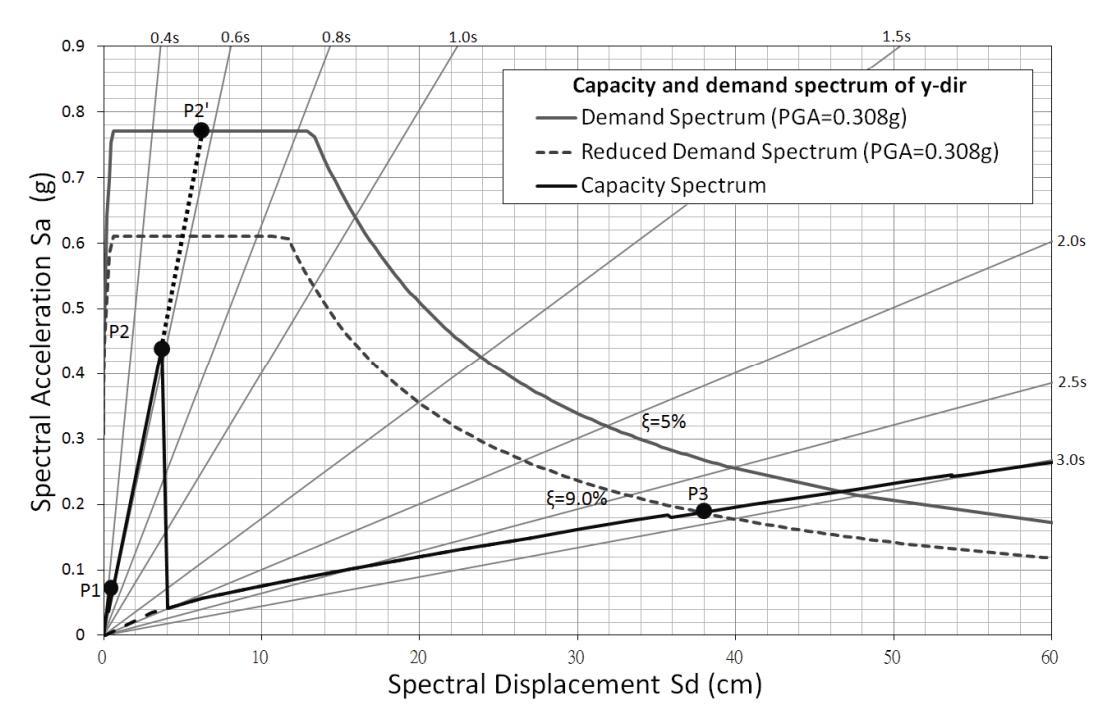
Figure 17. Capacity and demand spectrum of y-dir (PGA=0.308g)

Fig.17. shows the capacity and demand spectrum in y-direction. The demand spectrum is based on the design effective ground acceleration of 475-year return period in this site which is equal to 0.308g. There are 4 points to be discussed in this figure. The point P1 and P2 correspond to out-of-plane and in-plane failure of brick walls; their equivalent periods are 0.45s and 0.58s and equivalent damping ratios are both 5%. These two points could not intersect the 5% demand spectrum, and it means that in-plane shear resistance of two side brick walls could not be enough for the demand. If the strengthening strategy is improving the shear strength of walls, the point P2 has to extend to P2'. After wall in-plane failure, the structure transformed from rigid system to ductile system and its equivalent period extended longer than 2.0s. The point P3 is the matched performance point which could provide the code demand: its equivalent period is about 2.9s, equivalent damping ratio is 9.0%, and the spectral displacement is 38cm. Fig.18 shows the pushover curve and corresponding PGAs which is calculated with the inverse method provided by Chung, L. L. et al.(2009). The result could be adopted easily for strengthening design. The result shows that the roof displacement needs to reach 45cm (5% drift) to have ability to resist PGA=0.308g. Some retrofitting techniques for mortise-tenon joints are needed to improve, in order to prevent tenon joints being pulled out from mortise joints.

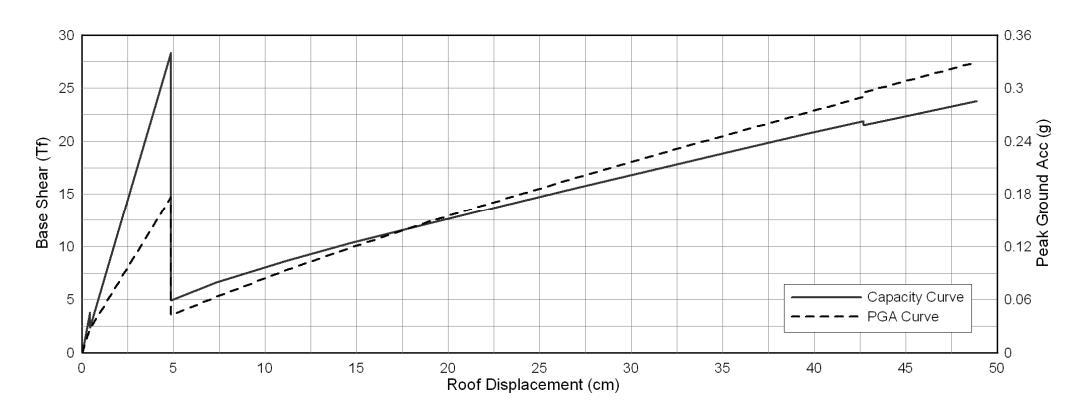
Figure 18. Pushover curve and corresponding PGAs (y-dir)

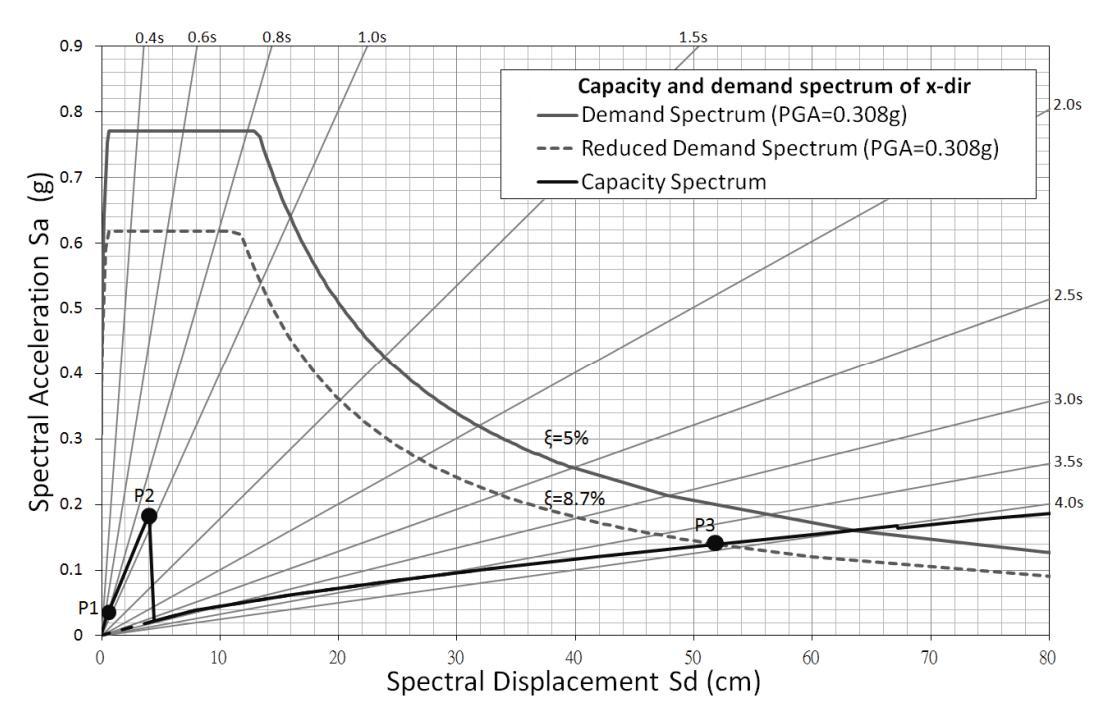
Fig.19. and Fig.20 shows the result in x-direction. The point P2 which corresponds to in-plane failure of back brick wall is farther from the demand spectrum than that in y-direction. And the corresponding PGA of the point P2 is only 0.09g as Fig.20. shows. The point P3 matched the demand spectrum of 8.7% damping ratio. The roof displacement reached to 65cm (7.5% drift) which is very large deformation. It is doubted whether the mortise-tenon joints could maintain the connecting ability. On the other hand, the P-Delta effect would also cause the structure deformed seriously. For the strategy of strengthening in x-direction, it is necessary to control the roof displacement and improve the stiffness both for back brick wall and for the wooden frames. To strengthen the in-plane resistance of the back brick wall has an advantage of preventing serious failure in medium scale earthquake. And the strengthening applied on wooden frames such as reformation between partition wooden panel walls and main frames could improve the stiffness in weak x-direction and make the performance point shift to smaller displacement.

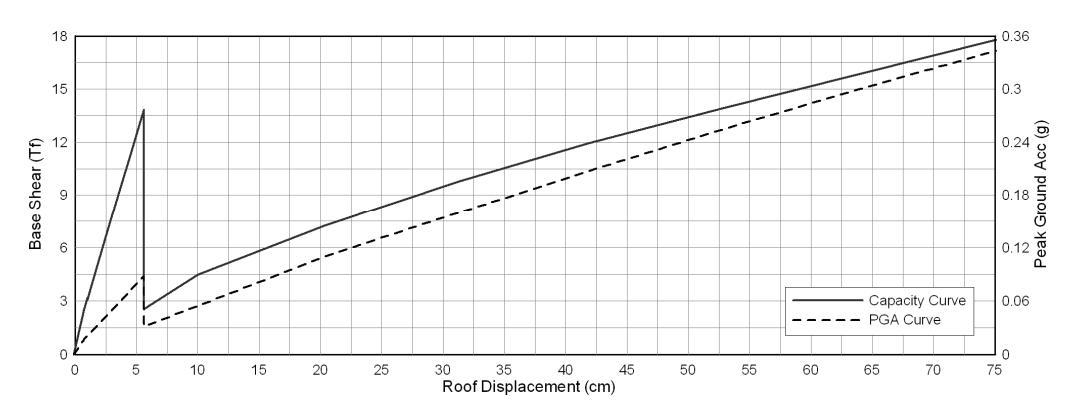
Figure 20. Pushover curve and corresponding PGAs (x-dir)
