A Study on the Influence of Non-Structural Member Timber Staircases on Seismic Performance

SUMMARY:

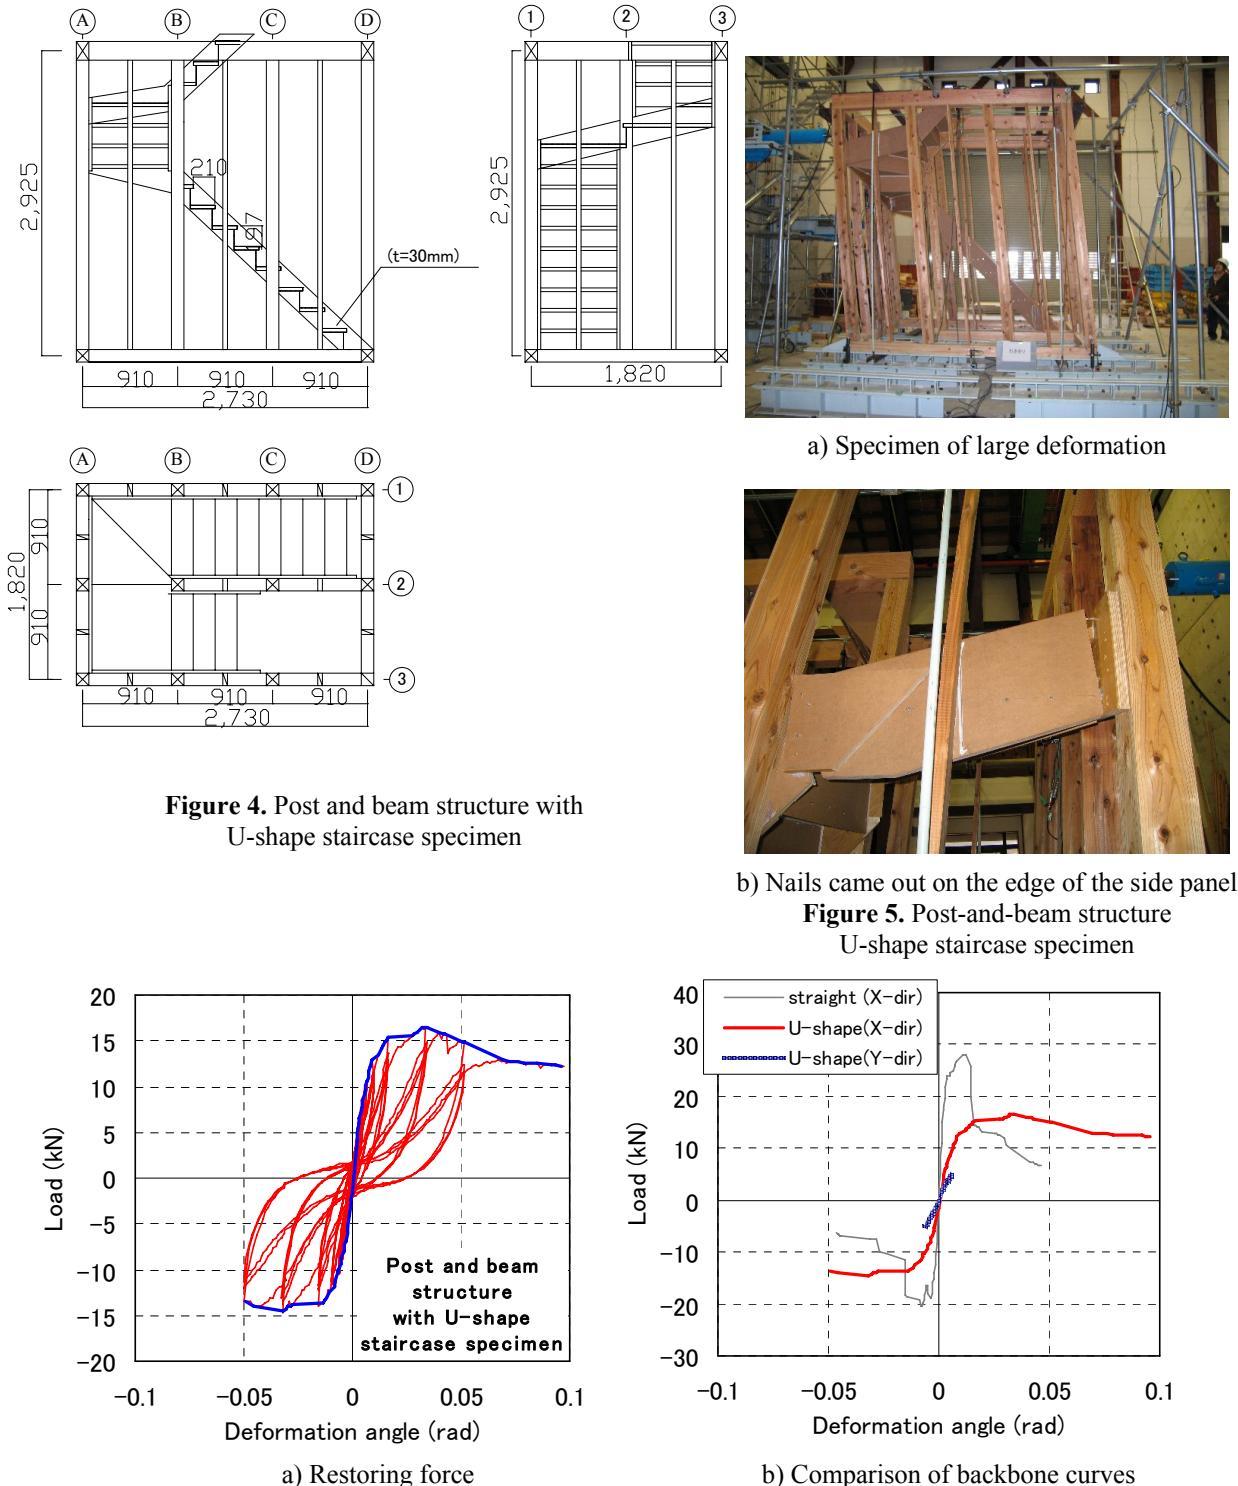
Figure 6. Restoring force characteristics of the post-and-beam structure U-shape staircase specimen

Figure 6 shows the restoring force and backbone curves of the U-shape winding staircase specimen, in the long and short directions. The maximum restoring force of the long direction was recorded as 16.43kN at 1/30rad. With respect to the short direction, a certain initial stiffness was observed, showing a load of 5.14kN with a loading of up to 1/150rad. Figure 6 includes a comparison with the backbone curves of the straight flight staircase specimen. Compared with the straight flight staircase specimen, the deformability performance was good, but there was low initial stiffness and maximum restoring force. The joining method of the side panel where the staircase is at right angles to the landing is considered to contribute greatly to such results.

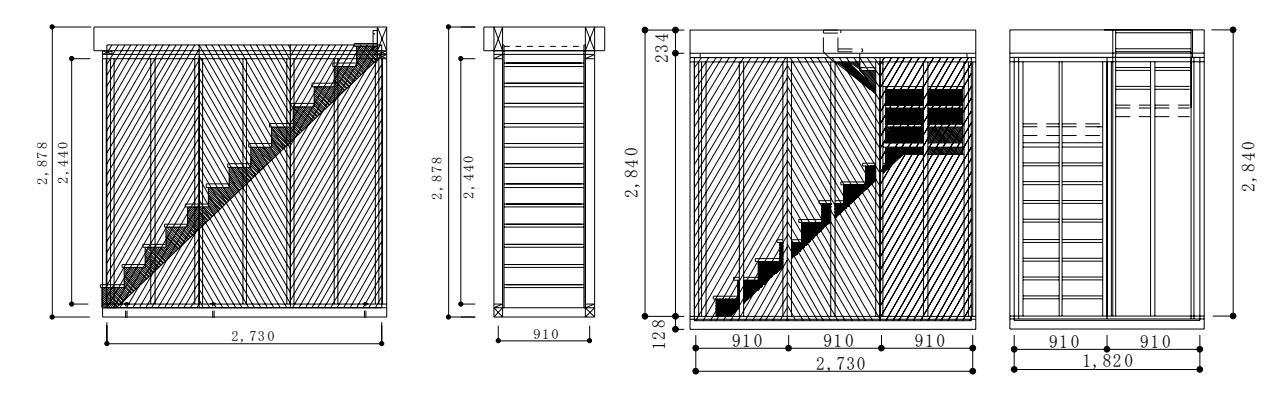
Figure 7. Light-frame wooden construction straight staircase specimen

A "light-frame wooden construction straight staircase specimen" and a "light-frame wooden construction U-shape winding staircase specimen" were constructed by referring to the Japanese two-by-four standard construction specifications. The two specimens are shown in Figures 7 and 8. The straight staircase specimen was installed between two parallel plaster boards with an interval of 0.91m, placed in a plane of 2.73 x 2.73m. The U-shape winding staircase specimen was likewise installed with an interval of 1.82m, placed in a plane of 2.73 x 2.73m. SPF and OSB were used for the stude of the specimen and the side panel respectively.

Damage was observed at the nail joints in the outer periphery of the plaster board at 1/100rad. As shown in Figures 10 and 11, cracks occurred on the plaster boards along the side panel, which became larger as deformation increased. Also, a significant bend was observed in the stud.

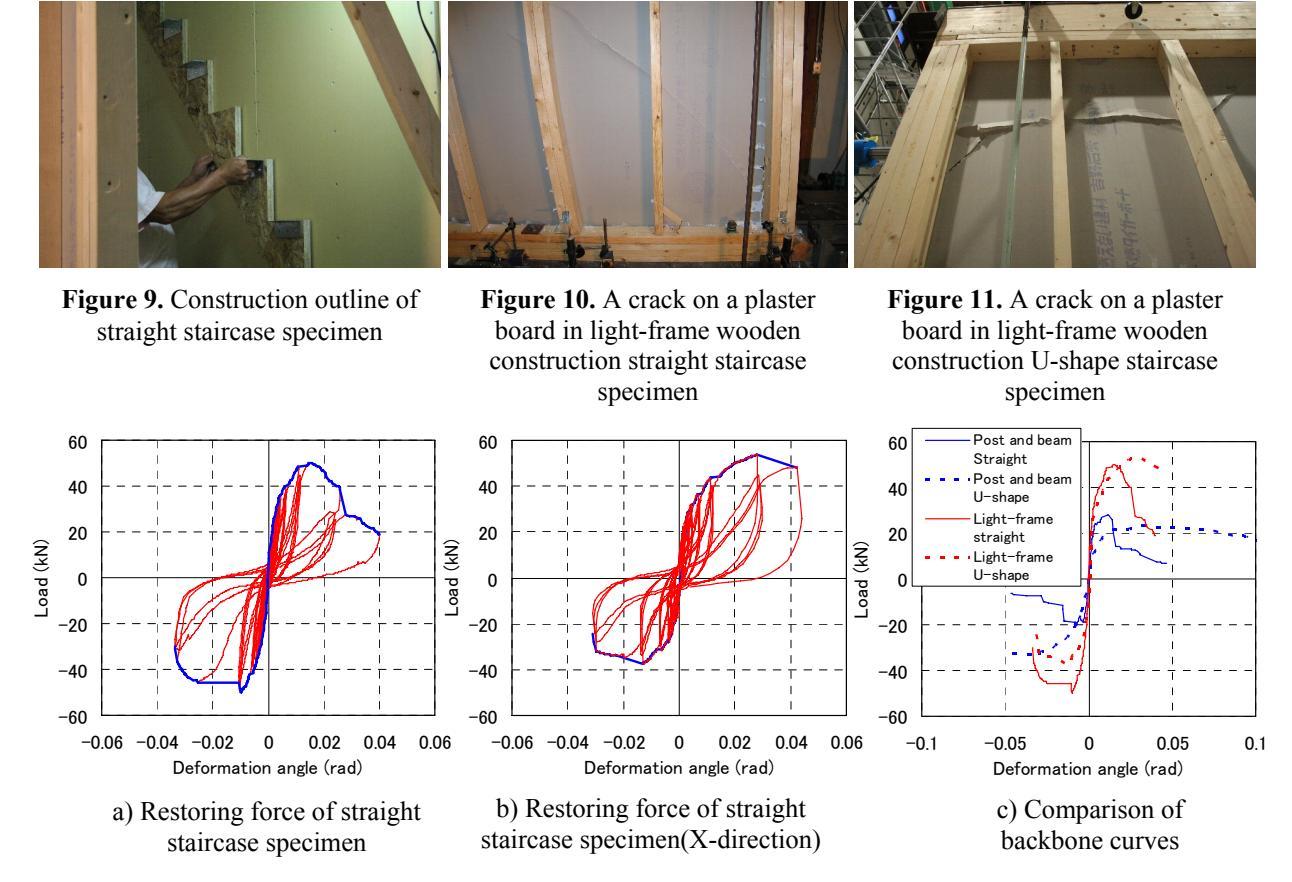
Figure 12. Restoring force characteristics of the light-frame wooden construction staircase specimen

Figure 12 shows restoring force characteristics and backbone curves of the light-frame wooden construction staircase specimen. The restoring force of the straight staircase specimen recorded 50.16kN at 1/66rad. As for the U-shape winding staircase specimen, the restoring force was recorded as 53.74kN at 1/36rad in the longitudinal direction, and 12.95kN with applied load up to 1/200rad in the short direction, showing a certain initial stiffness. Figure 12 c) shows a comparison with the backbone curves of the post-and-beam structure staircase specimen stated in Chapter 2. The maximum restoring force is larger in the light-frame construction staircase specimen compared to the post-and-beam structure staircase specimen. This is due largely to the inclusion of the restoring force of the plaster boards.

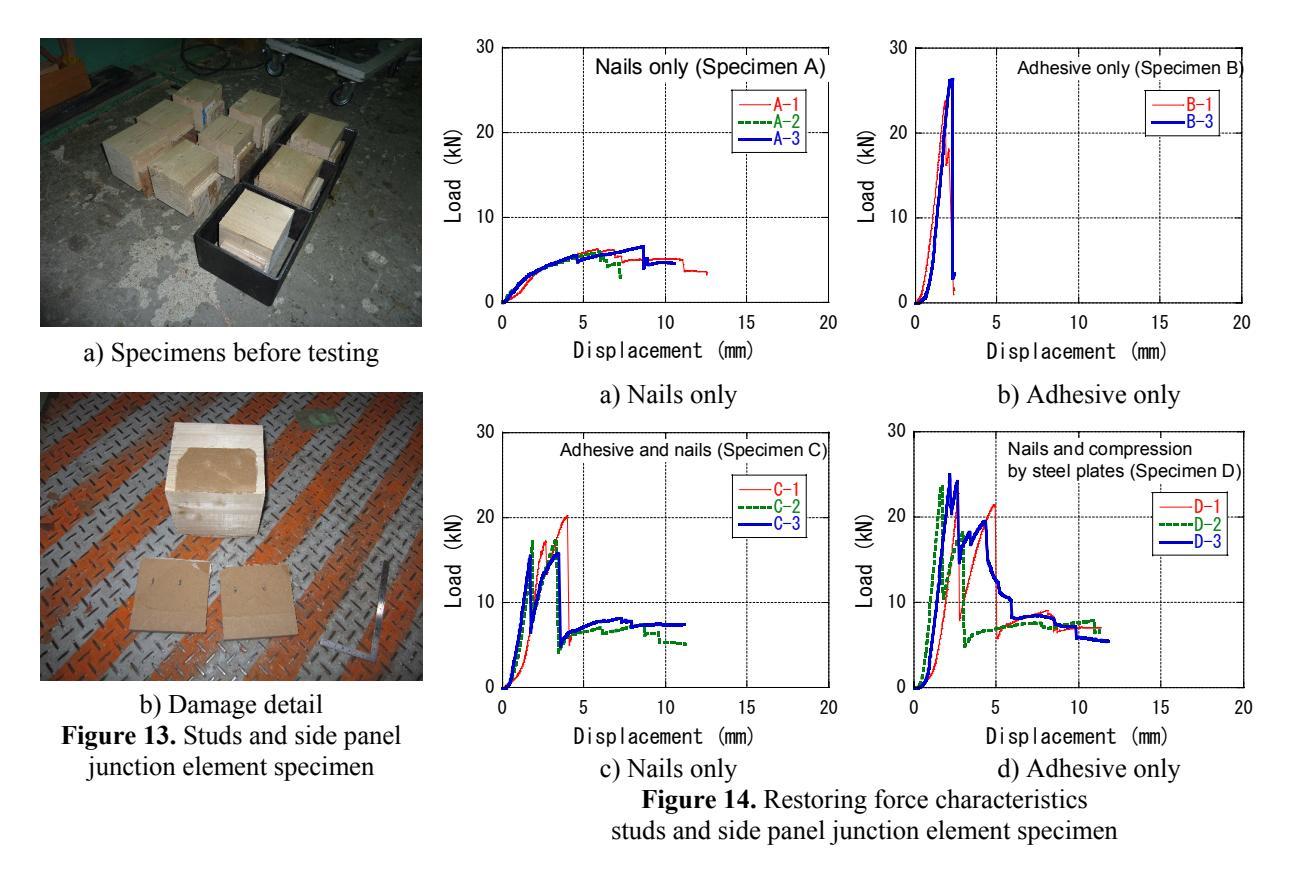
To implement the analytical study, a specimen for the element experiment was created (Figure 13). Because the test results in Chapter 2 showed that the joining of the side panel and the frame structure was important, the subject part was reproduced. The element tests were carried out as vertical loading tests, and a total of 12 specimens consisted of three each of four types. Experimental parameters were the use of nails only (Specimen A), adhesive only (Specimen B), adhesive and nails (Specimen C), and adhesive, nails and compression by steel plates (Specimen D) (Figure 13 a). Specimen A, C and D had four nails each. The adhesive drying time was more than 10 days following the experiment. The applied area of the adhesive was 7,000mm² each side (70 x 100mm).

Figure 13b) shows the typical damage of each specimen for the element experiment. Specimen A showed broken nails. Specimens B, C and D showed separation of the column from the panel, and breaking of the nails as shown in Figure 13 b). The separation of the column from the panel occurred in the form of peeling of the surface of the side panel (MDF).

Figure 14 shows the restoring force characteristics of each specimen for the element experiment. The maximum restoring force and the initial stiffness are shown in Table 1. The initial stiffness was represented by the angle produced by a straight line connecting the points of 0.4 times and 0.1 times that of the maximum restoring force. Specimen B-2 was not shown in Figure 14, as no appropriate restoring force was obtained due to defect of the experiment.

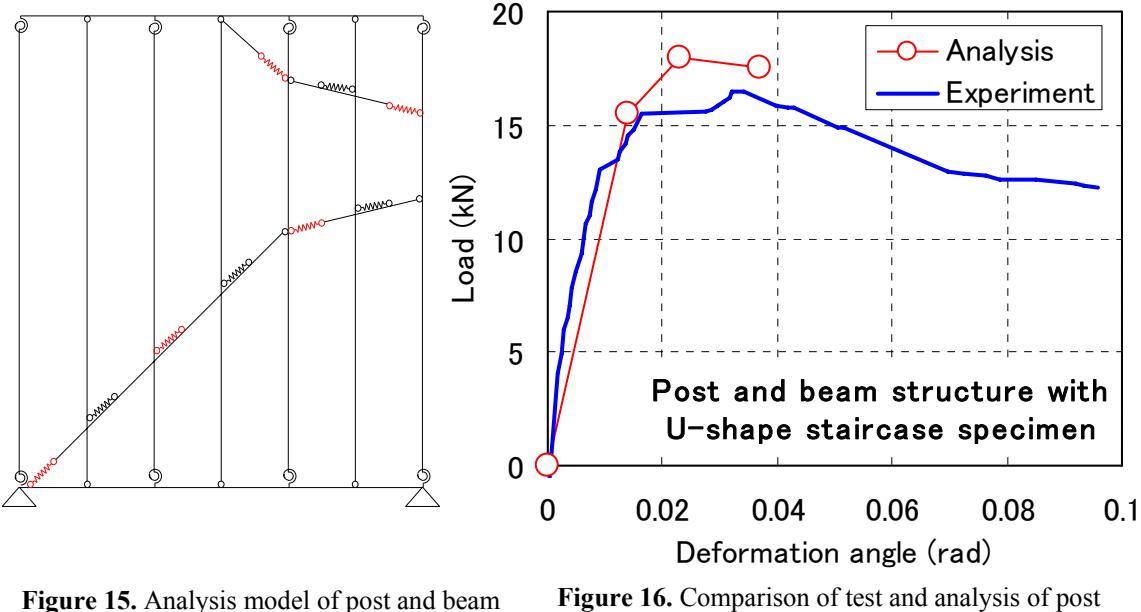
gure 15. Analysis model of post and bean structure U-shape staircase specimen

An incremental analysis was conducted on specimens of the post-and-beam method through the use of stiffness matrix based on the frame with no out of plane deformation in the side panel, and with the replaced spring of fasteners between the side panels. To replace the spring of fasteners, the load-

displacement relationship obtained by the element tests was used, while placing the spring in parallel with the side panel angle. Although the analysis showed results with a slightly lower initial stiffness and a tendency in maximum load to be higher by about 3kN compared with the test results, they more or less follow the actual values.

Figure 16. Comparison of test and analysis of post and beam structure U-shape staircase specimen
