# Seismic Performance of the Treasure of St. Gennaro's Chapel in Naples (Italy): past and present state

#### G.P. Lignola, A. Zinno & E. Cosenza

Department of Structural Engineering, University of Naples Federico II, Naples, Italy

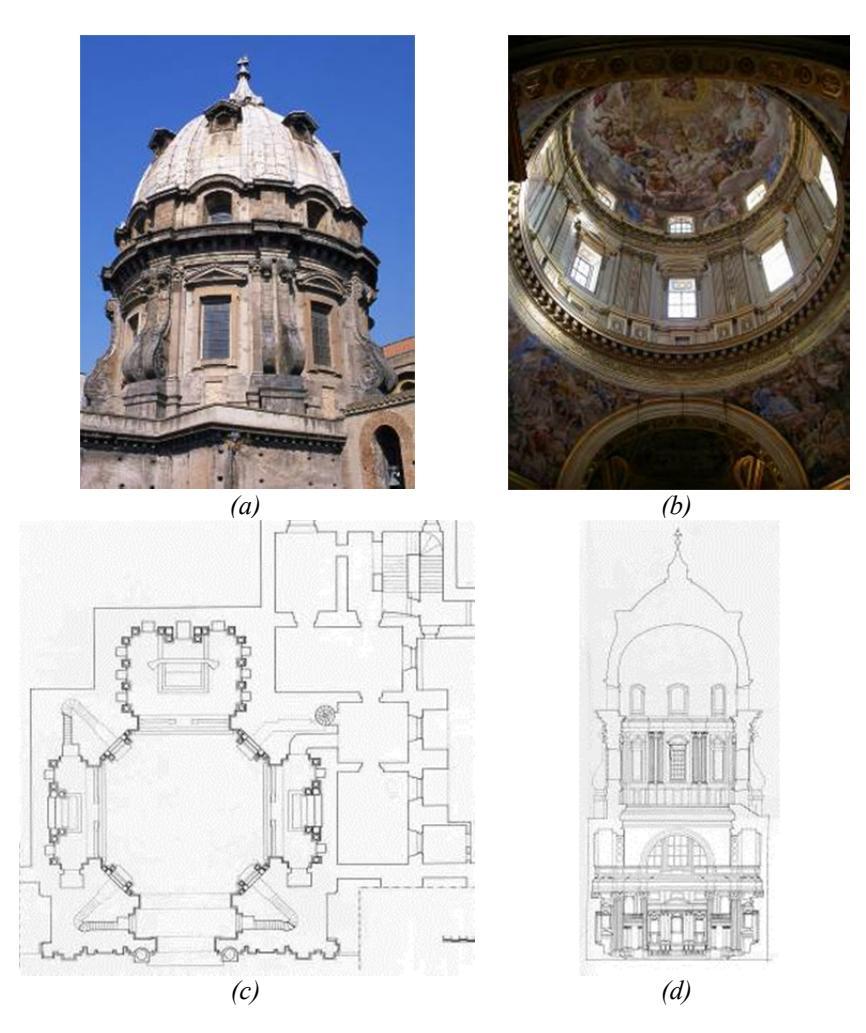
Figure 2.1. The Treasure of St. Gennaro's Chapel in Naples: (a) external view; (b) internal view; (c) plane section; (d) cross section.

The Treasure of St. Gennaro's dome, erected between 1608 and 1618, is composed of two groined masonry vaults with an internal diameter of about 14 meters (Figure 2.1). The structure is comparable to a long and narrow solid whose total height from ground is about 60 meters; it loads up four tuff masonry pillars connected by rounded arches. The external masonries of the Chapel, inscribable into a square, were made of tuff. The internal lantern was made of two rows of columns connecting internal and external domes and the external coating was made of lead. The external lantern, designed by Dionisio Lazzari in 1618, was made of piperno, a volcanic material widely used in Neapolitan monumental buildings. A first iron chain was already placed at the base of the second row of windows in 1612.

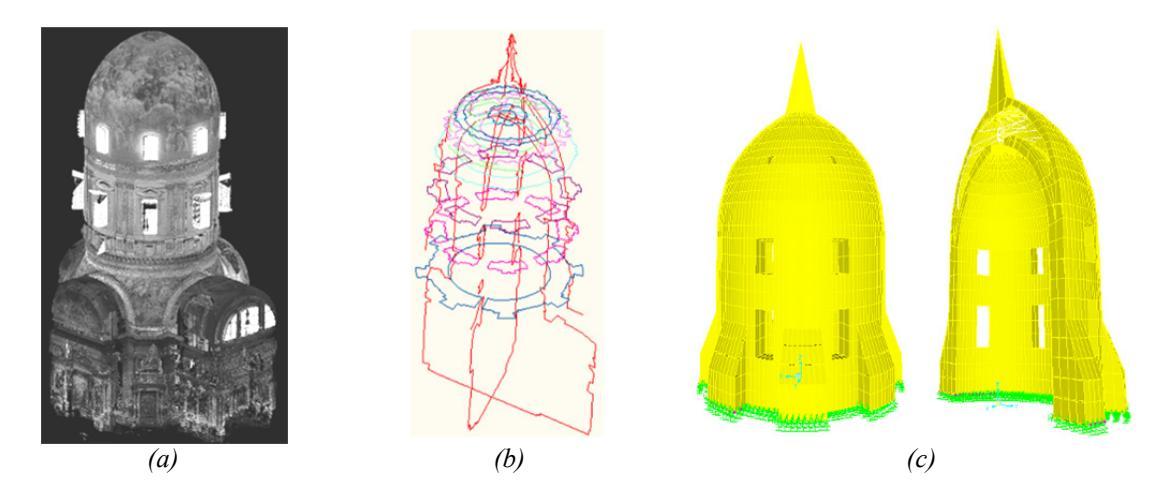
Figure 3.1. FE models development: (a) scanner digital image; (b) plane and cross sections of the dome in Cad environment; (c) 3D views of SAP FE model.

Starting from detailed geometric and structural surveys, obtained using sophisticated laser scanner and the correlation of bibliographical, archival and iconographical documentation, the Chapel's dome was modeled using the commercial computer code SAP 2000 (Figure 3.1).

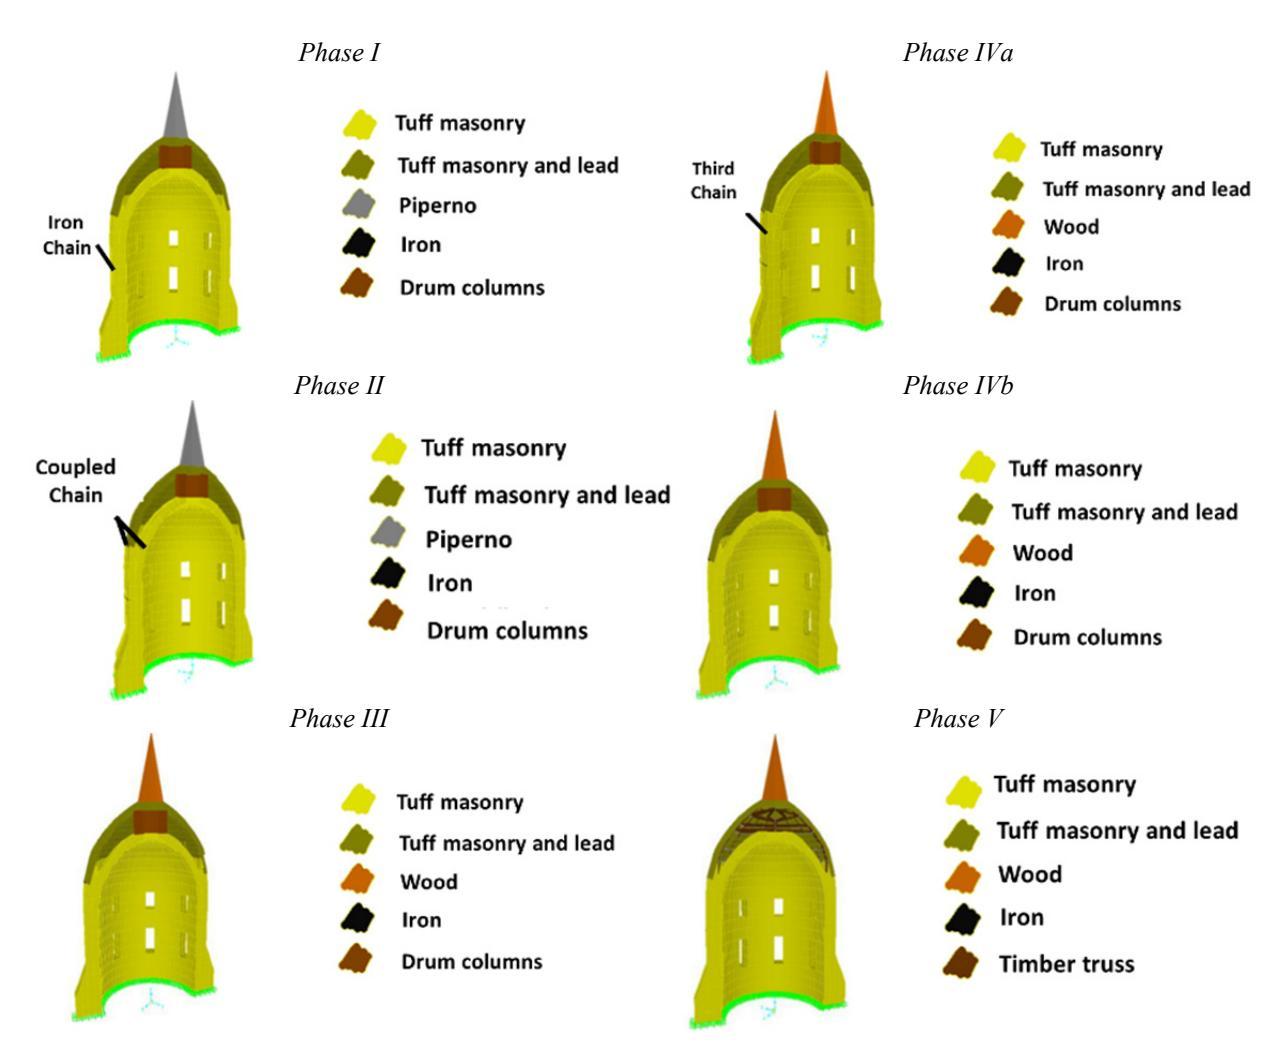
Figure 3.2. FE models and material schematizations for each phase.

The FE models (Figure 3.2) have been refined for each phase to account for openings, ribs on the internal calotte, buttress at the bottom drum, steel chains and timber truss when the lantern was removed.

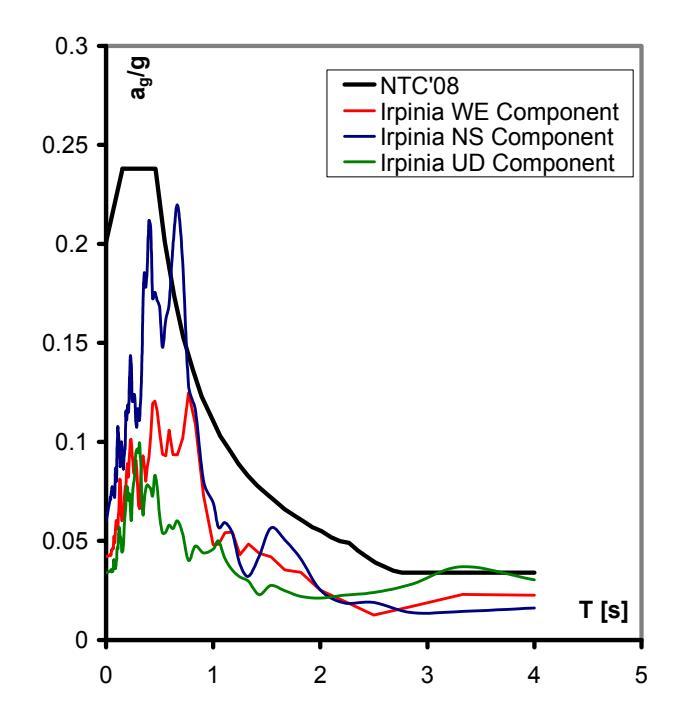
Figure 3.3. FE input for seismic analyses (Inelastic Spectrum).

The analyses have been performed for both dead and seismic loads. In particular, dynamic simulations of the dome are presented considering both the response spectrum registered by National Accelerometric Network at Torre del Greco, that is the closest station to the church area, during the Irpinia earthquake of the 1980 and the inelastic design spectrum provided by Italian Code (NTC '08) for the site of interest. The inelastic spectrum is obtained from the elastic one trough a reduction factor equal to 2, which accounts for the limited ductility and deformation capacity of masonry structures. (Figure 3.3)

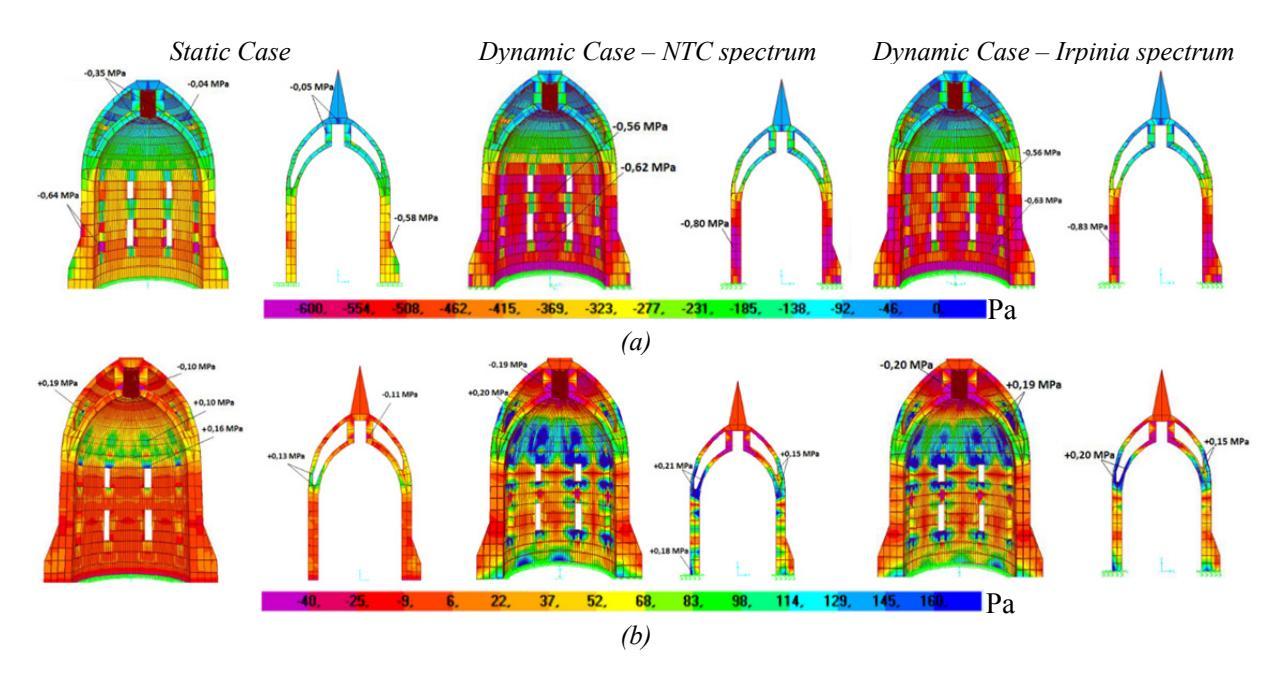
Figure 4.1. Principal stress map of the dome in the Phase I: (a) compressive stresses; (b) tensile stresses.

Figures 4.1a and b report, for the building site, the maps of the compressive and tensile principal stresses, respectively. As it can be seen, the maximum tensile stress zones, that are cracking prone, are located on the inner dome over the windows and these are reduced where groins increase the cross section. These high tensile stresses cross the thickness of the wall rising also close to the third row of windows. The maximum value in the dome is higher than 0.1 MPa also for the static case; this value is higher than a reasonable tensile strength of ancient tuff masonry, thus resulting in crack pattern evolution.

For both static and seismic load conditions the maps show maximum value of compressive stress lower than the minimum compressive strength equal to 1.4 MPa suggested by NTC'08 for tuff masonry.

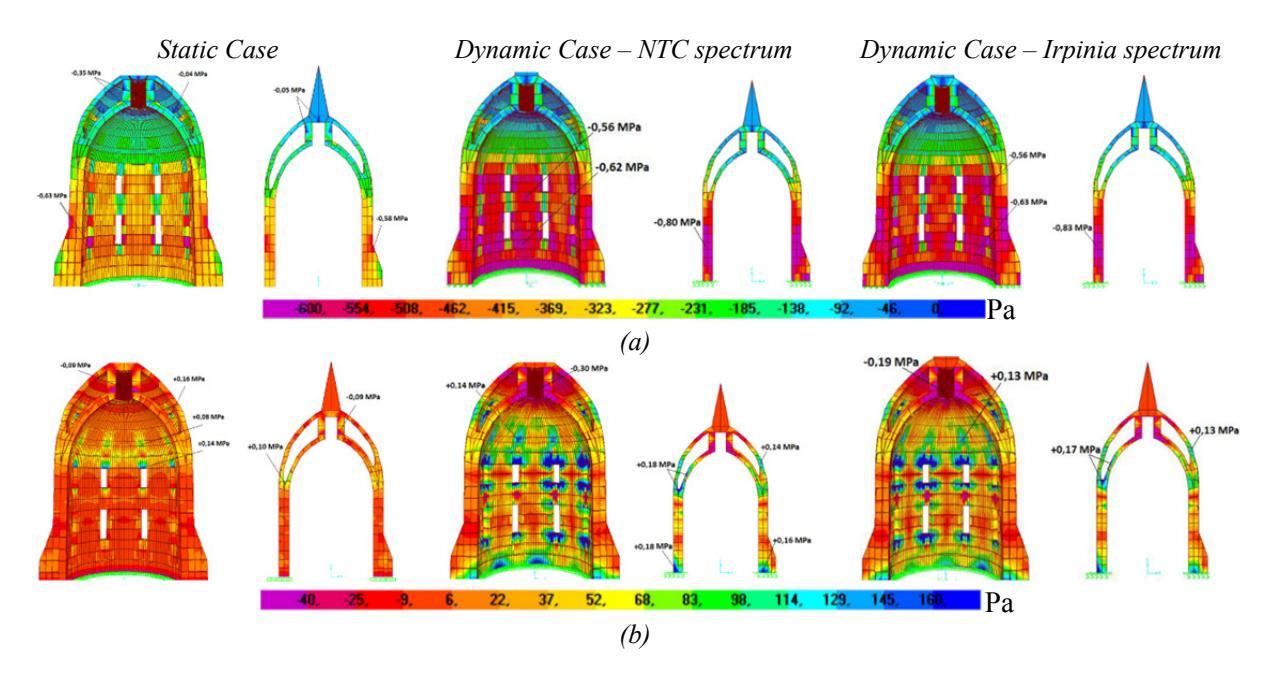
Figure 4.2. Principal stress map of the dome in the Phase II: (a) compressive stresses; (b) tensile stresses.

Figures 4.2a and b report, for the present case, the maps of the compressive and tensile principal stresses, respectively. As it can be seen, the second coupled chain, inserted close to the third row of windows where high stresses were previously found, provides a reduction of about 14% of the maximum tensile stress; reduced tensile stresses are also still present in the upper part of the internal drum. The present consolidation intervention, for the static case, allows to obtain tensile values lower than 0.1 MPa, except close to the openings.

As in the previous case, for both static and seismic load conditions, compressive stress is lower than the minimum compressive strength equal to 1.4 MPa suggested by NTC'08 for tuff masonry.

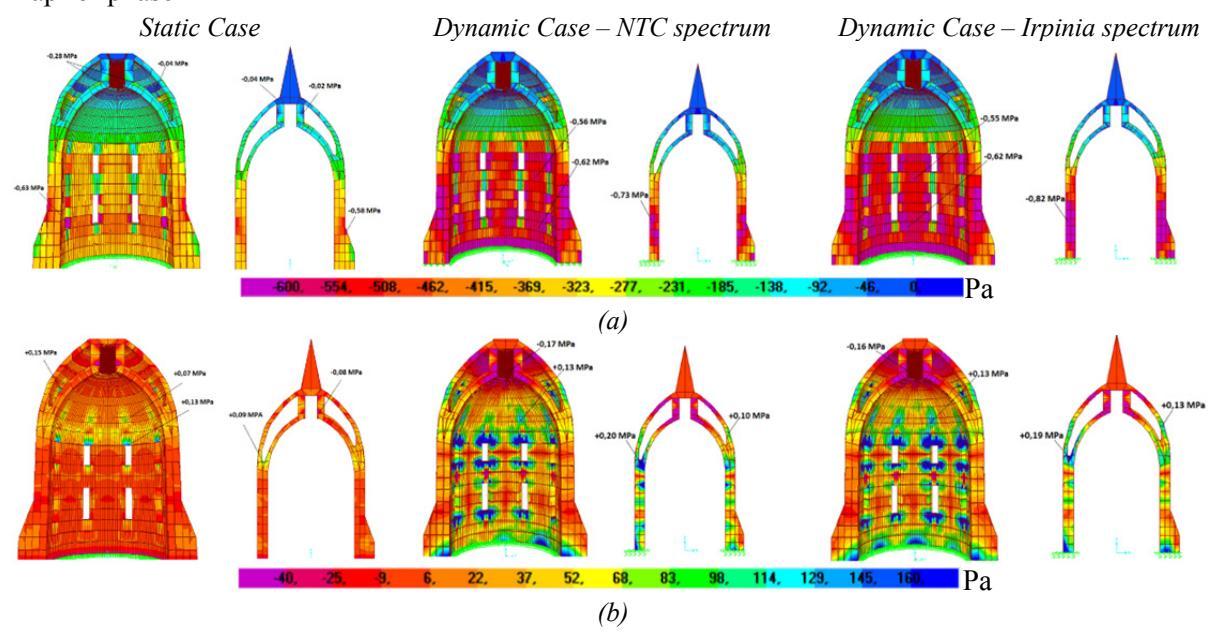
Figure 4.3. Principal stress map of the dome in the Phase III: (a) compressive stresses; (b) tensile stresses.

Figures 4.3a and b report, for the present case, the maps of the compressive and tensile principal stresses, respectively. As it can be seen, a reduction of about 20% is found in principal compressive stresses at the top of the structure due to the significant reduction in the applied load achieved by the substitution of the external lantern from piperno stone to wood.

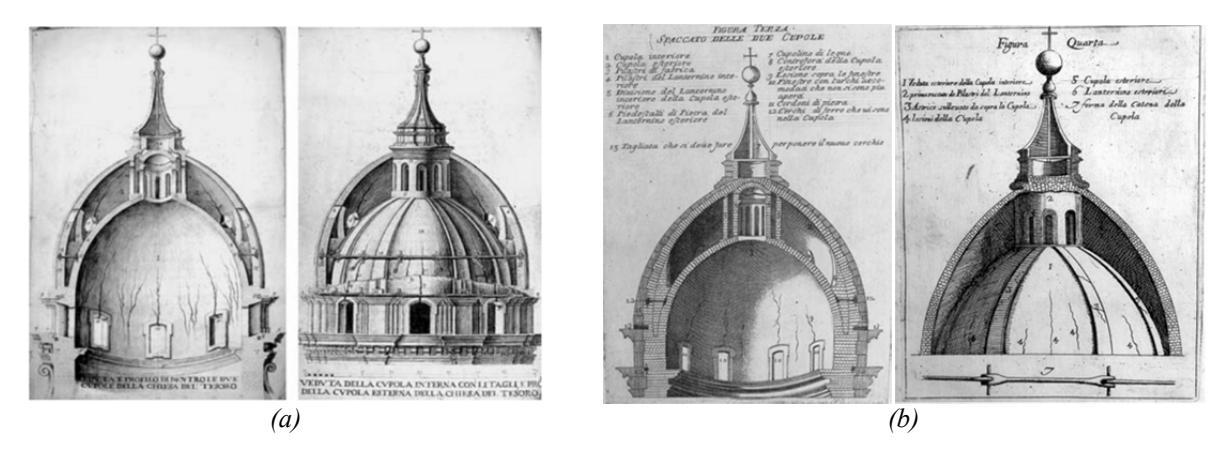
Figure 4.4. The 18<sup>th</sup> century descriptions of the crack pattern made by: (a) Lucchese; (b) Sanfelice.

The careful graphic descriptions of the crack pattern made by Lucchese in 1707 (Figure 4.4a) and Sanfelice in 1708 (Figure 4.4b) are clearly compatible with the peak localizations in the tensile stress map for phase III

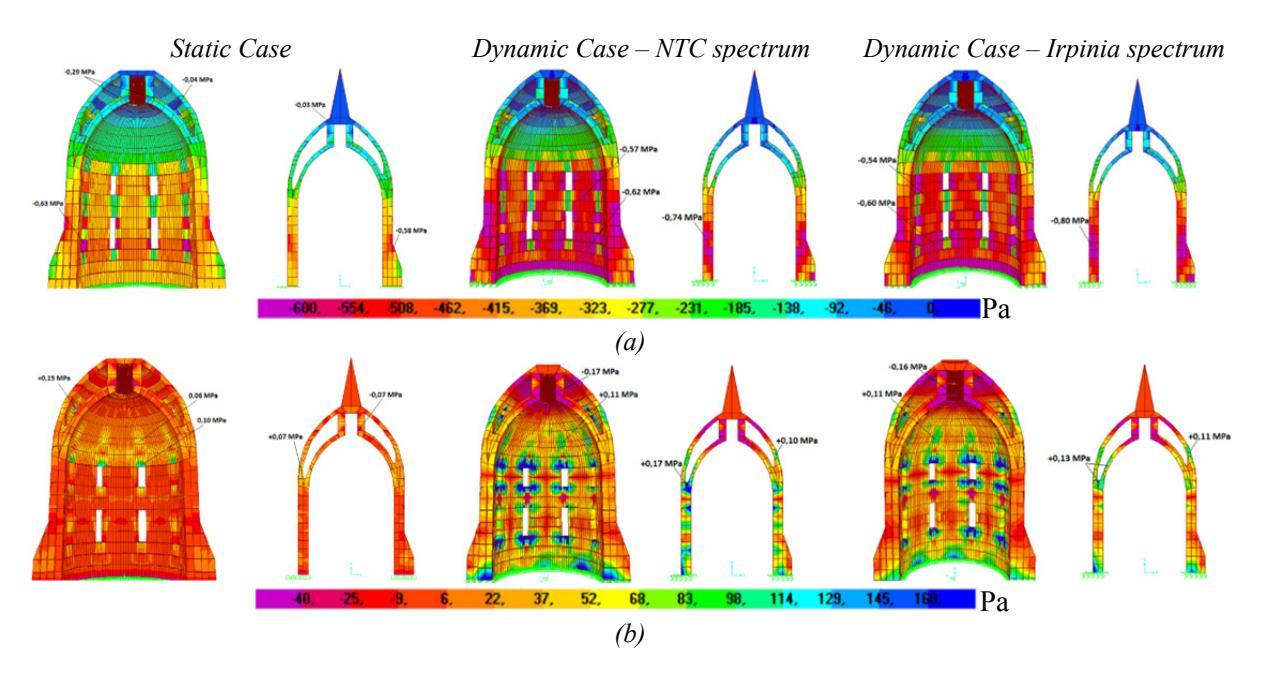
Figure 4.5. Principal stress map of the dome in the Phase IVa: (a) compressive stresses; (b) tensile stresses.

Figures 4.5a and b report, for the present case, the maps of the compressive and tensile principal stresses, respectively. As it can be seen, the third chain close to the first one surmounting the second windows row provides a reduction of the maximum tensile stress of about 10%, but it was never realized. As in the previous cases, no relevant peak compressive stresses were found in the dome.

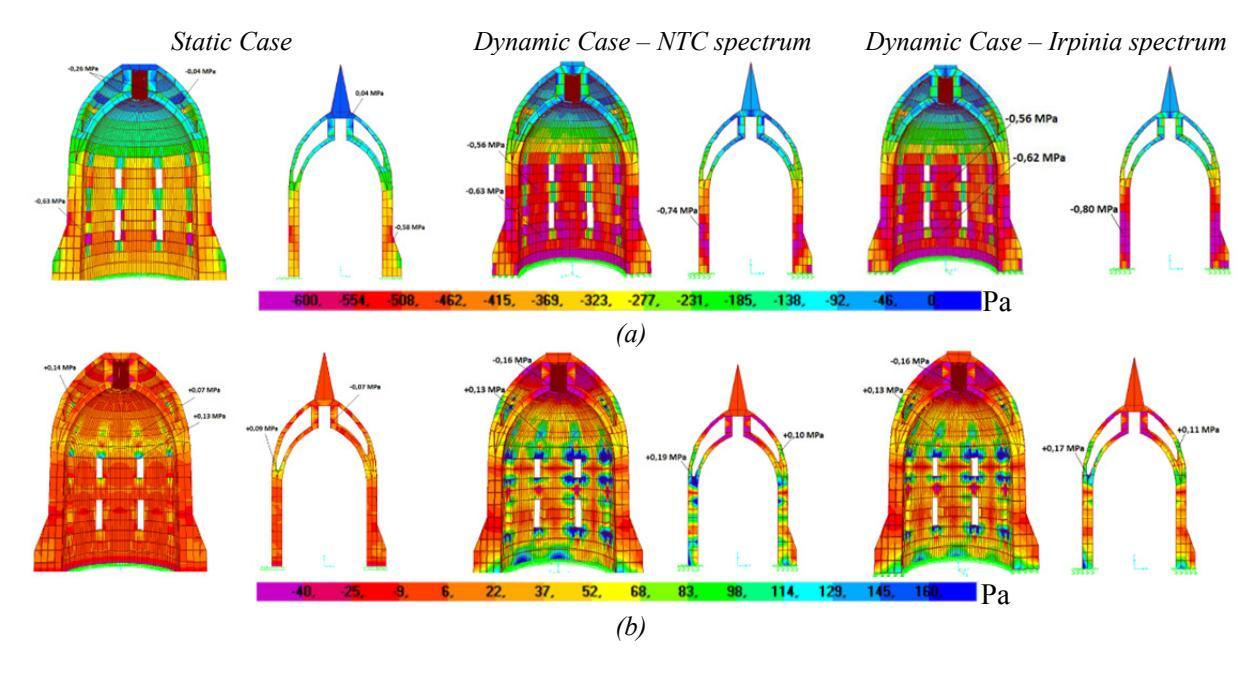
Figure 4.6. Principal stress map of the dome in the Phase IVb: (a) compressive stresses; (b) tensile stresses.

Figures 4.6a and b report, for the present case, the maps of the compressive and tensile principal stresses, respectively. As it can be seen, the reduction of the maximum tensile stress due to the present intervention is smaller than in previous case. As in the previous cases, no relevant peak compressive stresses were found in the dome.

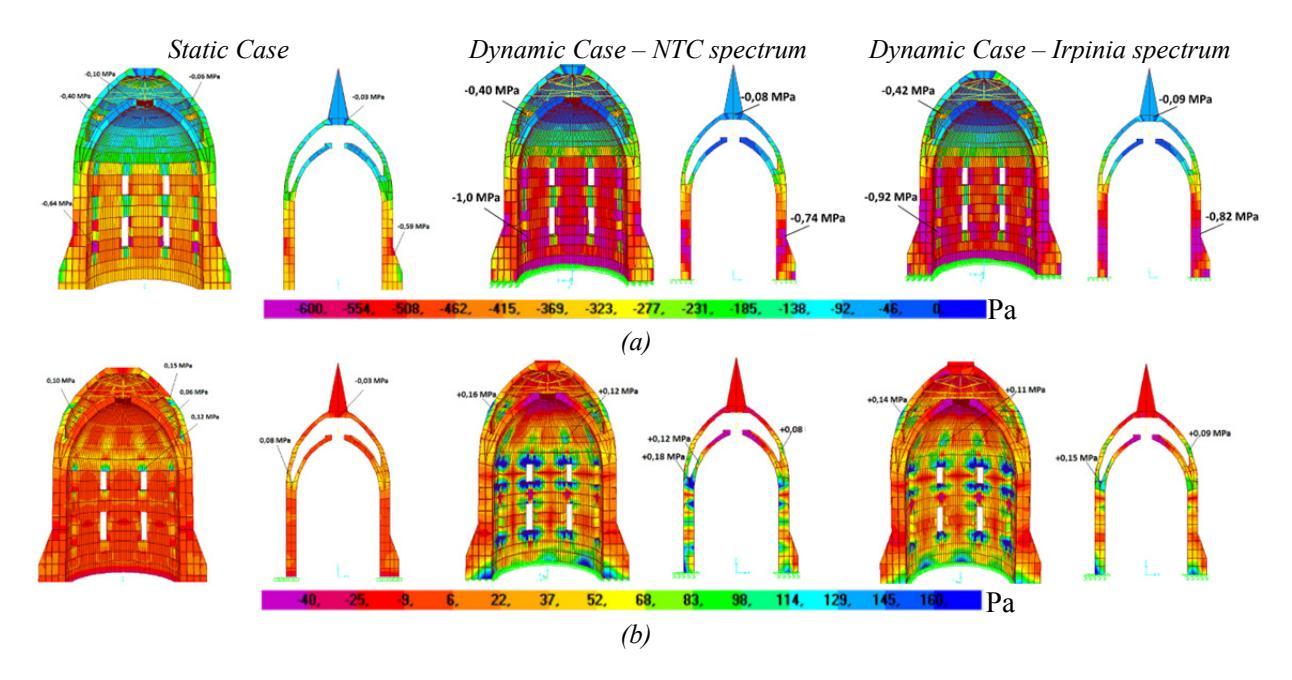
Figure 4.7. Principal stress map of the dome in the Phase V: (a) compressive stresses; (b) tensile stresses.

Figures 4.7a and b report, for the present case, the maps of the compressive and tensile principal stresses, respectively. As it can be seen, the insertion of the timber and iron made truss provides a

reduction of principal tensile and compressive stresses in the inner dome and partially in the outer dome. Although some stress concentrations raised at the supports of timber truss, a favourable reduction of stresses is gained all across the thickness of the walls. However, a weak tensile zone is still present above the second windows row, where a third chain was planned only (phase IVa) in 1707.

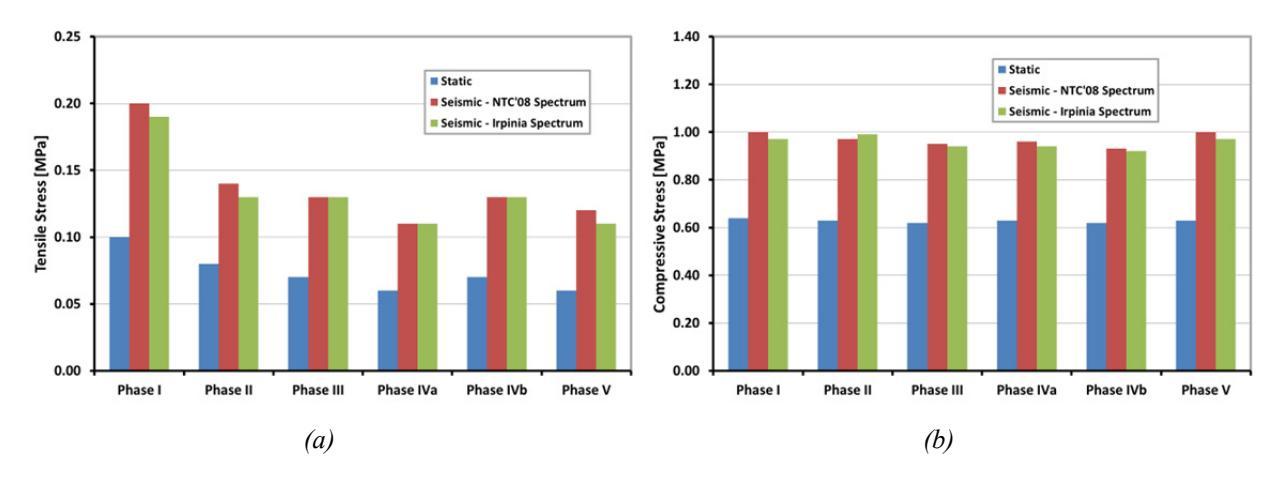
Figure 5.1. Comparison of peak stress value for each phase: (a) tensile stress in the inner vault over the windows; (b) compressive stress at the base of the dome.

Different phases highlight clear differences in terms of tensile stresses, while differences are almost negligible in the case of compressive stresses. Seismic analysis shows also that the stress fields in the dome are very similar for both Irpinia Earthquake and Italian code spectrums.
