Out-of-Plane Cyclic Experimental Testing of Traditional Stone Masonry Walls with Distributed Loads

A. Arêde, F. Garcia, A.A. Costa & C. Quintela *Faculty of Engineering, University of Porto, Portugal*

SUMMARY:

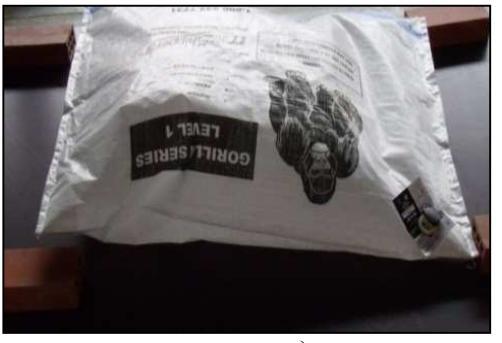
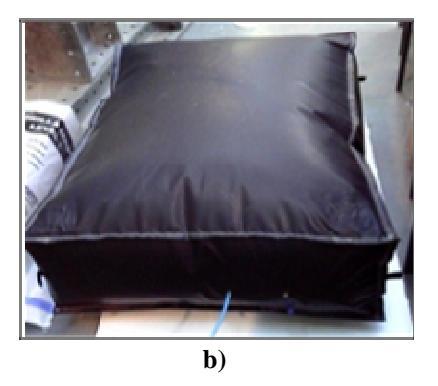
Figure 1. Adopted airbags: a) Gorilla airbags; b) Nylon airbags

In order to solve the referred problems, the "Gorilla" type airbags (Figure 1-a)) were replaced by Nylon airbags (Figure 1-b)). The main differences between the two airbags types refer to the material strength (the Nylon airbag is more robust), to the airbag rectangular shape (with lateral edges) that provides a more regular rectangular geometry of the contact surface and to the larger number of input/output air holes which allow better accuracy in the air pressure control.

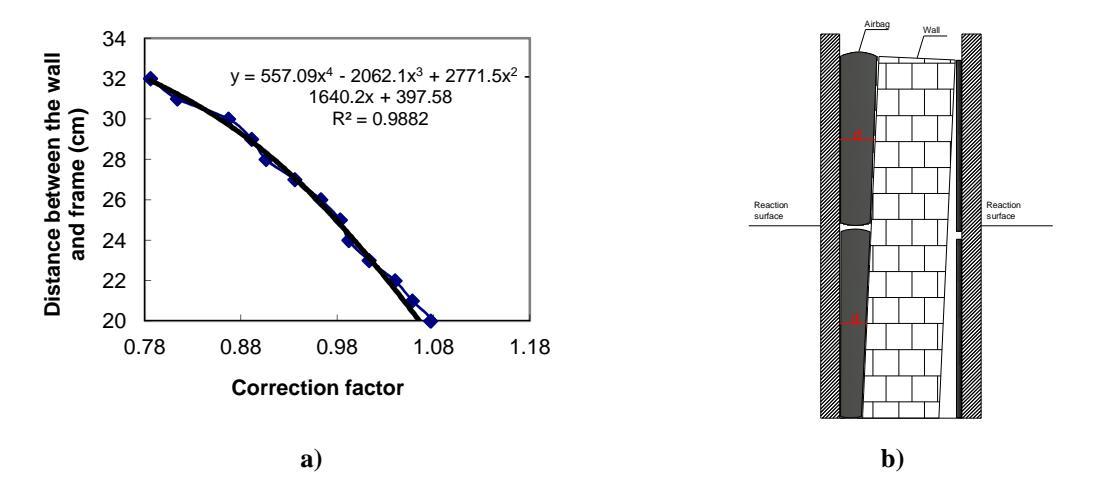
Figure 2. Contact area correction: a) correction factor; b) displaced wall.

A series of laboratory tests were carried out to calibrate the contact area, being found that the area is not constant during the test, since it is directly related to the wall displacement relative to the reaction structure. Figure 2-a shows the correlation of the force correction factor with the displacement of the wall relative to the deflected configuration presented in Figure-b.

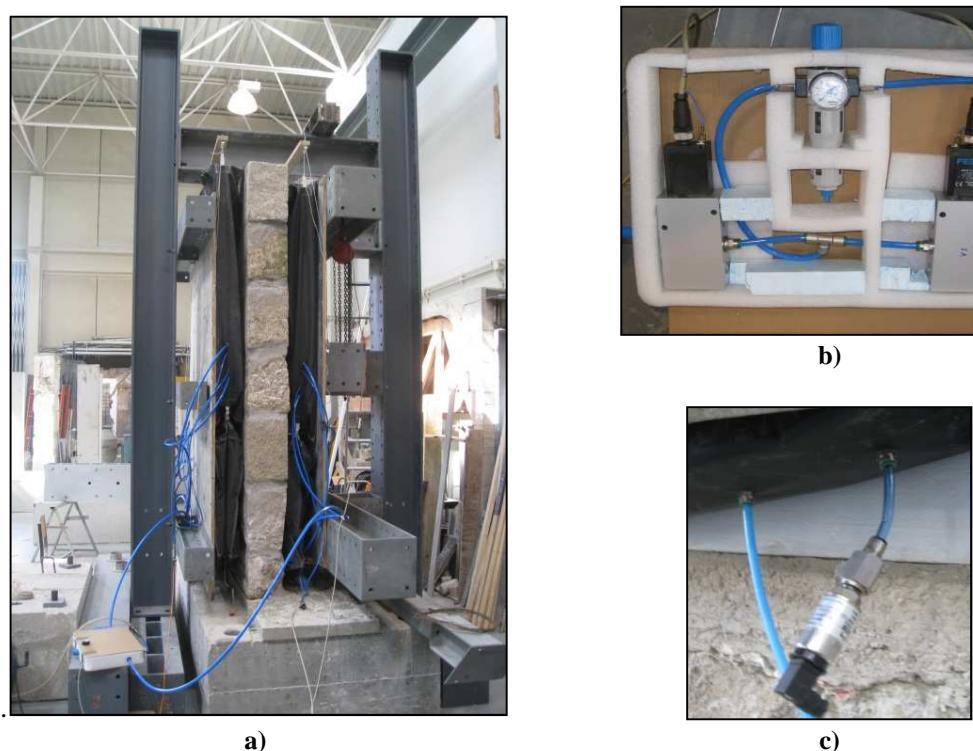
Figure 3. Test setup for software validation: a) test setup; b) electric valves; c) pressure transducer.

In order to check the control and acquisition system, a series of laboratory tests were carried out (Figure 3), in which the in-situ conditions were simulated as real as possible. The acquisition system is composed by an acquisition device (National Instruments hardware), where displacements and pressure sensors are connected to.

The tests carried out allowed to conclude that the data acquisition is satisfactory, pointing that in the initial phase, in which the airbag pressure increases, there is a slight gap between the defined loading law and what is in fact happening; this gap is due to the fact that, in the beginning, the airbag is completely empty, so it needs some time to fill its volume before the pressure monitoring starts.

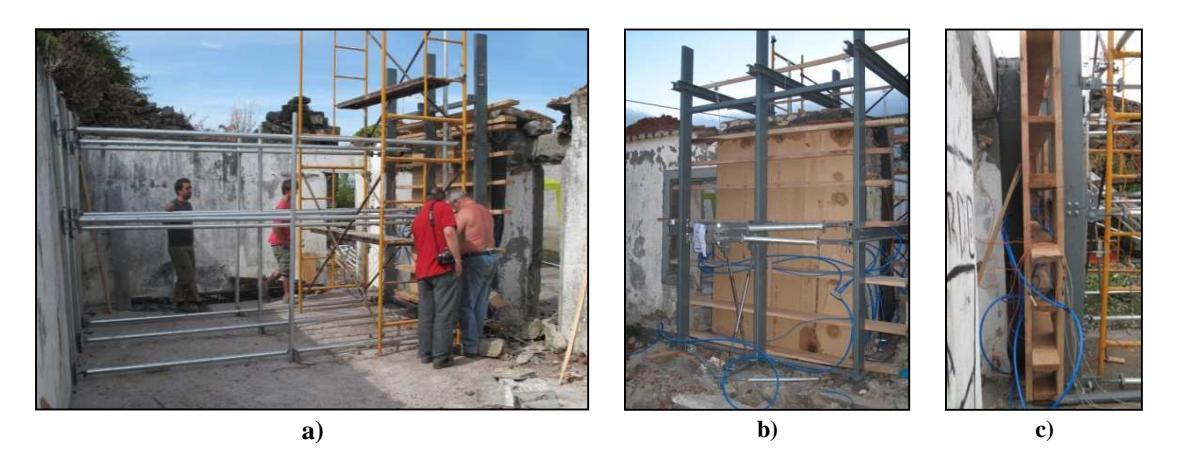
Figure 4. Main test setup: a) general view; b) external view; c) internal view

The defined reaction structure consists of steel elements specially designed for versatile and easy insitu installation. Despite a reasonable global weight of the structure, a group of individual elements was defined weighing less than 30kg each, thus allowing its manual transportation and assemblage without requiring heavy machines. The final solution was a frame structure, approximately symmetric, composed by a significant number of elements of similar type in order to simplify its assemblage. The structure was supported by a set of steel tubes (\emptyset =60mm), connected to the house back wall (parallel to the tested wall). For supporting the airbags, the structure included also timber elements and plywood plates (Figure 4-c)).

Besides the steel and timber structure, the test system included three airbags in each side of the wall, an air compressor, hose (to connect all the necessary devices to apply the pressure), valves to control the input/output air pressure, a pressure reducer, several wire transducers and pressure monitoring duly connected to the data acquisition card, which sends the information to a computer.

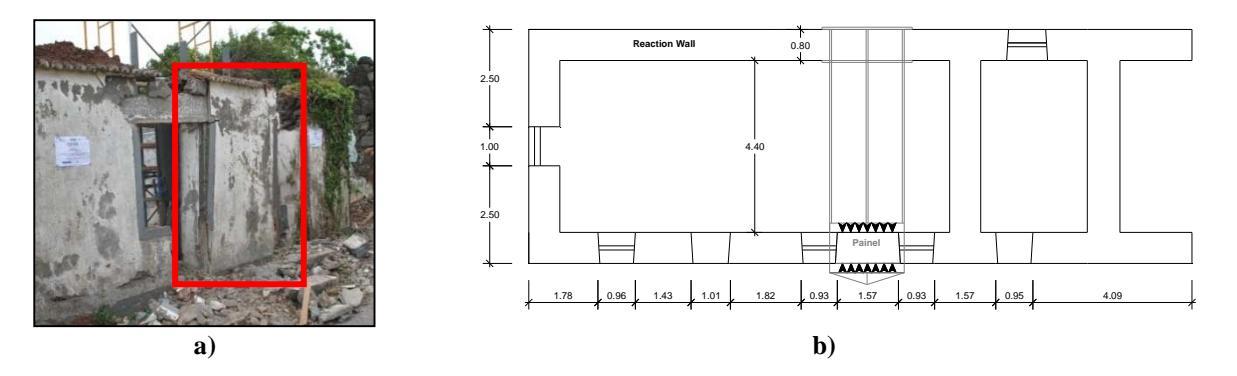
Figure 5. House CN: a) main façade and tested panel; b) plan view and location of the tested panel.

In order to evaluate the out-of-plane behavior of masonry walls, tests were made in two houses namely the "Casa Nove" (CN – Figure 5) and the "Casa do Salão" (S – Figure 6), both with only one floor.

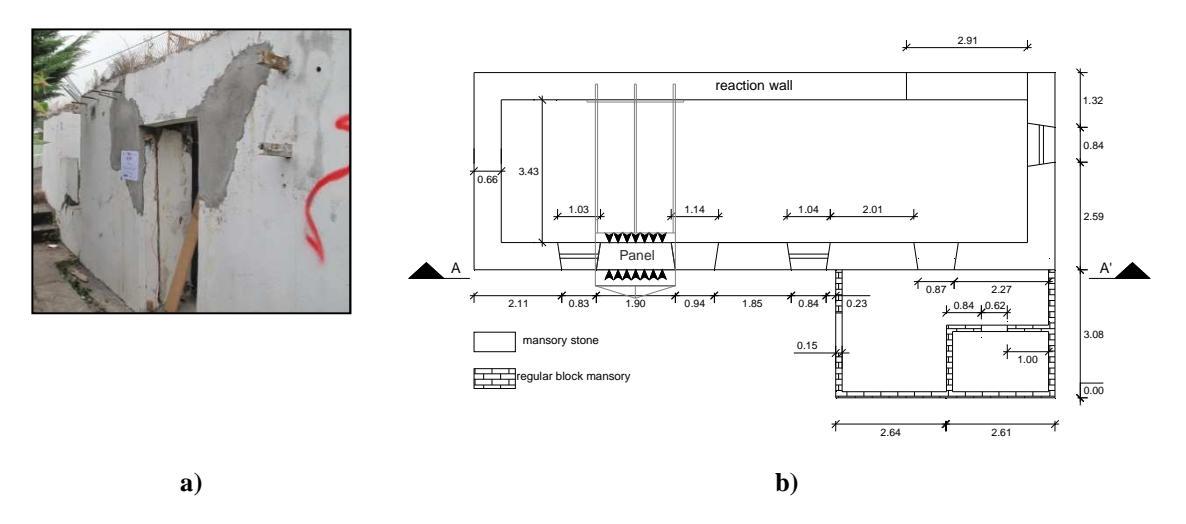
Figure 6. House S: a) main façade; b) plan view and location of the tested panel.

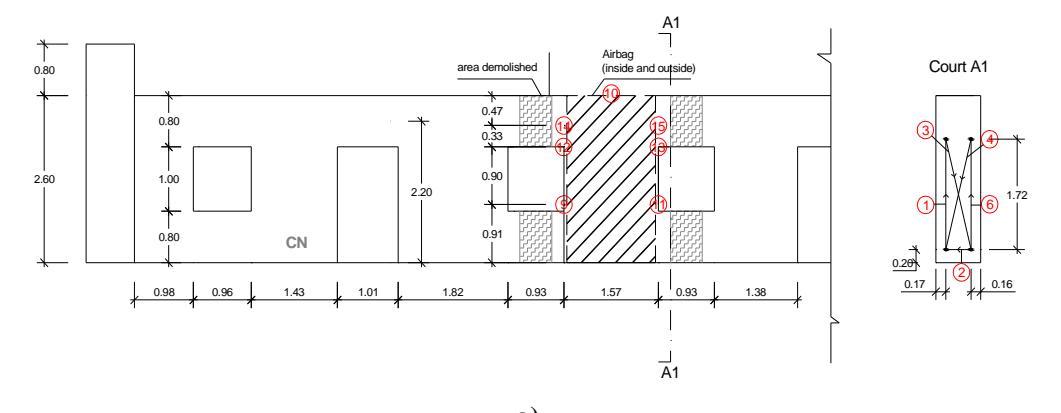
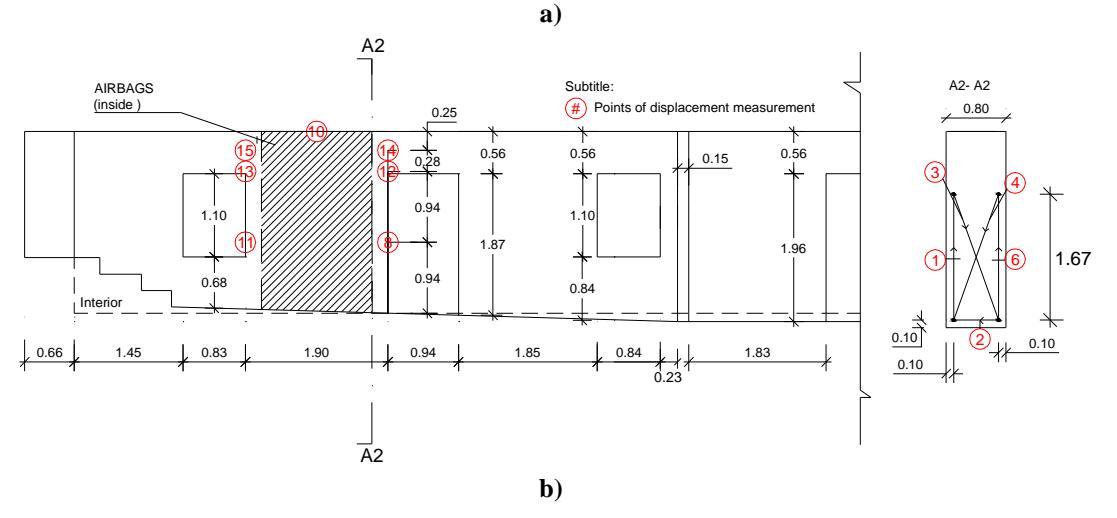
Figure 7. Tested panels and monitoring layout. Main façade and wall section for: a) house CN and b) house S

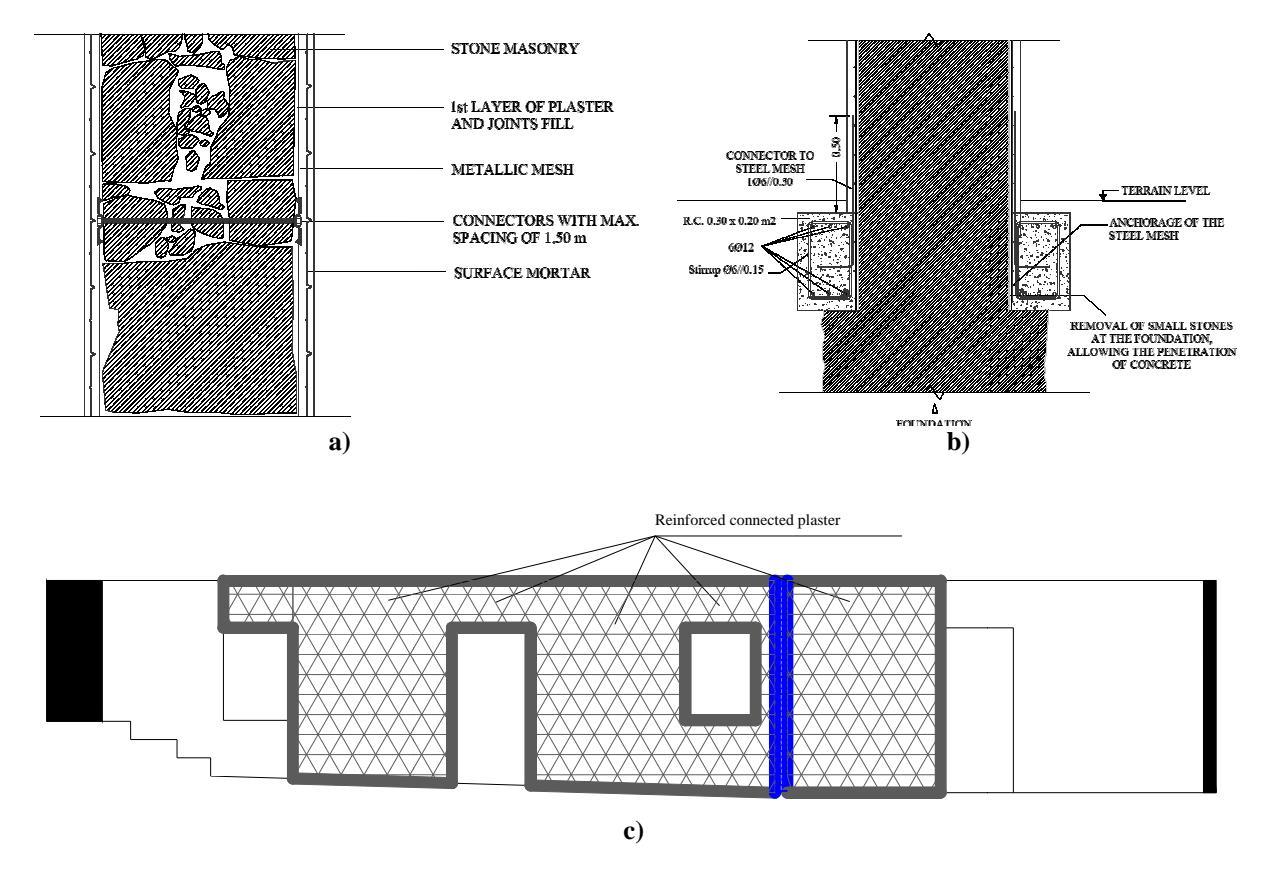
Figure 8. Strengthening solutions and application: a) reinforced connected plaster; b) reinforced concrete beams; c) main façade

However, the structural response to cyclic lateral loading can be further improved by providing appropriate anchorage of the steel mesh at the foundation level, resorting to lintel beams adjacent to each wall side as illustrated in Figure 8 b). This strategy was adopted for the tested panel of house S as herein presented.

Figure 8 c) shows the widespread use of reinforced connected plaster in the main façade of house S, evidencing that, by contrast with the CN house panel, the spandrel beams are likely to influence the response of each wall panel in between openings.

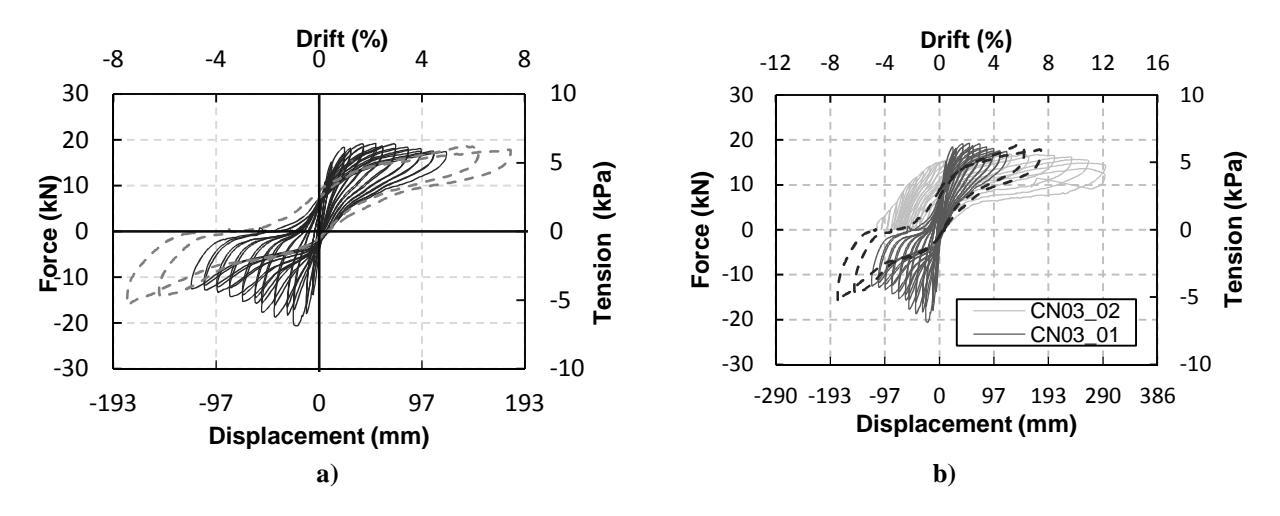
Figure 9. Results of the tests on house CN. a) Test CN03_1: outwards/inwards motion. b) Test CN03_2: inwards motion only (Dashed line refers to meaningless results for the real behaviour).

Figure 9-a) shows the Force vs. Displacement and Stress vs. Drift hysteretic plots of the CN house wall tests (herein denoted as CN03_1) where large displacements were imposed (positive values refer to outwards motion), up to about 180mm, when the test had to be stopped because the setup did not allow larger displacements.

The maximum surface stress reached approximately 6.2 kPa, for about 1% drift, after which progressive strength degradation started taking place up to approximately 4 to 5%. However, from then on, an unexpected strength recovery started developing, that was found to be caused by the wall contact with the reaction structure. Therefore, such results are meaningless for the wall response which is evidenced in the plot by the dashed line, in contrast with the solid line that refers to the valid results (i.e. representing the real behaviour of the wall).

The non-symmetric response exhibited in Figure 9 is caused by different free height of the wall which is larger outside than inside the house due to the internal pavement located about 30cm upper than the external one. Thus, for outwards motion, the panel is more flexible and allows accommodating larger deformations without significant strength loss, resulting in increased ductility for this motion sense. This effect is further justified also by the presence of a good cement mortar cover on the external surface (thicker and stronger than the internal one) and by the larger wall width of that surface.

However, in order to clarify the "final" outwards response, after stopping the CN03_1 test, a second one was made (CN03_2) by pushing the wall only into the outer direction (positive sense), though starting from the previous residual displacement. Plotting the response curves of both tests (Figure 9-b)) it can be seen that the outwards strength degradation is not as intense as for the inwards direction and the overall behaviour shows more ductility than pointed out before.

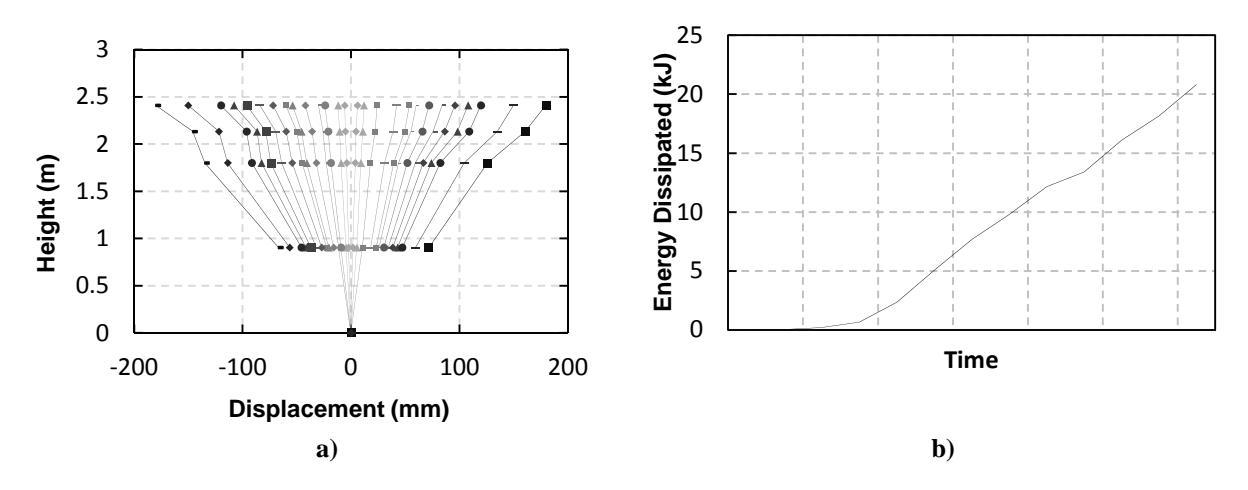
Figure 10. Performance evolution: a) displacement profile; b) energy dissipated

The displacements' profiles along the wall height (Figure 10-a)) allow observing a linear displacement pattern up to 1.75m high. This evolution turns into non-linear from that level up to the top (2.41m high), which can be related with the fact that the upper part of the wall was more deteriorated due to the demolition of the connection between the wall and the window lintel. Figure 10-b) evidences a linear increase of dissipated energy, thus at an approximately constant rate in agreement with the progressive damage observed during the test. The linear trend of both the displacement profiles and the evolution of dissipated energy are consistent with the essentially rocking type response exhibited by the wall panel.

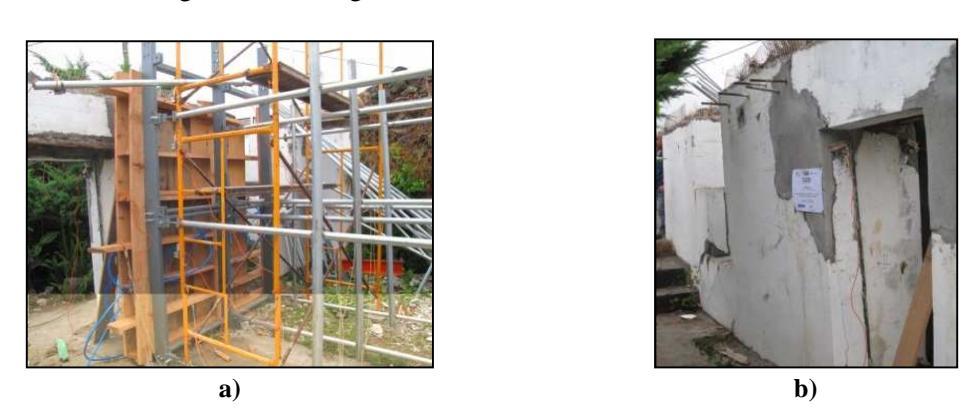
Figure 11. House S, test panel S01R2: a) test setup; b) outside view of the strengthened wall

Concerning the house S, due to in-situ constraints (Figure 11), the test S01R2 was carried out only in outwards direction, on a stone masonry wall panel strengthened with the technique described in 3.4. The free space in the exterior part of the house was reduced and did not allow the installation of one part of the reaction structure, thus preventing the bidirectional test to be accomplished. The obtained results are shown in Figure 12 and Figure 13.

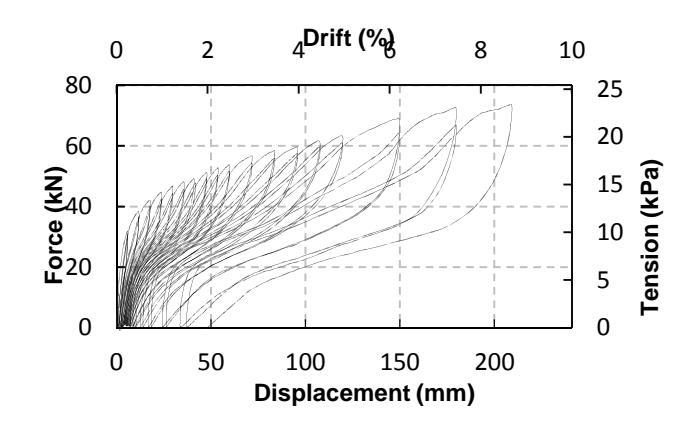
Figure 12. Force-displacement and stress-drift results for panel S01R2 test

Figure 12 evidences the initial phase with linear elastic behaviour, until approximately 4mm top displacement. The second phase shows elasto-plastic response (with increasing plastic displacement) coupled with rocking behaviour until 210mm top displacement. The latter was found to be due to rotation at the foundation level, without significant damage in the wall as a result of the adopted

strengthening technique of wall which behaved as a rigid block. The foundation rotation prevented the test to proceed beyond 210mm because the lintel beams started interacting with the reaction structure, thus affecting the correct test development.

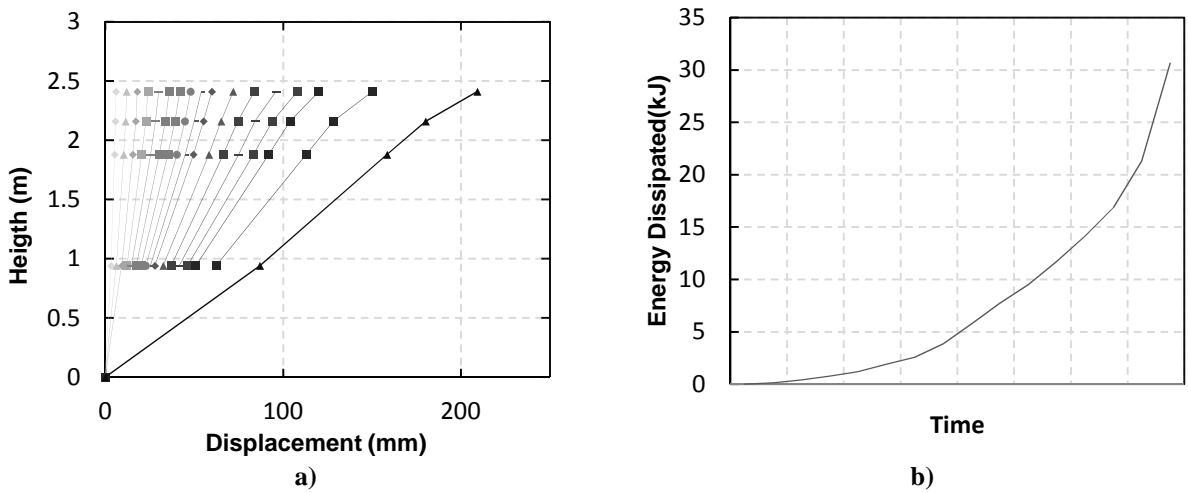
Figure 13. Panel S01R2 behaviour evolution: a) vertical displacement profile; b) energy dissipated

However, it is clear that this strengthening technique provides a very high stiffness when compared to the initial wall stiffness, the same holding true for strength as well. Although some influence might exist due to differences in spandrel beams, both CN and S01R2 wall panels are similar regarding its geometry and material, thus allowing comparing the obtained results, namely in terms of strength for which the S01R2 panel exhibited 3.7 times larger value than the non-strengthened wall (CN). The height wise horizontal displacement profiles for the S01R2 panel test (Figure 13-a)) show slightly curved shapes for the initial stage, turning into more linear like for larger displacements, thus in

curved shapes for the initial stage, turning into more linear like for larger displacements, thus in agreement with the rocking response. However, the energy dissipation (Figure 13-b)) developed exponentially, evidencing that almost 1/3 of the total energy was dissipated in the first half of the test, whilst the remaining 2/3 of energy was dissipated afterwards.
