# Integrated Design for Achieving Building Seismic Resilience

**A. Liu**

*BRANZ, New Zealand*

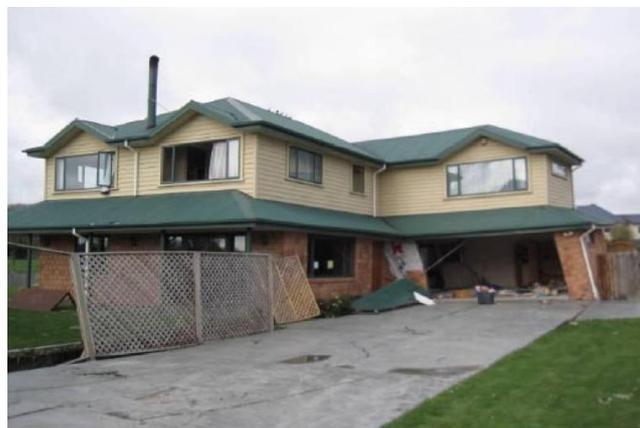
Figure 1 shows the observed damage for a modern residential house with concrete ground slab during Feb 2011 Earthquake. The inadequate design for the structural integrity at ground level has caused the extensive damage of the house.

Figure 1. Loss of Integrity at Ground level due to Big Cracks in Concrete Slab

Should the ground slab foundation structure have been properly constructed, the houses probably have performed as base-isolated structures and the damage levels could be significantly less. A base-isolated structure always requires robust diaphragm action above the isolated plane.
