Seismic Risk Management in Areas of High Seismic Hazard and Poor Accessibility

Alpa Sheth

V. Thiruppugazh

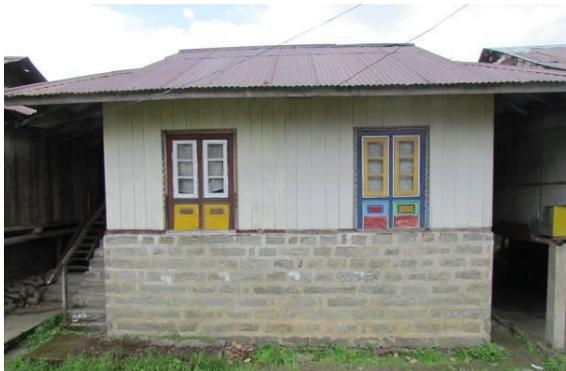
Figure 1. Shee Khim House after 2011 Sikkim earthquake

Many historically seismic regions traditionally have earthquake resistant features inbuilt in their vernacular architecture and design. In Sikkim for example, the traditional construction is popularly called Ekra; it comprises of a wooded frame with cross-woven wood matting (originally made from Ekra grass, hence the name) infill wall panels, and a light roof. The matting is plastered on both sides with mud or mud with sand, and more recently by cement mortar. Another variation is the use of wood planks – Shee Khim. This is more expensive and not as common. The homes rest on a masonry plinth (made of stone and mud mortar), and when made along hill slopes, rest on a tapered stone plinth. During the earthquake, both these typologies have performed exceptionally well, except for some distress in the stone masonry plinths in some cases or when traditional methods were tampered with such as where the cross-woven wood traditional matting was replaced by clay-brick masonry in cement mortar. The highly satisfactory performance of this typology of housing validates the appropriateness of this typology in the Himalayan region and makes a compelling case for its sustenance. The notification by Government of Sikkim of this typology as “informal” (as against formal housing) is unfortunate and makes this typology unqualified for any government subsidies. Most of the traditional houses in the capital city of Gangtok have been replaced by non-engineered reinforced concrete building. Almost all buildings that suffered serious damage in the earthquake were of reinforced concrete construction. Fortunately, homes in the remote villages are still built in the traditional way (Ekra or Shee Khim) but with growing restrictions on use of wood and a tacit discouragement by the State for such traditional construction, it is feared that the traditional earthquake resistant homes will be replaced by unsafe RC homes. A change in the mindset of the stakeholders is urgently required to reverse the situation.

But there are clearly some extremely effective earthquake resistant traditional systems which need a strong boost for their renewal as sustainable building practices. The Ekra and Shee Khim in Sikkim, the Dhajji Deewari and Taq constructions in Kashmir and the Bhungas in Kutch are some such earthquake resistant traditional systems.

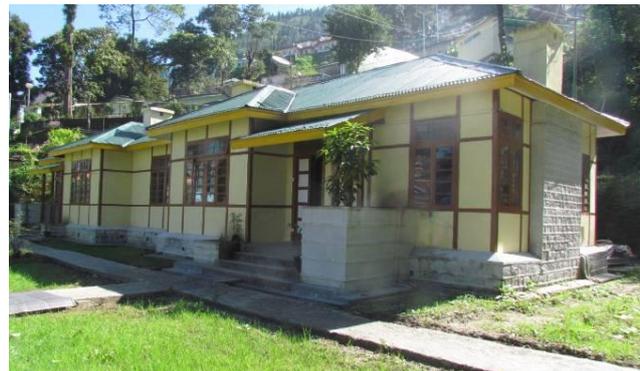
Figure2. Ekra House after Sikkim earthquake

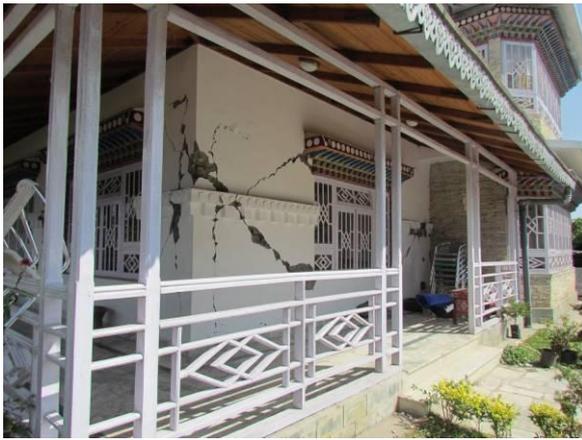
Figure 3. Newly built non-engineered RC house in Sikkim Earthquake 2011

However with the onset of “development” and growing aspirations of the people coupled with a general belief that reinforced concrete (RC) frame homes are stronger and desirable as markers of prosperity, the vocabulary of construction across the rural regions in India has changed to non-engineered reinforced concrete construction, even though it is fairly established in successive earthquakes that un-designed RC homes are perhaps the most vulnerable typology in an earthquake.

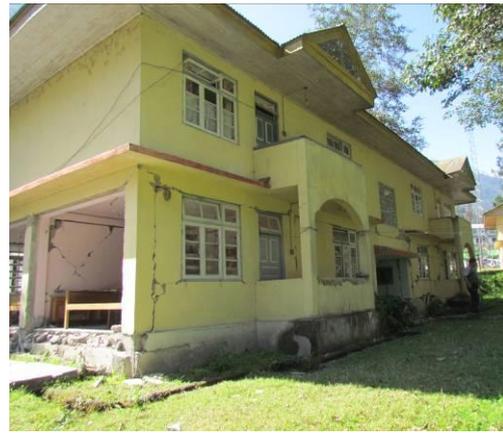
Figure 4. Government RC house after Sikkim Earthquake 2011 – Out of plane infill collapse, and column failure

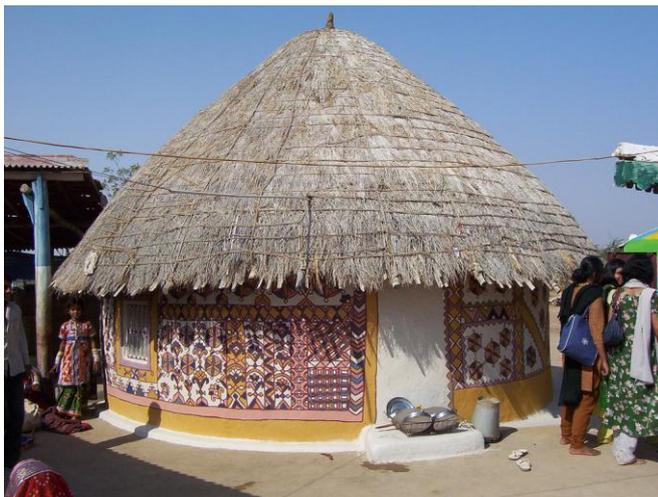
Figure 5. A Bhunga in Kutch

In Kutch, before the arrival of the ubiquitous reinforced concrete, a large number of houses, especially in the Banni region were Bhungas. The Bhunga is circular in plan and has an eaves height of about 1.8 meters with a sloping thatch roof. The walls may be of various types but the wattle and daub was the most earthquake resistant. Multiple bhungas may be built in clusters in a compound as living and sleeping quarters. No Bhunga was destroyed in the 2001 Bhuj earthquake.

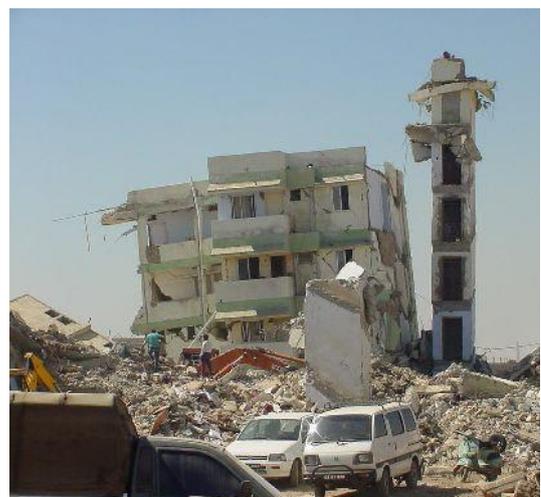
Figure 6. Behaviour of poorly-engineered RC Building in Bhuj 2001 earthquake

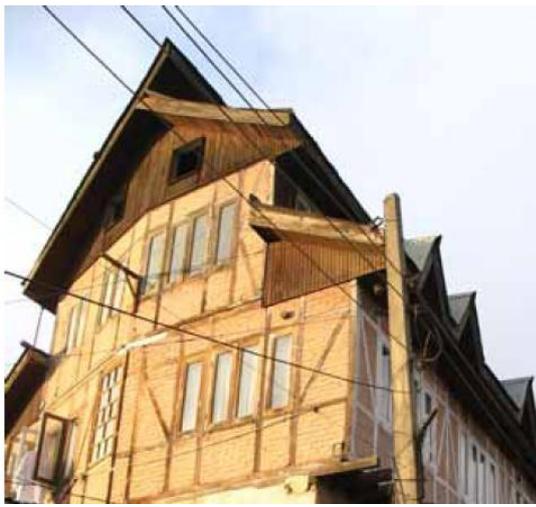
Figure 7. Dhajji Deewari in Kashmir (Rai, Murty)

A popular traditional construction method in Kashmir is the Dhajji dewari. This is a timber –lattice masonry, i.e, bricks filled in a framework of timber. This results in confined masonry that displayed excellent performance in the 2005 earthquake, showing no or very little damage. No collapse was observed for such masonry even in areas of higher shaking. Progressive destruction of the walls was arrested by timber studs which subdivided the wall and prevented diagonal (shear) cracking of the wall as also out-of plane failure. Dhajji-dewari system is very light and sometimes used for the upper floor even when the lower floor may be of brick masonry. A variation of Dhajji is the use of stone pieces in lieu of brick between the wooden framework. Another traditional building system in Kashmir is Taq in which large pieces of wood are used as horizontal runners embedded in the heavy masonry walls, which add to the lateral load resisting ability of the structure.

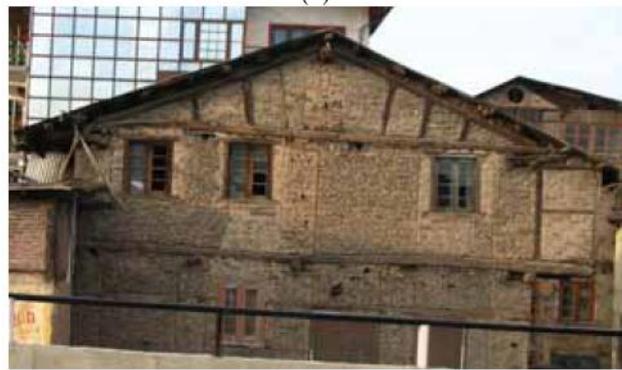
Figure 8. Taq Construction in Kashmir (Rai, Murty)

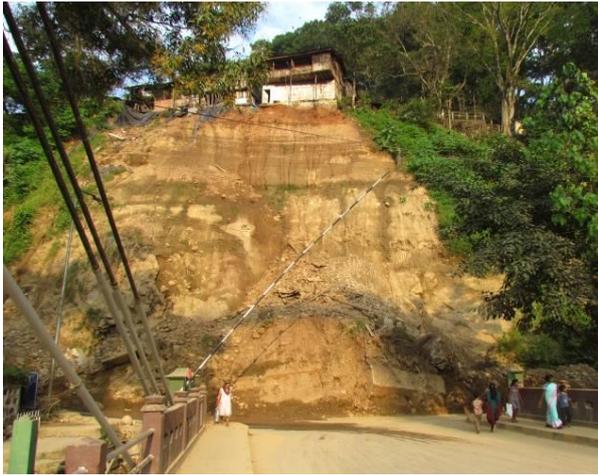
Figure 9. Landslide in Sikkim Earthquake 2011

While landslide activity is largely a product of the geological features of the topography and rock formations of the region, poor application of engineering skills in development of roads in this region cannot be discounted as one of the main culprits for the ensuing challenges in relief and rescue in the aftermath of an earthquake.. Cuts on mountain slopes for roads should be native cuts for the full width of the roads, rather than on fill soils with retaining walls to ensure stability. However, quite the reverse was observed in Sikkim. Poor drainage system to inner edges of the cuts also causes erosion leading to vulnerability to landslides. Engineering expertise and good construction techniques are found wanting. Typically, ad-hoc and trial-and error methods are employed, and important detailing of the roads, drainage and mountain cuts is left to the wisdom of the local supervisor, compromising safety of the build. Oftentimes, specific geological data and support from structural geologists is not sought for assessing slope stability.

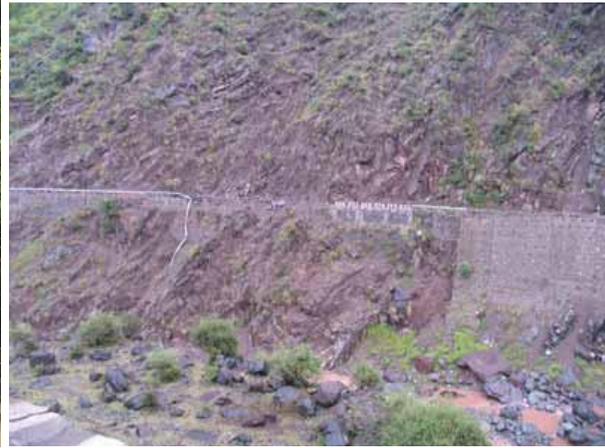
Figure 10. Landslide in Kashmir Earthquake 2005
(Rai, Murty)
