## SEISMIC RETROFIT PROGRAM FOR TAIWAN SCHOOL BUILDINGS AFTER 1999 CHI-CHI EARTHQUAKE

Keh-Chyuan Tsai<sup>1</sup> and Shyh-Jiann Hwang<sup>2</sup>

### ABSTRACT :

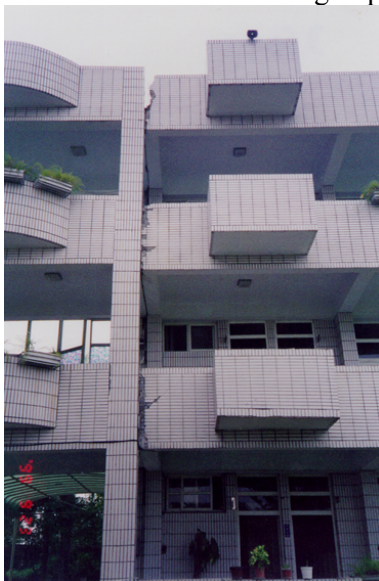
Figure 1 Ponding damage due to insufficient seismic gap

In Taiwan, a large number of old buildings in elementary and secondary schools appear lacking of an integral planning in advance. In stead, many old school buildings have been constructed and later on expanded in a patchy way. It was due to the population growth in the school district and the rising of multifarious branches of teaching, the number of existing classrooms was no longer enough. Hence the school authorities had strived for funding from year to year. When the budget allowed, new classrooms were added to the existing ones in the horizontal or vertical directions at different times in order to solve the problems of under-supply of classrooms. If the new classrooms were added horizontally, the structural system of the old school building could be spoiled. If the new classrooms were built on top of the old ones, seismic and gravity load demands on the old classrooms would be significantly increased. The new classrooms expanded in the horizontal direction are rather closely adjacent, if it is not connected, to the old ones so as to maintain the continuity of activity space for pupils and teachers. Having constructed at different times, the old and the new classrooms could be different in height, weight or stiffness. Thus, the two structures may possess different fundamental vibration periods. When an earthquake occurred, the old and new classrooms would vibrate not in-phase. Under this circumstance, if the adjacent seismic gaps were not wide enough, those classrooms could have pounded each other (Figure 1). The pounding could cause the complete failure and collapse of columns in the adjacent building.

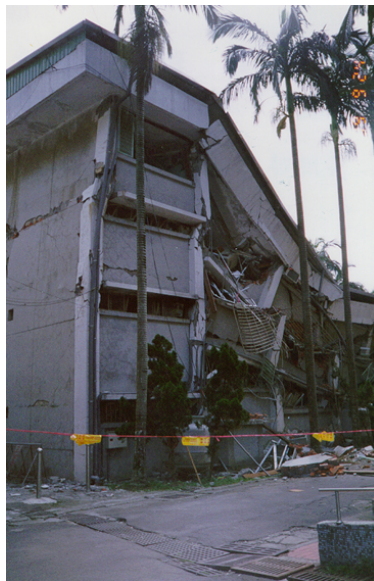
Figure 2 Earthquake damage due to vertical building expansion

The seismic force of each floor is in direct proportion to its floor weight and acceleration. The seismic shear force undertaken by the old classrooms would be the sum of inertia force of each floors of the entire school building. Building new classroom over the old ones would increase the story shear force and the overturning moment, result in the collapse of the entire structure during a severe earthquake (Figure 2).

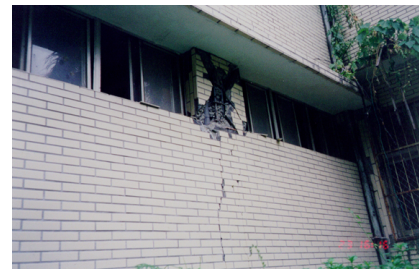
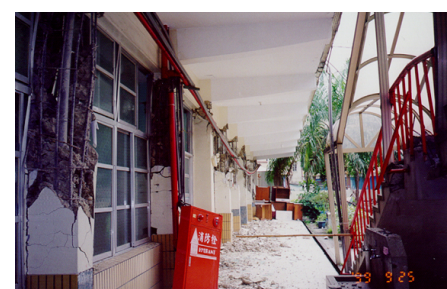
Figure 3 Short column damage

In order to gain lighting and ventilation, the two exterior side of the classrooms have been built with windows and doors. At the upper portion of the columns, it is often constrained by concrete or brick lintel above the window. At the lower portion of the columns, it is typically constrained by the noted infill below the windowsill. Thus, the effective length of the column has been significantly shortened. During a earthquake, the shear demand on the shortened column is therefore greatly increased. Unfortunately, these columns have been constructed with poor concrete and without sufficient shear reinforcement. Consequently, the columns have been found frequently failed in the shear mode, with X-shape cracks commonly observed (Figure 3). As a matter of fact, if a seismic gap had been cut between the column and the infill, the effective length of the column would not be shortened. In this manner, a more desirable flexural failure mode could be achieved. The seismic gap could be filled with compressible but watertight material.
