GEO-TECHNICAL STUDIES, KINNAUR EARTHQUAKE, 19TH JANUARY 1975.

by
B.M. Hukku^I and A.K. Srivastava^{II}

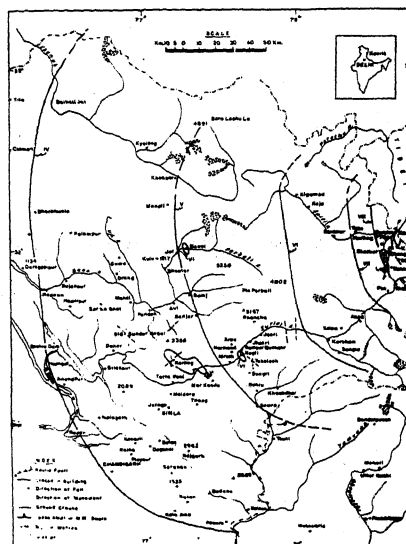
FIG. 1 ISOSEISMAL MAP OF KINNAUR EARTHQUAKE, 19TH JANUARY, 1975.

During the earthquake maximum damage had occurred in lower Spiti and Pare-Chu valleys affecting Leo, Chango, Shalkar, Sumdo and Kaurik villages. Wide open cracks in the ground were recorded parallel/sub-parallel to Kaurik fault in the region of epicentral tract falling in intensity X M.M. Scale (Fig. I). Large landslides occurred in intensity VII and above. The quantity of additional silt likely to be contributed by the landslides in the Sutlej river catchment and deposited in Dhakra reservoir in next few years is estimated to be 4.5 million cu. m. Upstream of Sumdo, the large reservoir with high hydro-static head formed over the hot spring area by the landslide dam across Pare-Chu river was reported to have turned fairly warm. Increase in temperature and discharge of hot spring was also reported at Sakina. These features are considered to be surface manifestation of magmatic activity in depth.
