# Response of Historic Masonry Structures to Tectonic Ground Displacements

The response of historic masonry buildings subjected to tectonically induced ground distress is studied through analysis of a simple yet representative soil–foundation–masonry wall system. A hybrid methodology is adopted to rigorously account for the multiple response nonlinearities, combining a validated 3D FE model for simulation of fault rupture–soil–foundation – structure interaction with a well-established nonlinear macro-element model for simulation of the response of masonry panels. It comprises two steps: (a) calculation of the foundation displacements due to interaction with the fault rupture assuming elastic superstructure response, and (b) analysis of the nonlinear response of the masonry wall subjected to the foundation displacements of the first step, to predict its consequent damage. Following a sensitivity analysis of the effect of the exact location of the structure with respect to the fault, the paper discusses several characteristic mechanisms of response to reverse fault rupture and assesses the associated masonry damage.

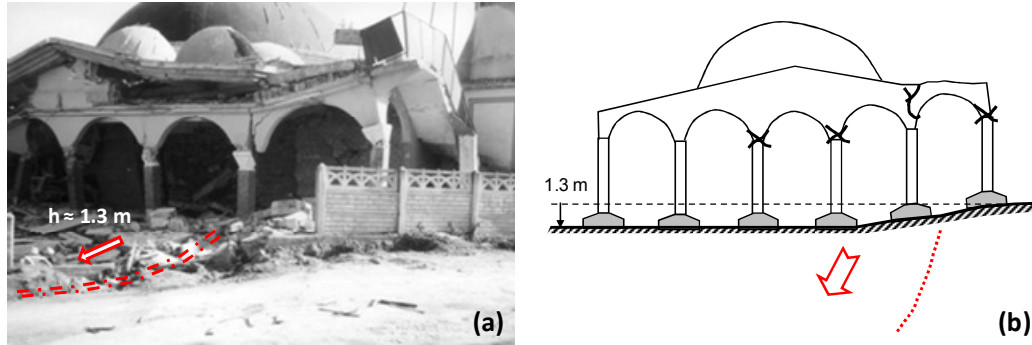
**Figure 1.** Mosque collapse in Denizli (Turkey) due to permanent tectonic deformation of the soil surface: (a) photograph of the Mosque showing the differential settlement of the un-scarped ground surface and the distress of its superstructure, and (b) sketch of plausible failure mechanism [Anastasopoulos & Gazetas, 2007].

Although the response of historic structures subjected to tectonic loads has not been explicitly addressed in the literature, it is evident that, as well as most other structure types, monuments can be particularly susceptible to such permanent ground deformations. **Figure 1a** shows the only, to the authors' knowledge, documented failure of a monument due to interaction with a rupturing fault. This took place in Denizevler (Turkey), when during the Kocaeli 1999 earthquake the causative fault outcropped and the surface rupture crossed the mosque depicted in the figure. Anastasopoulos & Gazetas [2007] interpreted the failure of the mosque anticipating the fault–soil–structure interaction mechanism shown in the schematic of **Figure 1b**.

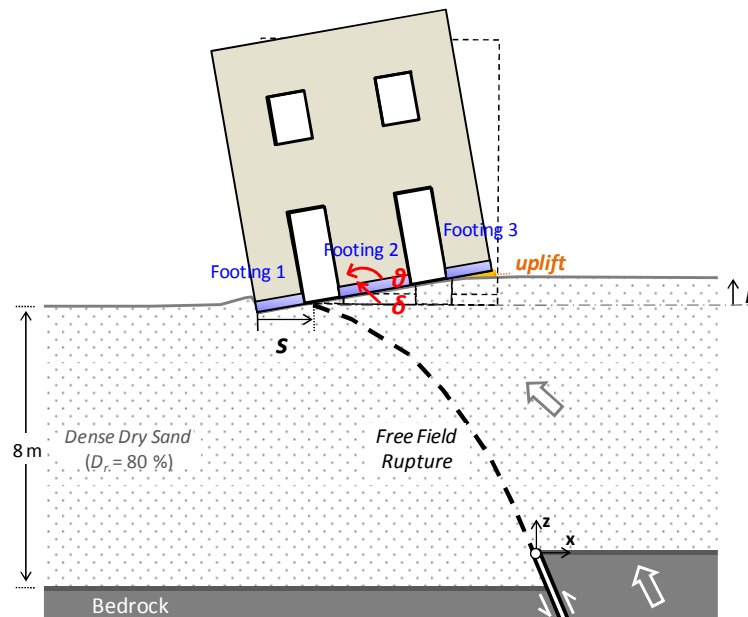
**Figure 2.** Definition of the studied problem: geometry and key parameters.

**Figure 2** defines schematically the geometry of the studied problem. A very simplified, yet representative, single wall structure model is herein employed to study the vulnerability of old masonry buildings under permanent ground displacements due to interaction with a reverse fault rupture. Its geometry is inspired by the well known "Door-Wall" used in the large scale experiments reported by Magenes et al. [1995]. The structure is made of unreinforced masonry, consisting of solid fired-clay bricks and mixed hydraulic mortar, representing typical old urban construction in many European cities. It carries the dead weight of two floors (248.4 kN and 236.8 kN) through three shear wall elements, which are supported by isolated footings (Footings 1-3).

The masonry structure is founded upon an 8 m deep layer of dense dry sand and tectonic displacement of vertical throw  $h$  is imposed at the underlying bedrock. For the case of thrust faulting, which is investigated herein, the displaced block (hanging-wall) moves upwards. If the structure did not exist (i.e., in free-field conditions), fault deformation would localize upon a rupture plane as indicated by the dashed line. The presence of the structure, however, is expected to more or less modify the rupture path. As a result, the foundation–structure system is bound to experience some permanent displacements ( $\delta$ ,  $\theta$ ). Past studies on the interaction foundation–structure systems with dip-slip fault ruptures suggest that the exact response would significantly depend on the position of the structure with respect to the fault. This parameter is here quantified by distance  $s$ , which is the horizontal distance between the left (footwall-side) corner of the structure and the point where the free field rupture plane would cross the foundation level.

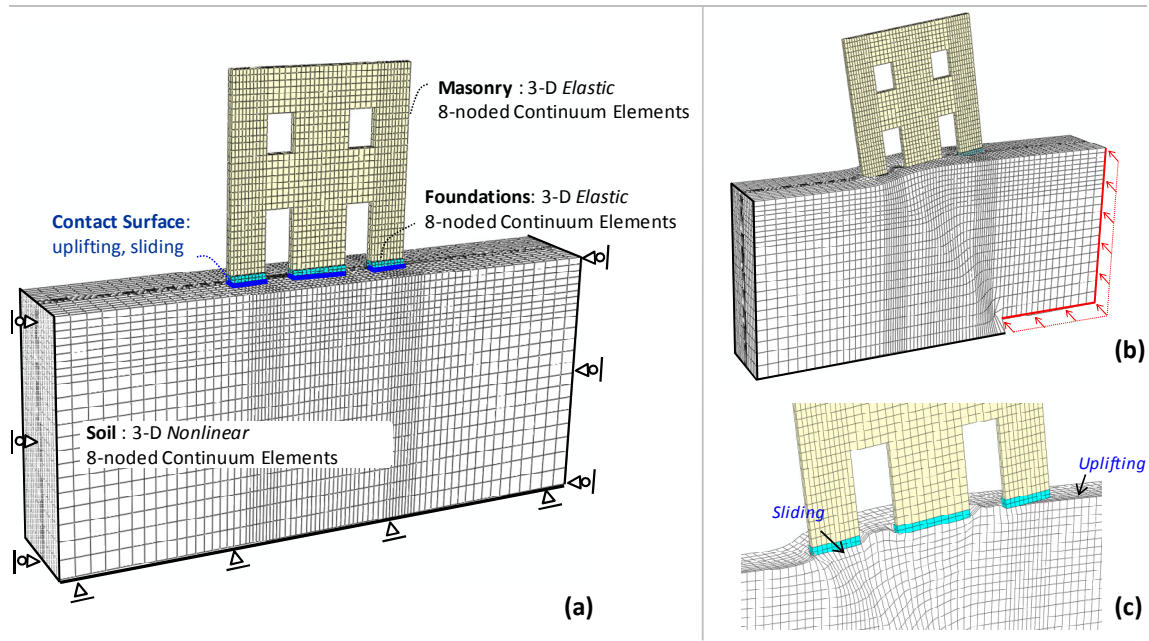
**Figure 3.** 3D FE mesh indicating material and surface contact modelling details and boundary conditions.

Former studies have shown that the finite element (FE) method can quite accurately simulate the phenomenon of fault rupture propagation in the free field [e.g., Bray et al., 1994; Anastasopoulos et al., 2007] as well as its interaction with foundations [e.g., Anastasopoulos et al., 2009; Loli et al., 2011]. 3D FE modelling is required to realistically simulate the problem considered herein mainly due to the importance of footing shape effects. The FE code ABAQUS was utilized for this purpose and **Figure 3** depicts the adequately discretized FE mesh used in the analyses, also indicating the main modelling features and mesh characteristics.

Loading was applied through consecutive steps: (i) geostatic stress; (ii) static load of the structure; and (iii) incremental fault displacement. During the first two steps the model boundaries were restrained according to the conditions illustrated in **Figure 3a**. Boundary conditions were then modified, so as to apply the fault displacement of the bedrock, moving the hanging wall side up-left with a dip angle of  $60^\circ$  (**Figure 3b**). It should be noted that the numerical analysis included a sensitivity study of the effect of the exact structure position with respect to the fault, by parametrically varying parameter  $s$ , aiming at enveloping all the possible mechanisms of interaction. Moreover, as shown in **Figure 3c**, soil–foundation interface behaviour was found to greatly influence the response and was therefore realistically modelled, using a suitable interface allowing for sliding (with friction coefficient  $\mu = 0.5$  to account for the rather rough interface between masonry and soil) and detachment (loss of contact at zero pressure).

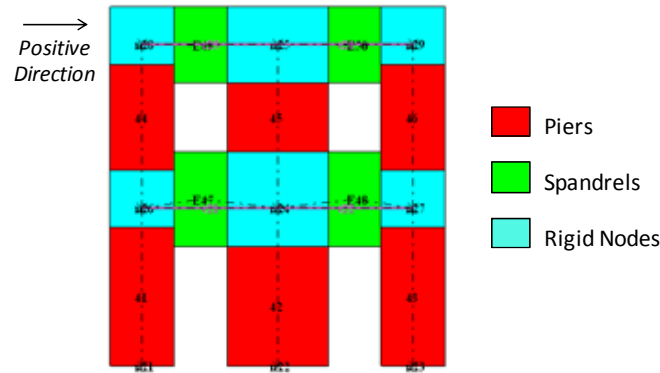
**Figure 4.** Equivalent frame idealisation of the masonry wall.

The wall is discretized in a set of masonry panels connected by rigid nodes (**Figure 4**). The panels, which are deformable and undergo damage, are classified into two main types, the piers (the principal bearing elements carrying dead and seismic loads) and the spandrels (secondary horizontal elements providing coupling between the piers), which are connected with rigid elements.

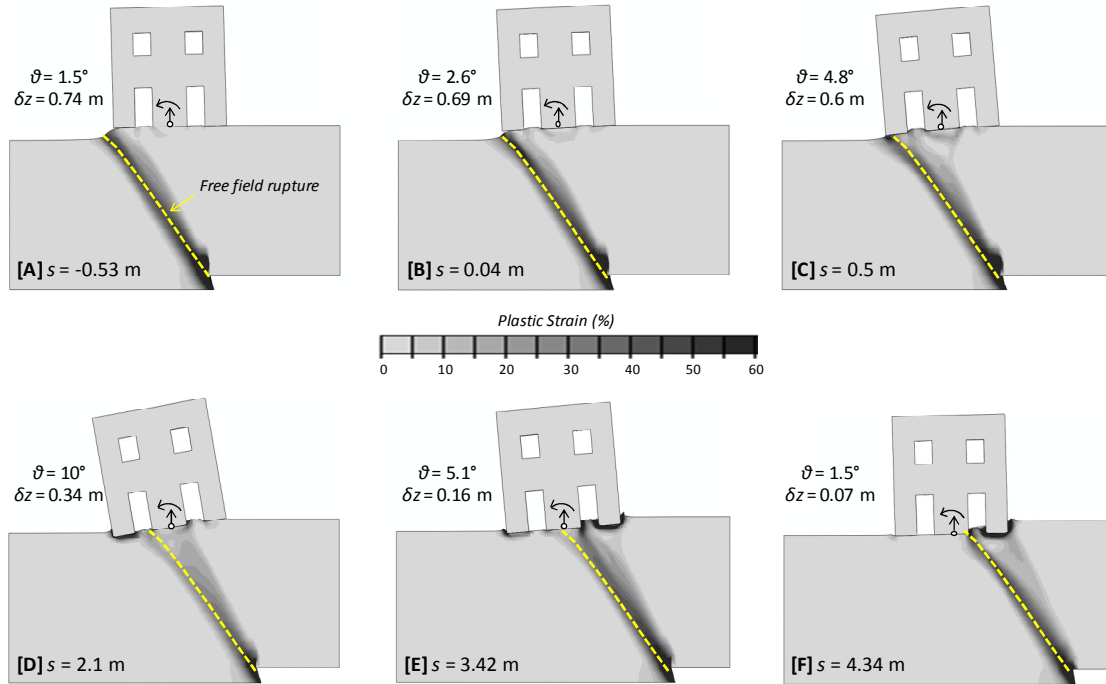
**Figure 5.** Fault rupture–structure interaction with respect to position parameter  $s$  for 0.8 m of fault throw .

**Figure 5** serves as an illustrative demonstration of the so called fault rupture–soil–foundation–structure interaction (FR-SFSI) phenomenon which is herein addressed with particular emphasis to the structure position  $s$  with respect to the fault. The figure portrays a set of six cross-section views of the deformed FE mesh with superimposed plastic strain contours for six different positions of the masonry wall. Plastic strain localizations indicate in every case the dominating soil failure mechanism, characterized mainly by the propagation of fault deformation but also by the soil deformation due to the displacement of the structure.

All six deformed FE mesh snapshots refer to 0.8 m of bedrock displacement. It is evident that the presence of the masonry structure on the way of the fault alters more or less the free field rupture path, the extent of this effect ranging from very limited to dramatic depending on the exact position of the structure. Minimum appears to be the deviation of the fault rupture pattern from the free field fault plane in cases A and B. Yet, as the free field fault–structure interaction point moves towards the hanging wall, and hence the fault outcrops at some position underneath the foundation base, soil failure does not localize upon a single well-defined plane but spreads into a wider zone. This is associated with either (i) diffusion of the fault deformation in a wider area under the structure body as in cases C and D or (ii) formation of secondary fault strands, which deviate from the main rupturing plane propagating with greater dip angles to outcrop off the foundation area towards the hanging wall (as in cases E and F). Domination of strikingly different fault rupture patterns for different positions of the structure naturally brings about equally important differences in its response. The latter is pointed out by the variation in the magnitude of foundation displacements (rotation  $\theta$  and vertical displacement  $\delta z$ ) illustrated in **Figure 5** for the specific fault throw magnitude ( $h = 0.8$  m). In a few words, it may be observed that in cases A and B, where the fault crosses the structure near its left edge, the response of the structure is governed by translational movement which follows the movement of the hanging wall. By contrast, minimum rigid-body displacements are associated with positions where the fault crosses the structure near its right edge (case F) when the structure remains stationary standing almost entirely on the footwall side. Intermediate positions are characterized by a combination of translational and rotational movement and peak rotational response occurs in the range of possible positions  $s \approx 1 - 2$  m.

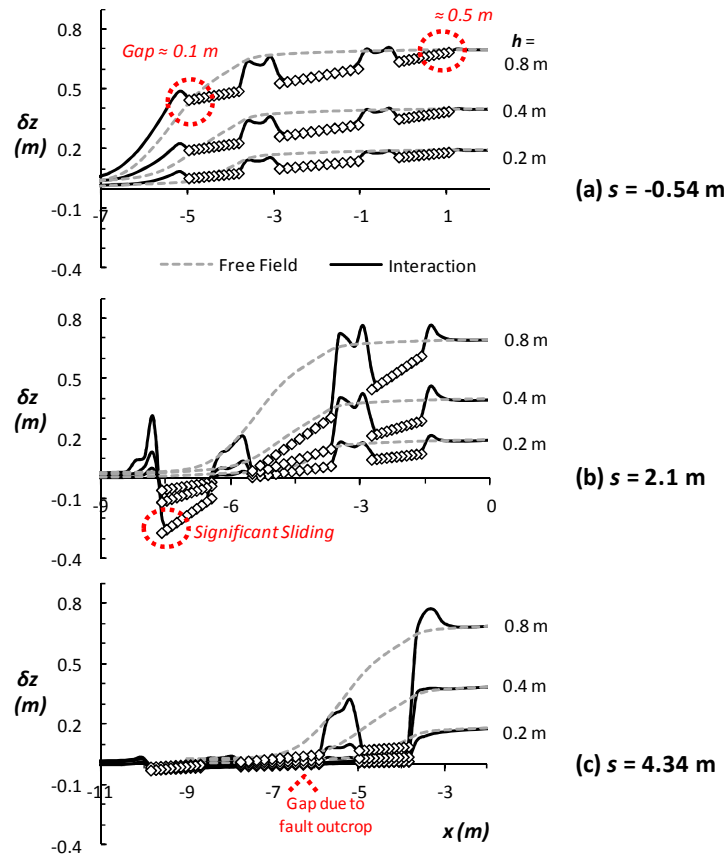
**Figure 6.** Surface displacement profiles for three different structure positions for a range of fault displacements.

**Figure 6** compares the surface displacement profiles for these three characteristic positions to the case of fault propagation in the free field (dashed gray lines) for a range of bedrock dislocation amplitudes  $h$ . In the case of  $s = -0.54$  m the structure obviously moves along with the hanging wall, standing practically on the edge of the fault crest. Its presence causes only some rather negligible difference in the soil deformation pattern with regard to the response in the free field. Contrastingly different is the case for  $s = 2.1$  m. Here the free field fault would cross the centre footing near its middle point, but interaction mechanisms take place to drastically modify the response. Fault deformation propagates over a wide soil area, which spans the entire width of the centre footing and forms two distinct soil bulges at both door openings, where relative fault displacement takes place thanks to the reduced stress field. As a result, the structure experiences very large rotational displacements. Finally, in the case of  $s = 4.34$  m the fault practically outcrops on the right (hanging wall side) of the structure, leaving it barely undisplaced on the footwall side. Furthermore it is worth observing the excessively nonlinear soil–foundation interface response, manifested by evident sliding and uplifting of the foundations in all three position cases.

Such assessment is conducted in two steps, wherein the structure is first subjected to base displacements according to the results of the preceding FE analyses (see **Figure 6**) and then it is subjected to horizontal pushover loading, aiming to take account of the following two response parameters: (i) the masonry wall damage induced owing to the deformation of its foundation level, and (ii) the effect of this on the ability of the structure to carry lateral loads, or in other words, the effect of fault displacements to the seismic vulnerability of the structure. It should be pointed out that the second step constitutes a simplified, yet essential, attempt to couple the components of fault rupture load with the naturally associated seismic (lateral) loads. Characteristic results of this analysis are shown in the following in terms of lateral load ( $V$ ) versus lateral displacement ( $u$ ) pushover curves accompanied by corresponding snapshots of the deformed wall with indication of damage patterns.

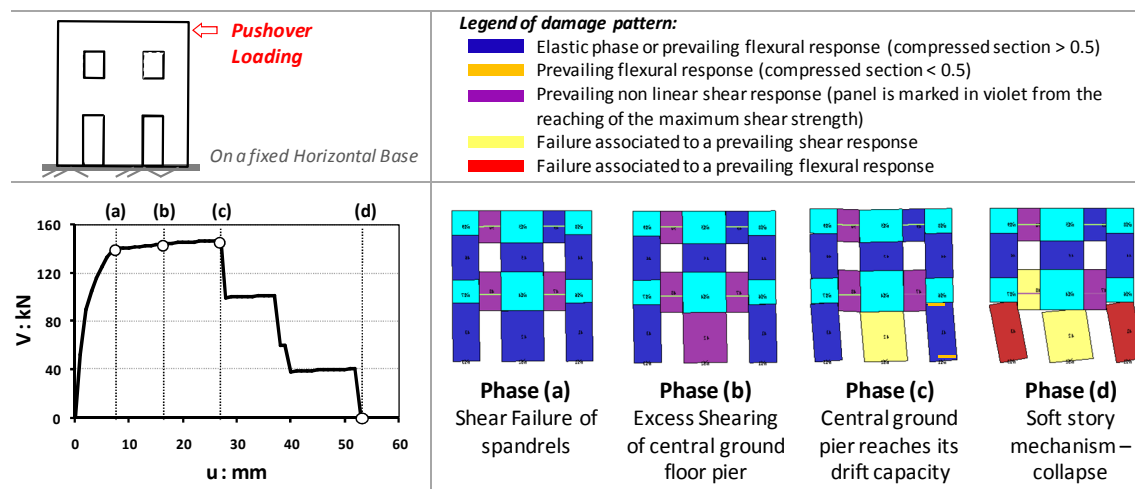
**Figure 7.** Lateral load ( $V$ ) versus horizontal displacement ( $u$ ) response and associated evolution of the wall damage for the case that the structure is *not* affected by permanent ground displacements due to fault rupture.

For clarity, it is necessary to briefly discuss first the case where the structure is subjected to horizontal pushover loading while standing on a horizontal undeformed base, which serves as reference for comparison. **Figure 7** summarizes the results of such a loading scenario showing the response of the structure in the  $V-u$  domain with particular remarks on critical phases of response and indications of the associated wall damage. Nonlinear response of the structure is signaled by the concentration of shear stresses in the spandrels (phase a), where shear capacity is exhausted after approximately 8 mm of horizontal displacement. Conspicuously nonlinear element behaviour characterizes the response after this point, resulting in excess shearing (phase b) and failure (phase c) of the central ground floor pier. Peak lateral capacity of the structure is reached at this point ( $u \approx 27$  mm) and evident strength degradation takes place thereafter. Finally, after about two times greater lateral displacement, the development of a "soft storey" mechanism leads to collapse (phase d).

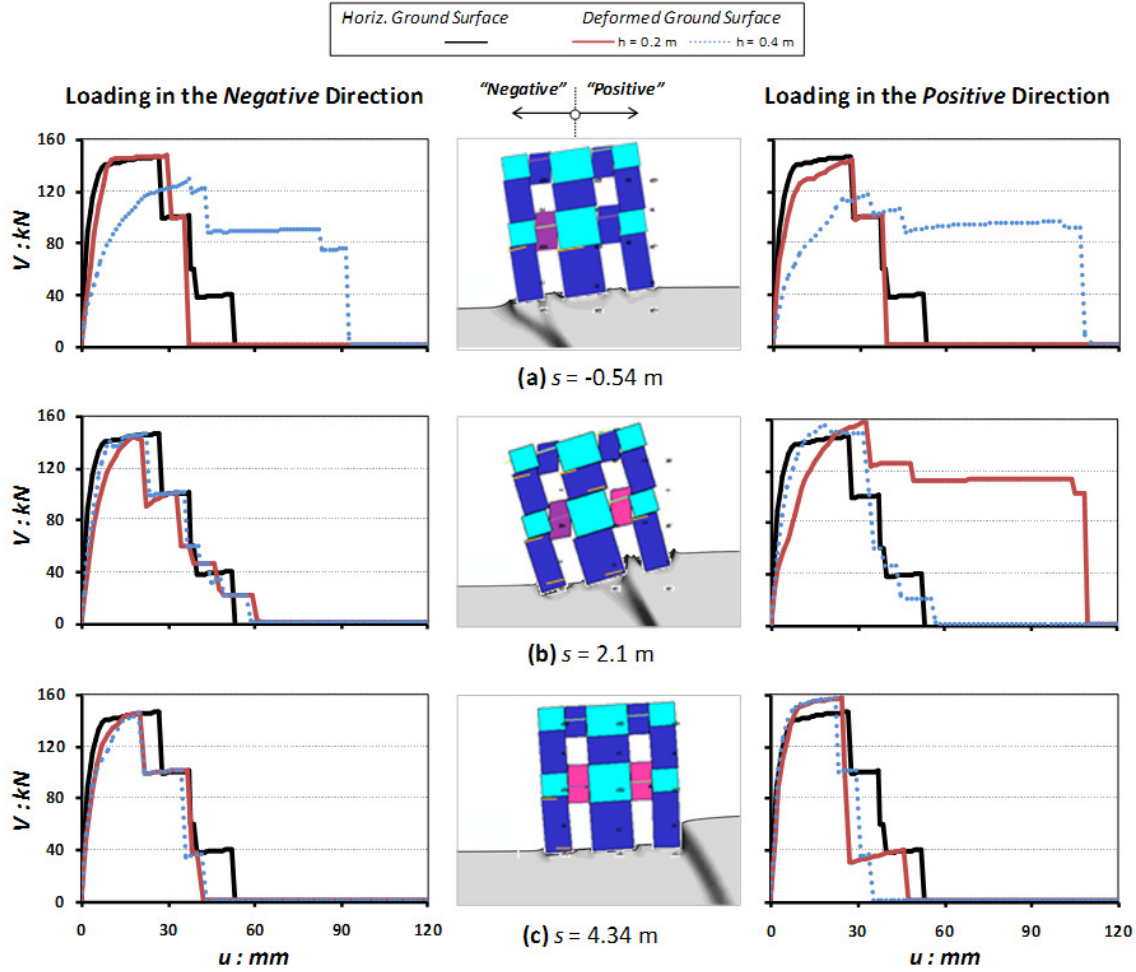
**Figure 8.** Effect of the fault associated permanent ground deformation on the lateral capacity of the structure.

**Figure 8** summarizes the effect of fault rupture ground deformations on the response of the structure for the three considered characteristic positions:  $s = -0.54$  m; 2.1 m; and 4.34 m. It should be noted that due to the assumption of elastic structural response in the FE analyses, it was considered realistic to focus on relatively small amplitude tectonic displacements which would not induce profoundly nonlinear structural response. Hence, the presented results refer to fault throws of 0.2 and 0.4 m.

The three illustrated schematics combine results from the FE analyses, showing in each case the prevailing interaction mechanism, with results from the equivalent frame structural analysis, indicating the amount of structural distress induced after 0.2 m of fault displacement. The indicated wall damage configuration suggests that nonlinear response does take place in all three cases, although limited to the spandrels, even for such small bedrock displacement. Characterized by shear overload of the spandrels, accompanied in some cases with considerable flexural distress in the piers, the damage pattern experienced by the wall is quite similar in all three positions, being yet evidently more intense in the case of  $s = 2.1$  m wherein the fault outcrops just underneath the structure causing amplified foundation rotations in comparison to the other two cases.

$V-u$  plots highlight the “asymmetry” in the effect of ground displacements, comparing the response of the structure during lateral pushover loading after 0.2 m or 0.4 m of fault displacement with the benchmark scenario of undeformed base for loading in the “positive” direction (against the direction of fault displacements) or in the opposite (“negative”) direction. It is interesting to observe that there is no clear trend in the effect of increasing bedrock displacement, and in some cases the response varies significantly with respect to  $h$ . Yet, it can be generally deduced that due to the damage caused by fault displacements, the stiffness is reduced in all of the investigated scenarios. Furthermore, loading in the “negative” direction consistently causes deterioration of the structure capacity, in terms of maximum load and/or ductility, in comparison to the benchmark scenario. Less straightforward appear the results for loading in the “positive” direction, as in some cases the counteracting fault deformations surprisingly lead to an increase in the maximum lateral load capacity of the structure.
